SECTION 1 – INTRODUCTION

BONDURANT
ARCHITECTURE

COMPASS POINT SOUTH AT WINDSTAR

Site-Visit Date:
August 09, 2023

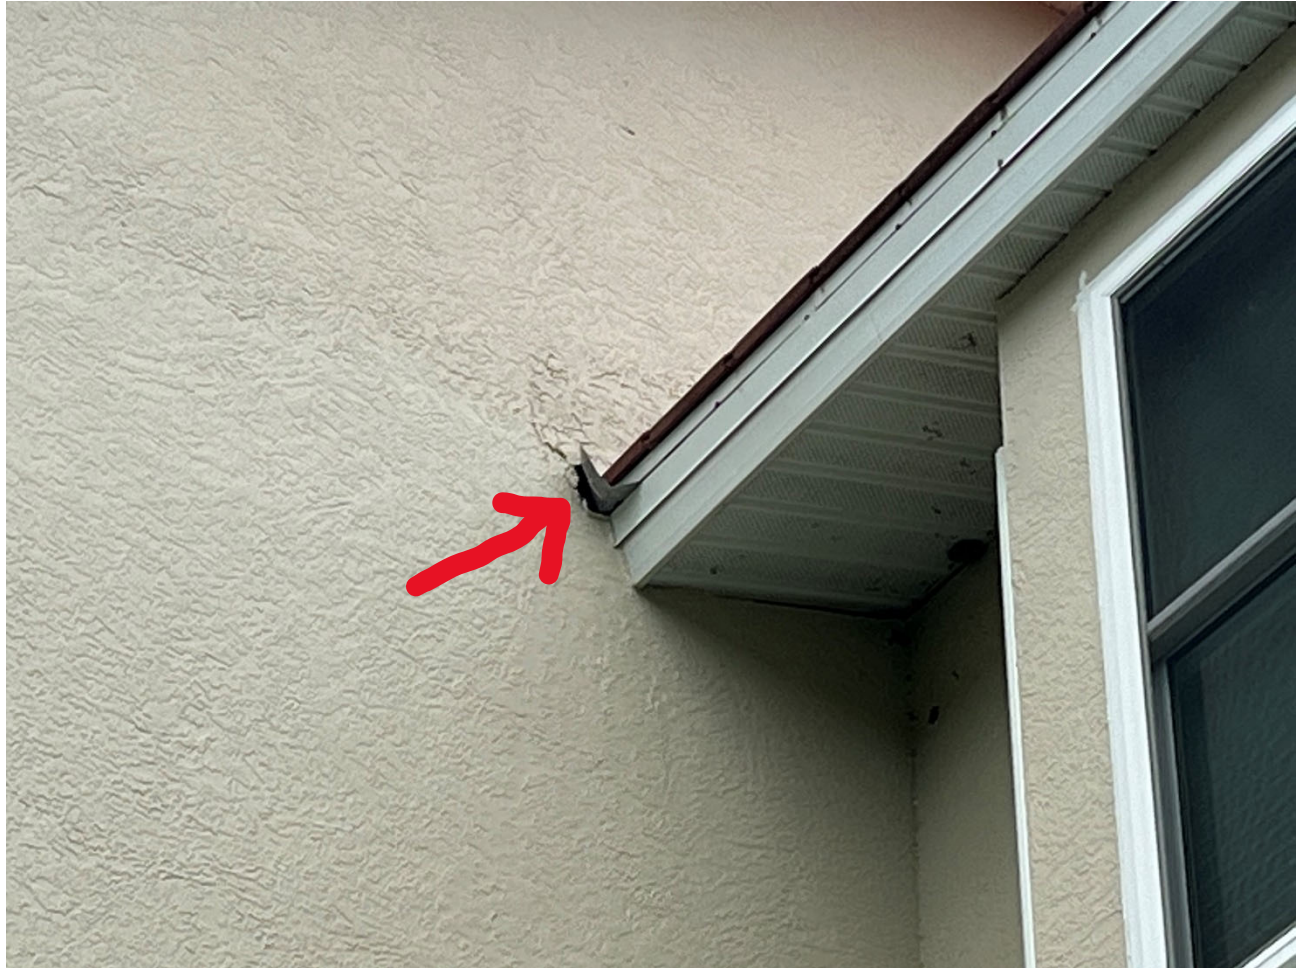
Stucco Repair Needed on Left side of Building 3522

There was an area at the intersection of the left wall and the overhang of the setback that looked to have a significant opening in the stucco finish just behind the metal flashing diverter. Suggest having a stucco technician review this intersection to assure no moisture is being allowed to penetrate behind the surface of the stucco.

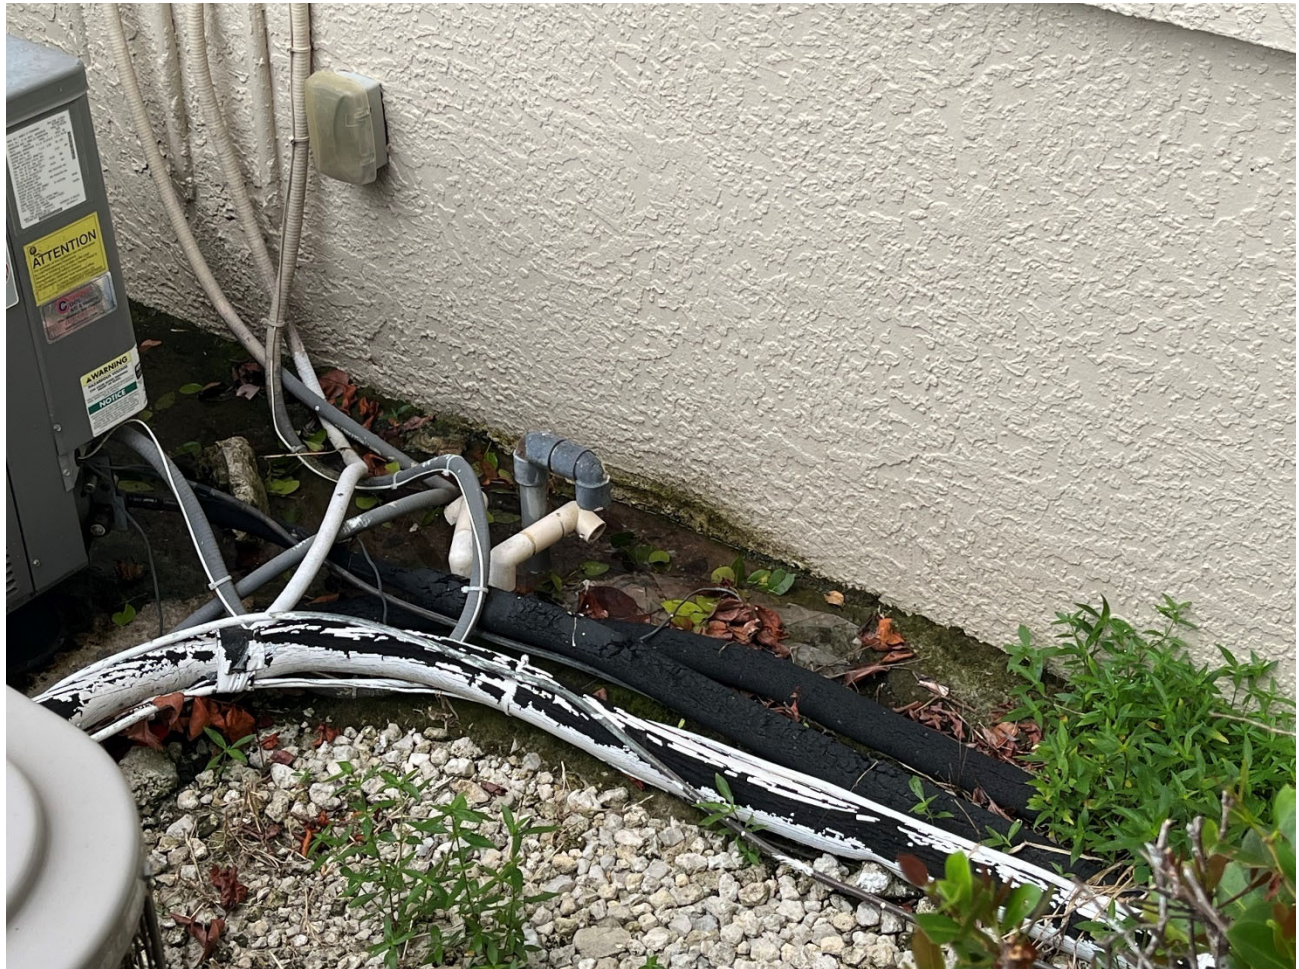
Ponding of Condensate Against Building 3522

Also on the left side of this building was an area where some condensate drains from the air conditioners was emptying. The water was ponding against the building which can lead to a deterioration of the supporting soils and/or the structural components of the foundation. Suggest either having this area graded so it slopes away from the building, or install a drain to route water away from the building.

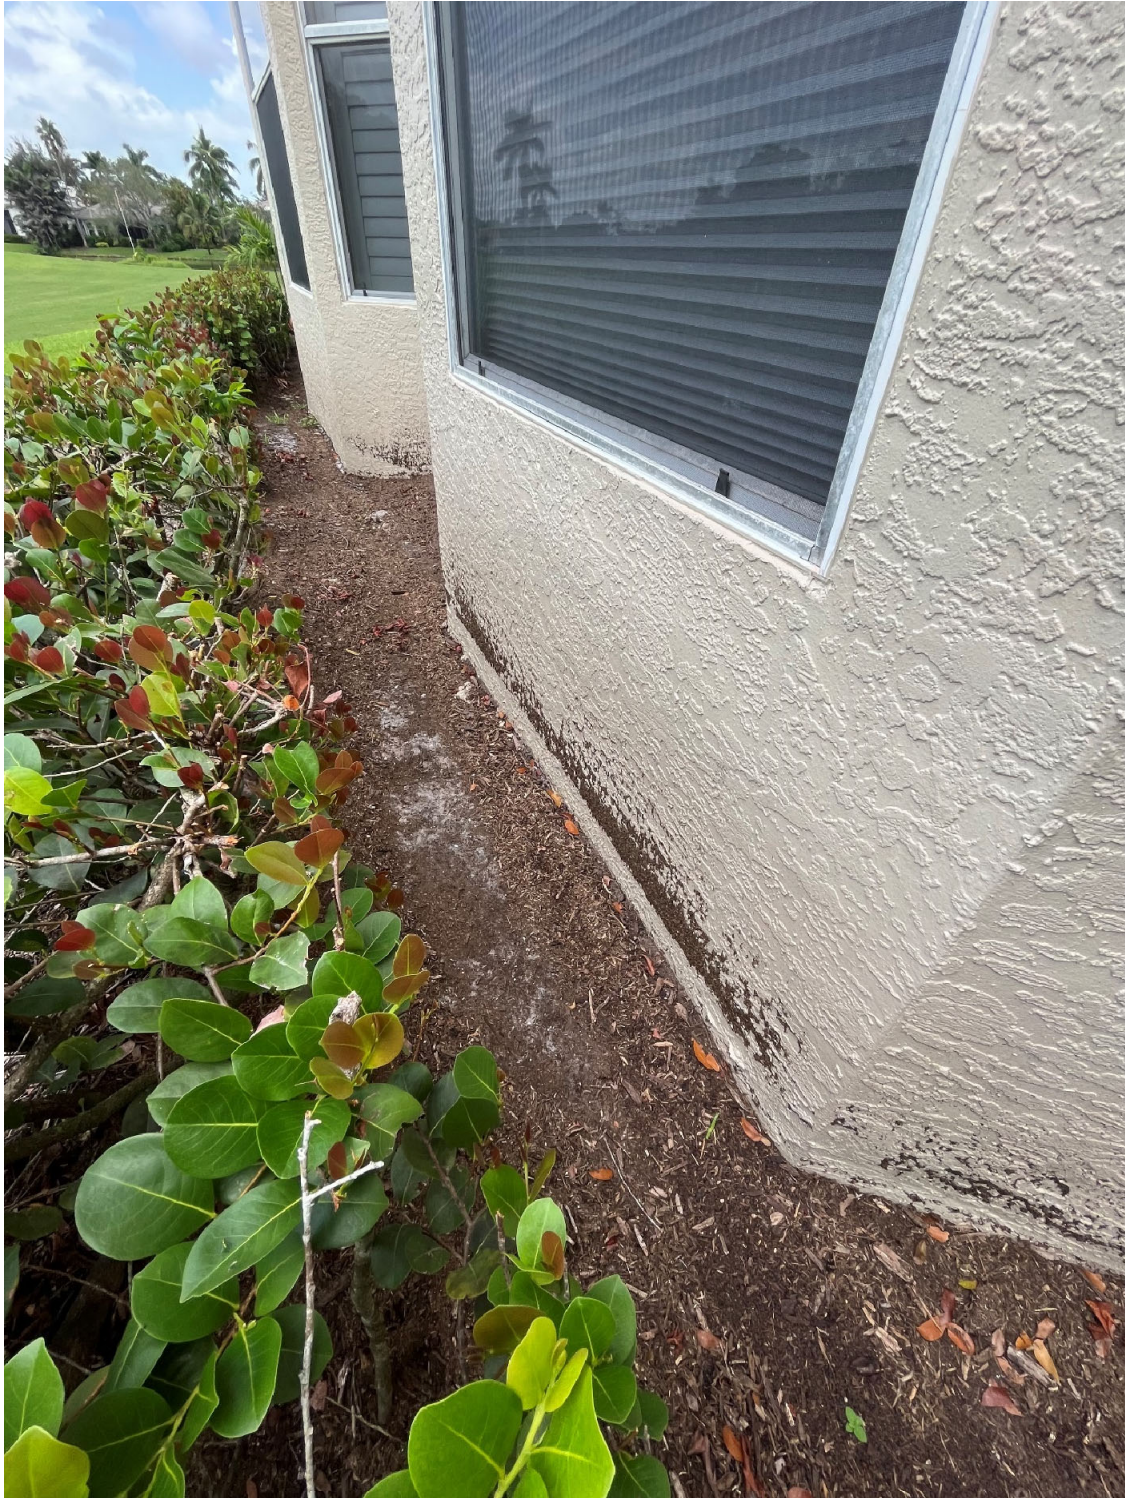
Dirt Splashed onto Building

This condition was observed in a few locations on several of the buildings. The dirt is being splashed onto the building by the rain running off the roof and dropping a long distance to grade. Gutters on the rear of the building would solve this issue but if gutters are not desired, then more impact resistant materials on grade could prevent this splash up. See following photo of solution behind Building 3570 that well addresses this condition.

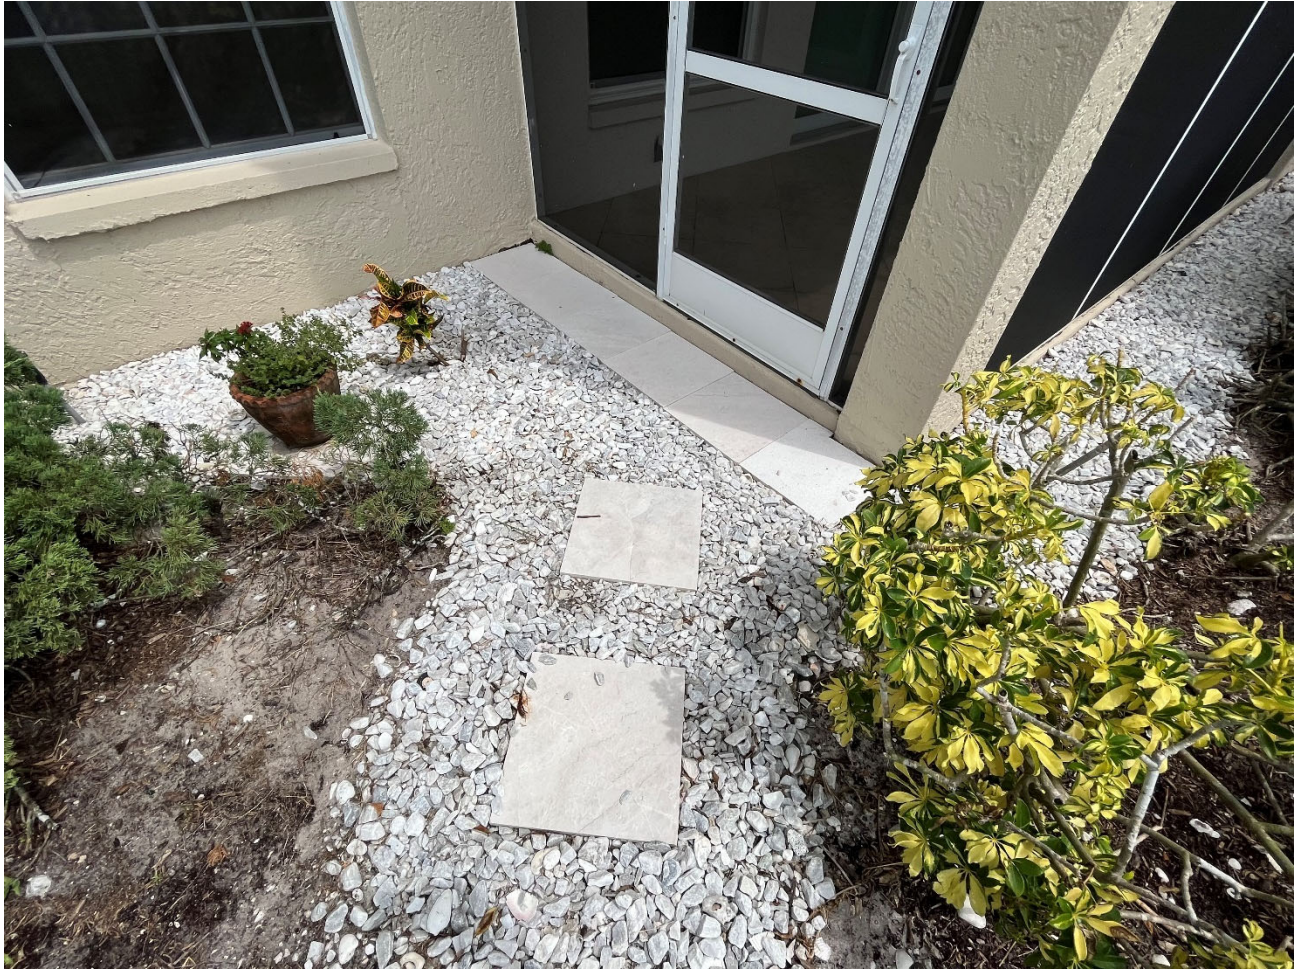
One Effective Solution to Splash Up Problem

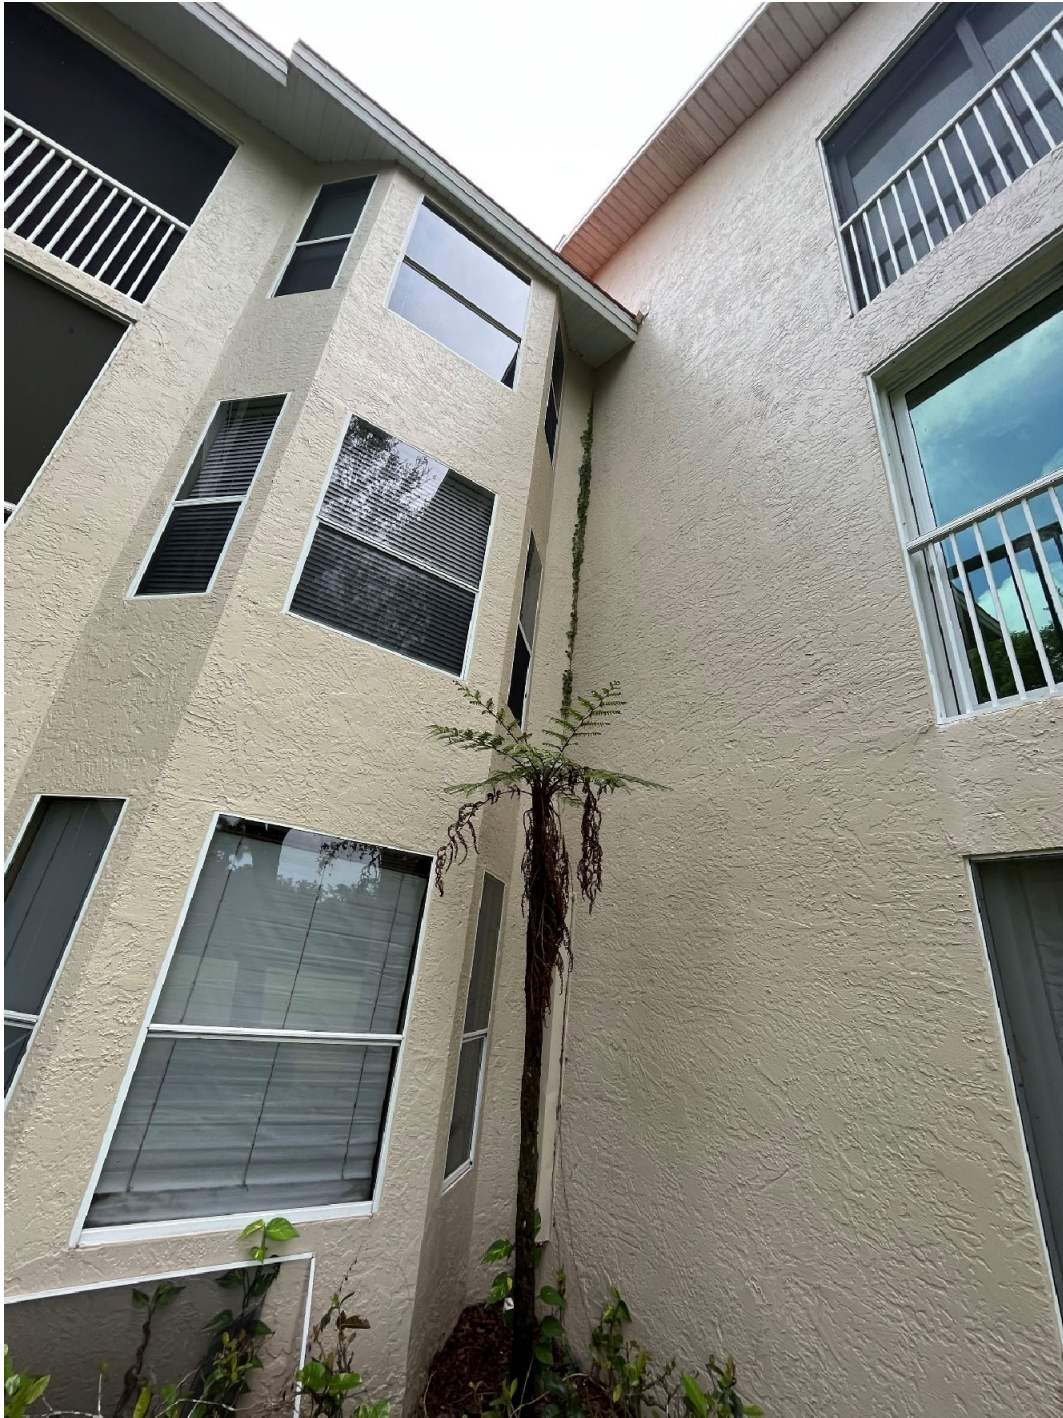
Landscaping Growing Up Face of Building

In one of the inside corners on the rear of the building, a vine was being allowed to grow. These organic materials can damage the stucco and components on the face of the building. Suggest having this vine removed, and keep all landscaping trimmed off the face of the building.

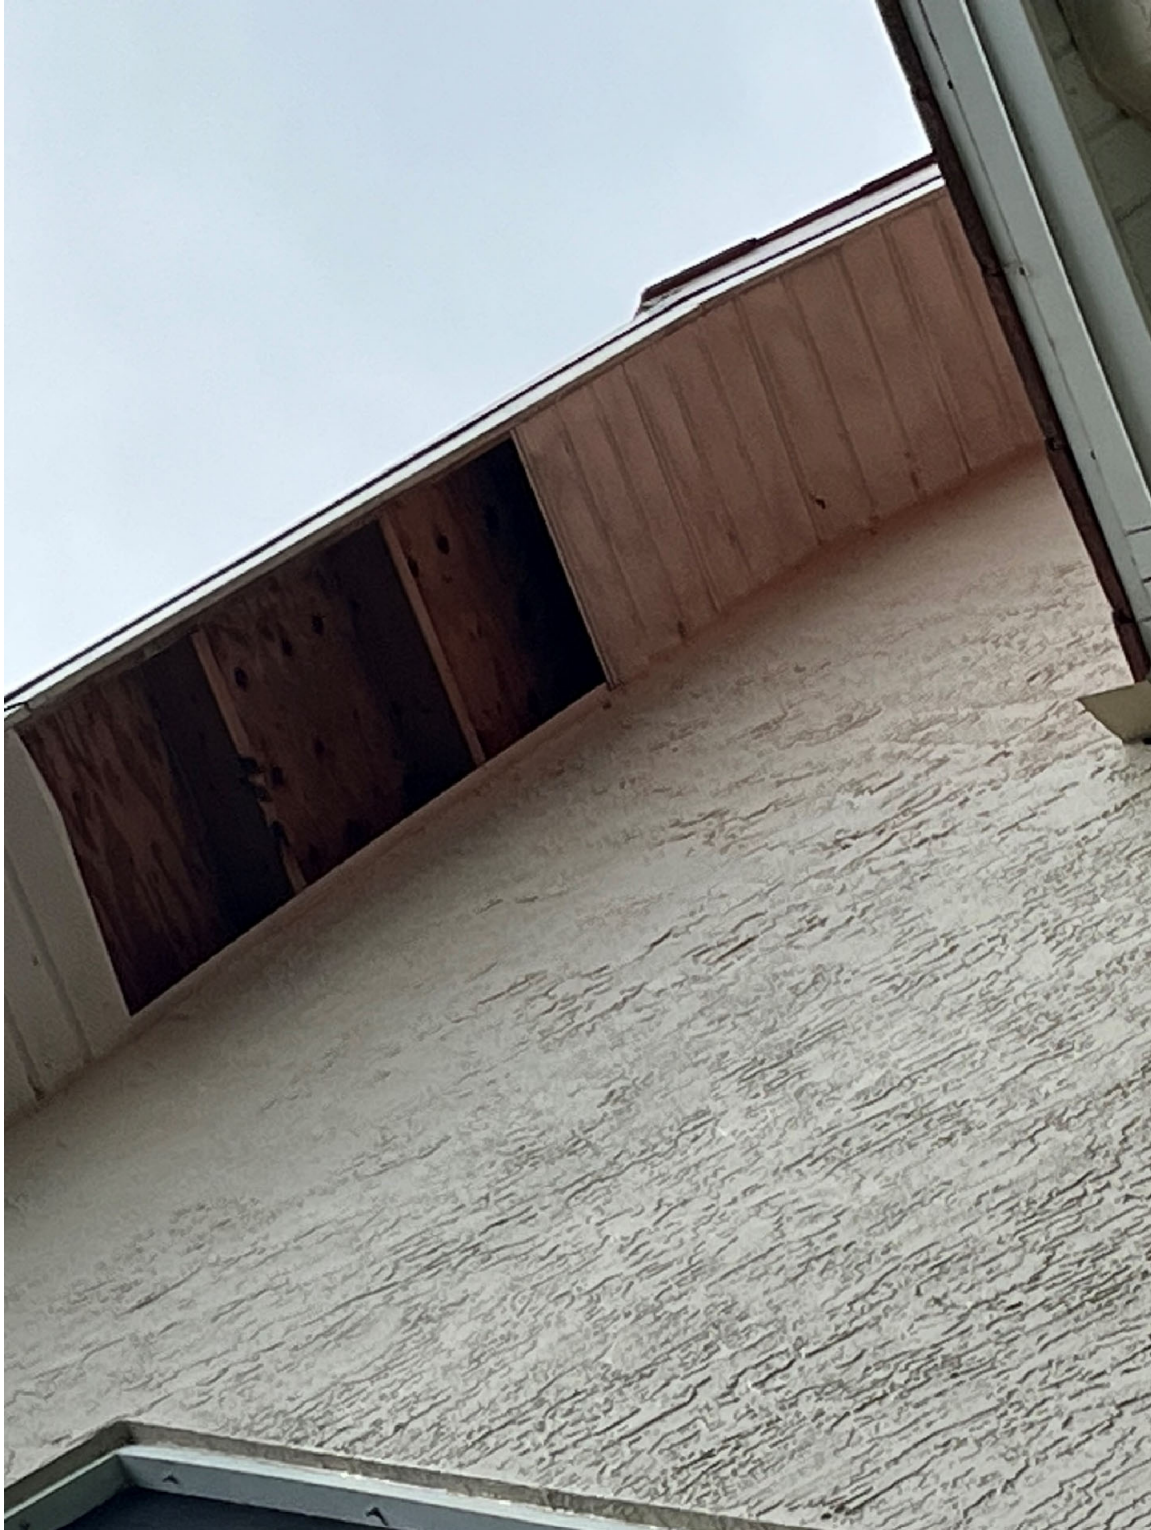
Missing Soffit Material from Eave on Left Side of Building

On the left side of the building there was a significant amount of the soffit missing. This covering protects important structural components from moisture. Suggest having this condition repaired as soon as possible, and the adjacent soffit materials evaluated to see if more water damaged parts need replacing as well.

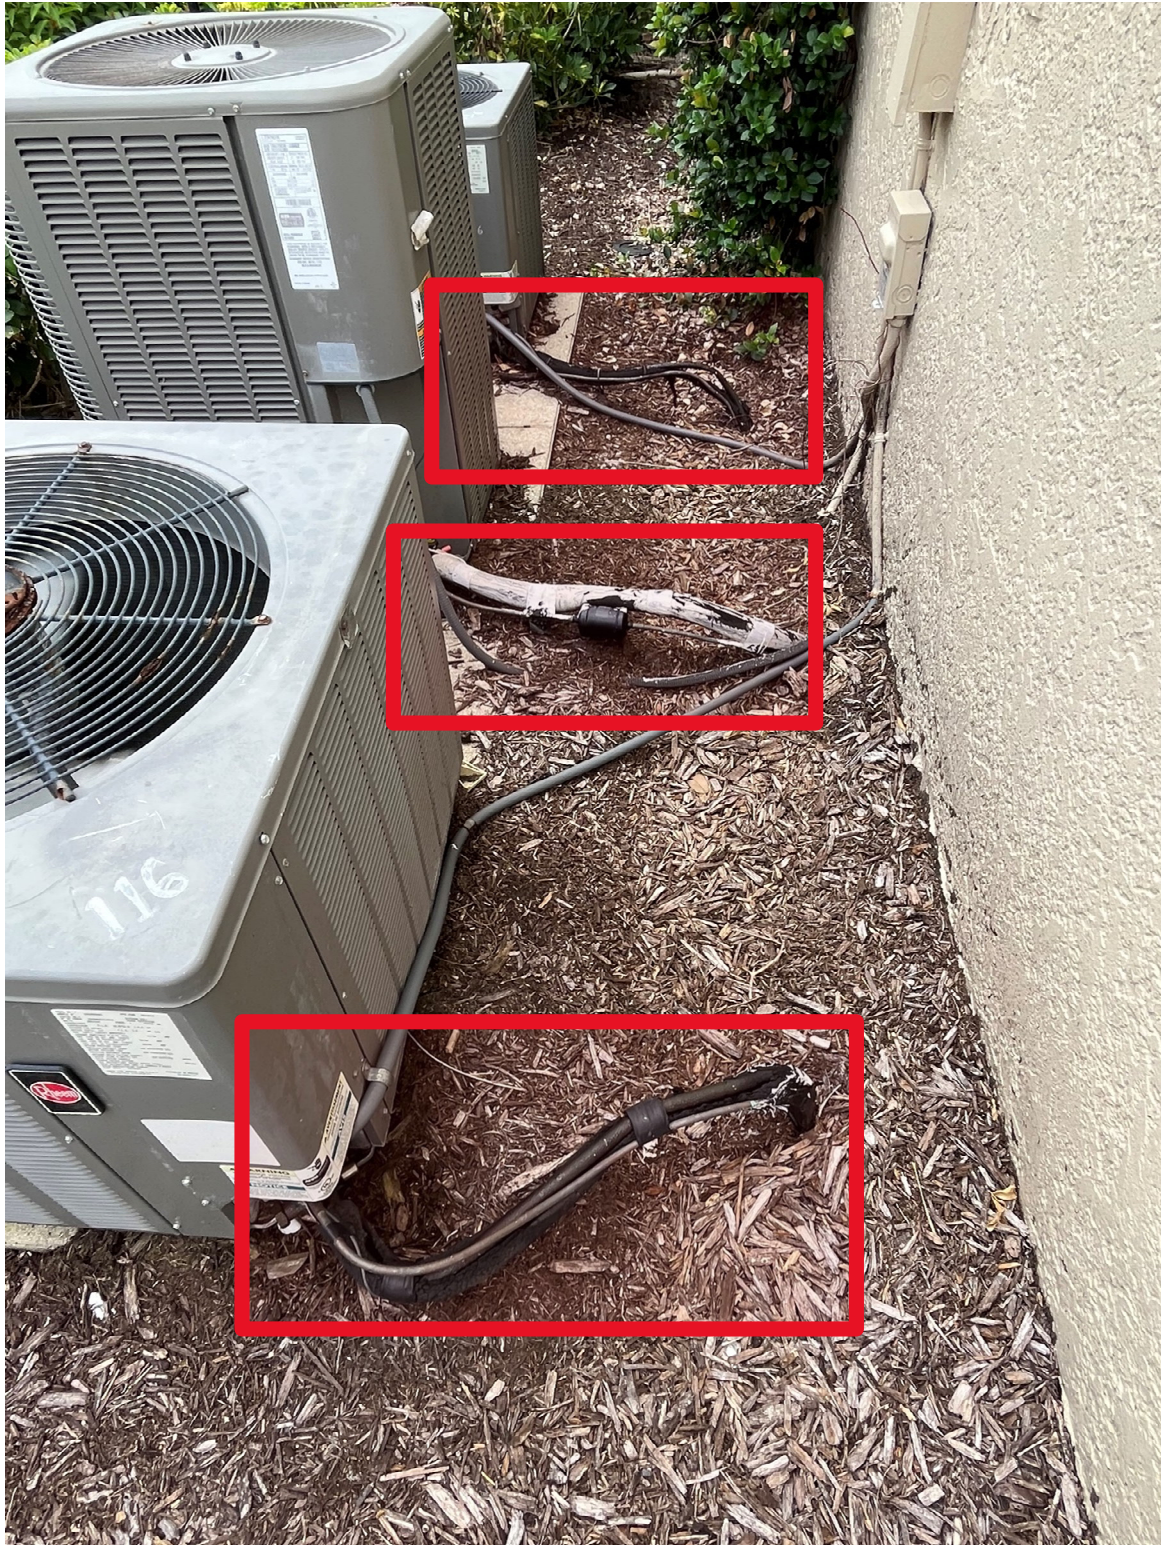
Missing or Damaged Coolant Lines on AC Units

On the front right of Building 3570, the inspector observed the insulation on the condenser coolant lines was either damaged or missing. This decreases the efficiency of the unit and can shorten the life of the unit and/or these coolant lines. The problem may be worse because of the lack of gutters on the eave above these units. If gutters are not desired, suggest provided some impact resistant covers over them, once the insulation is repaired or replaced.

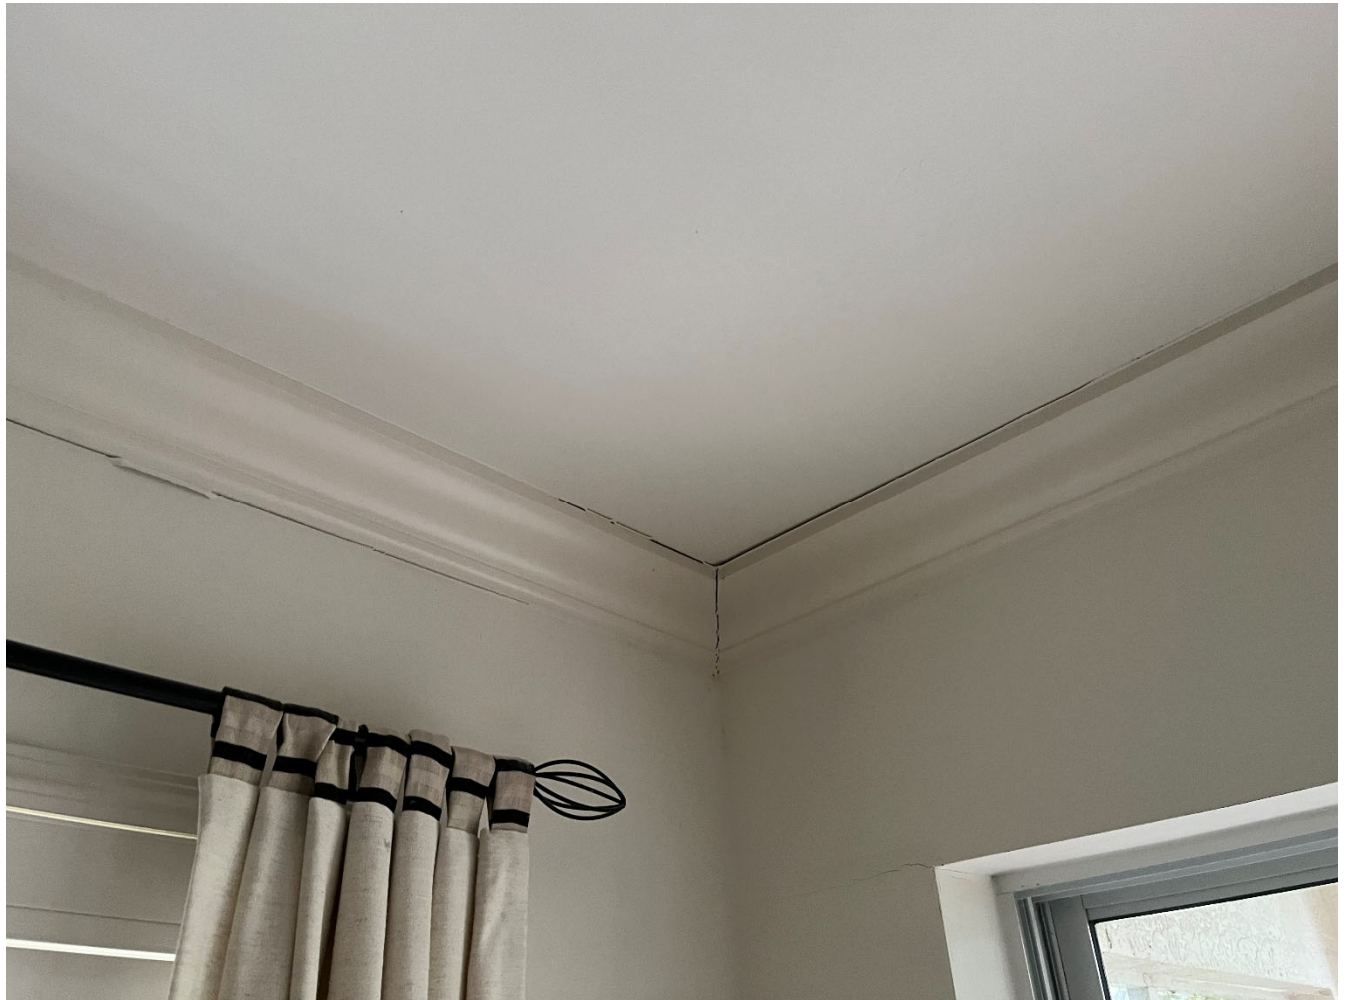
Unit 112 – Building 3538

This Unit 112 had several hairline cracks in and around the crown mould at the ceiling. This is just a cosmetic condition most likely caused by the expansion and contraction of dissimilar materials; however, inspector suggests having these repaired and monitored over time to see if they try to return. If they reappear, it may be a result from excessive moisture and need further evaluation.

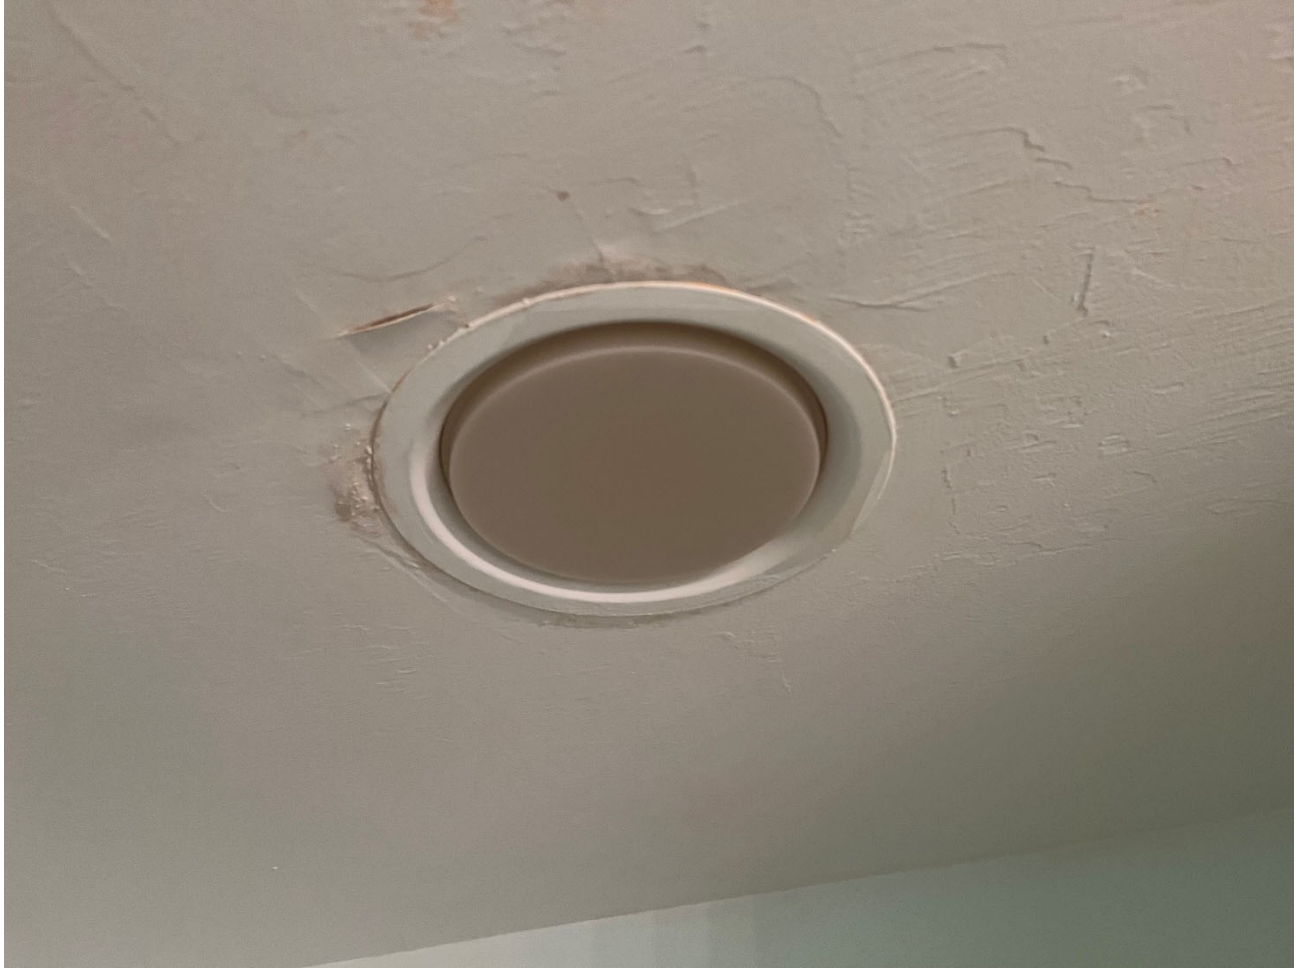
Unit 115 – Building 3538

The shower in the Master Bath of Unit 115 had some water damage around the light fixture above it. Water in electrical components is a safety hazard so inspector suggests having this condition evaluated to be sure that water leak above this area has been corrected. Repair water damaged areas and monitor for any reoccurrence.

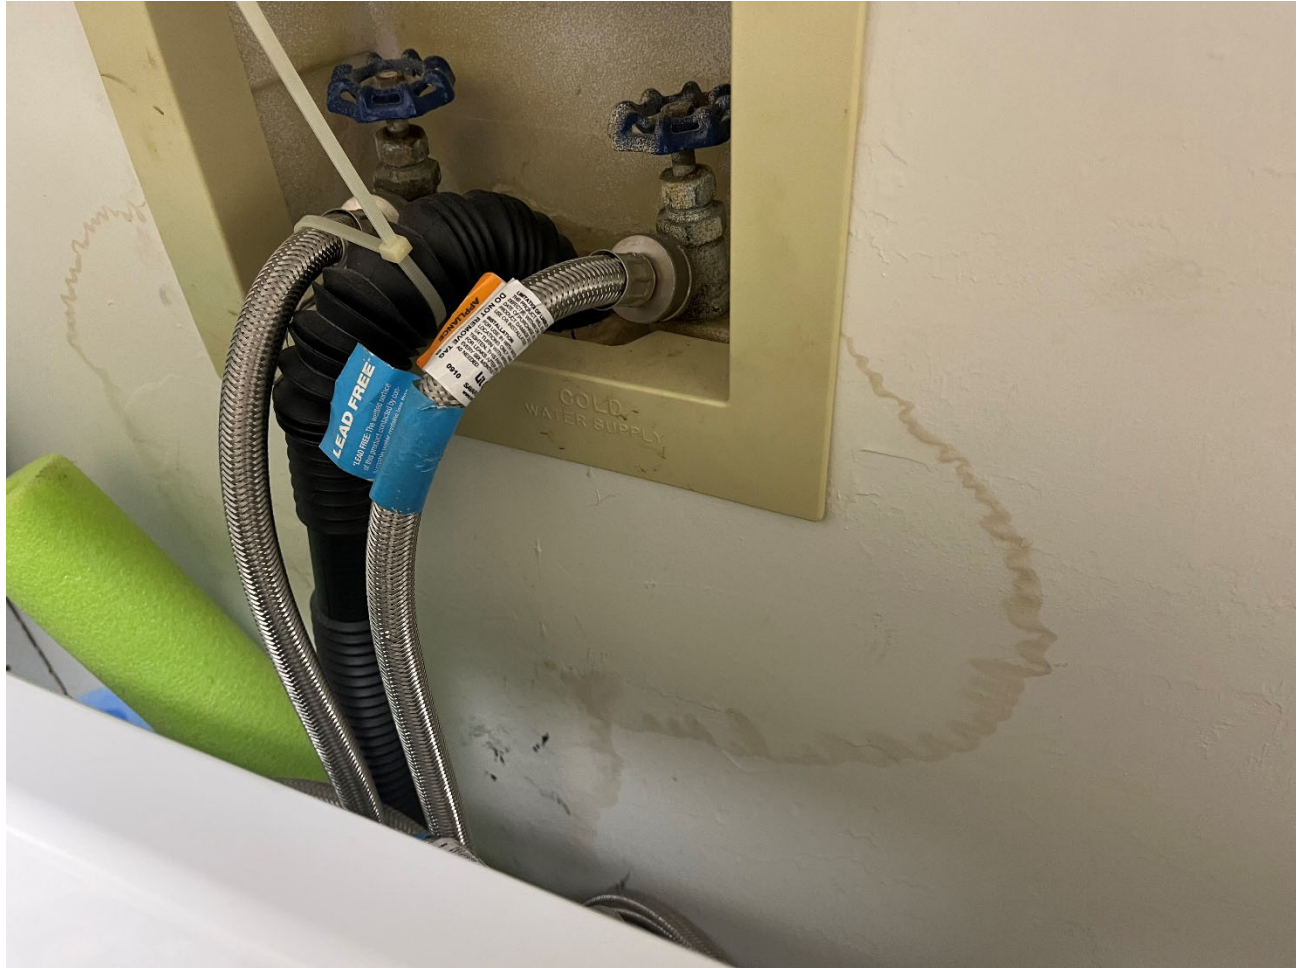
Unit 116 - Building 3538

This unit had a water stain around the washer connection box. A chronic leak in this area can erode or damage structural components over time. Suggest having plumber evaluate this area to be sure that water leak has been fixed. Paint over this water stain with a high coverage primer (i.e. Kilz), then apply final coat of paint. Area should be monitored after repair to see if evidence of a water issue tries to return.

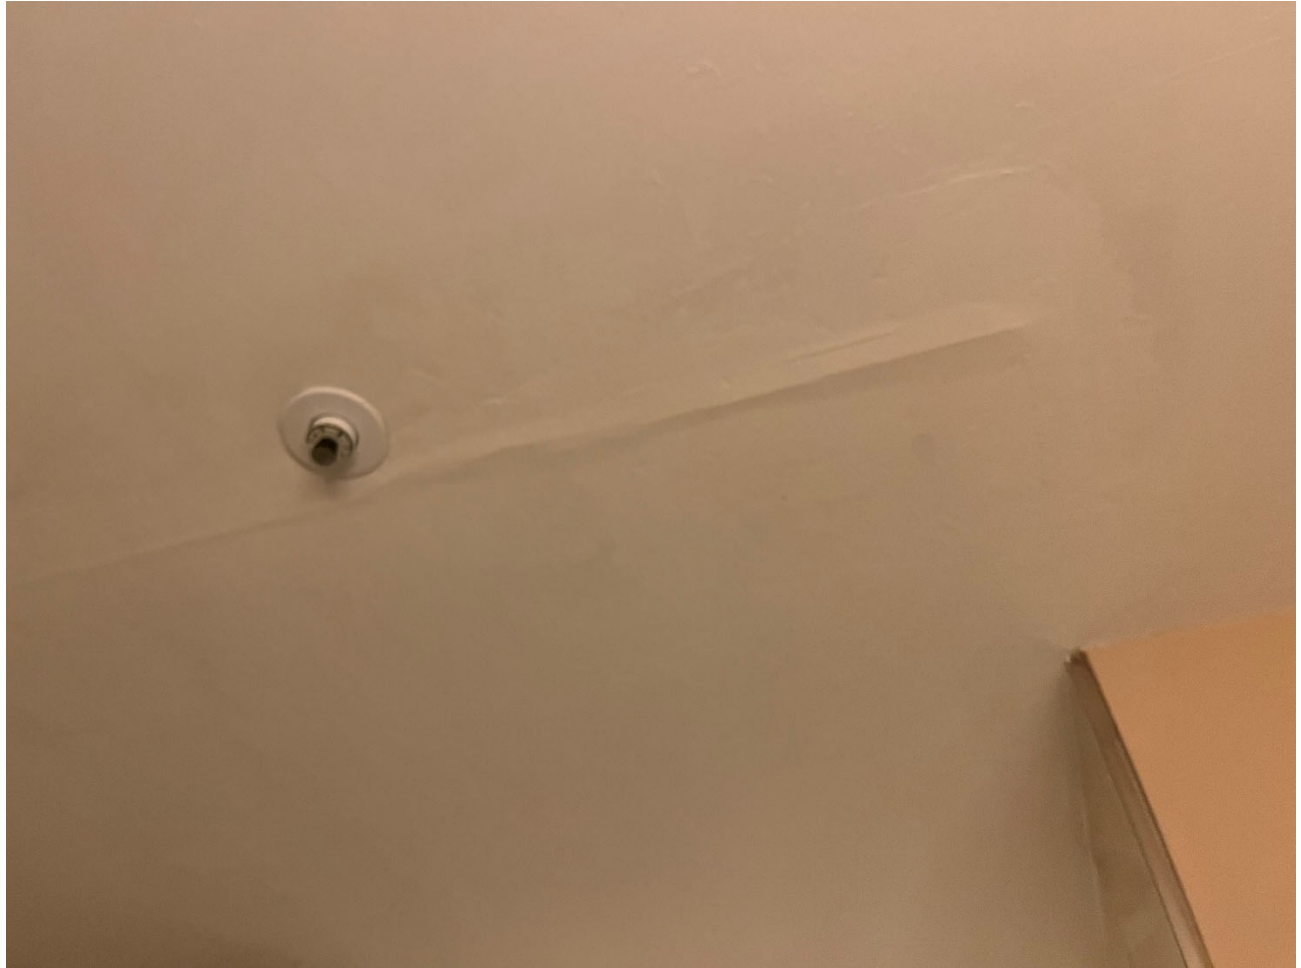
Unit 131 – Building 3538

This photo is of the ceiling of the Master Bath in Unit 131. This is evidence that a water issue was realized in this area but has been repaired. Inspector suggests having this wrinkle in the ceiling repaired and then monitored over time to see if it tries to reappear.

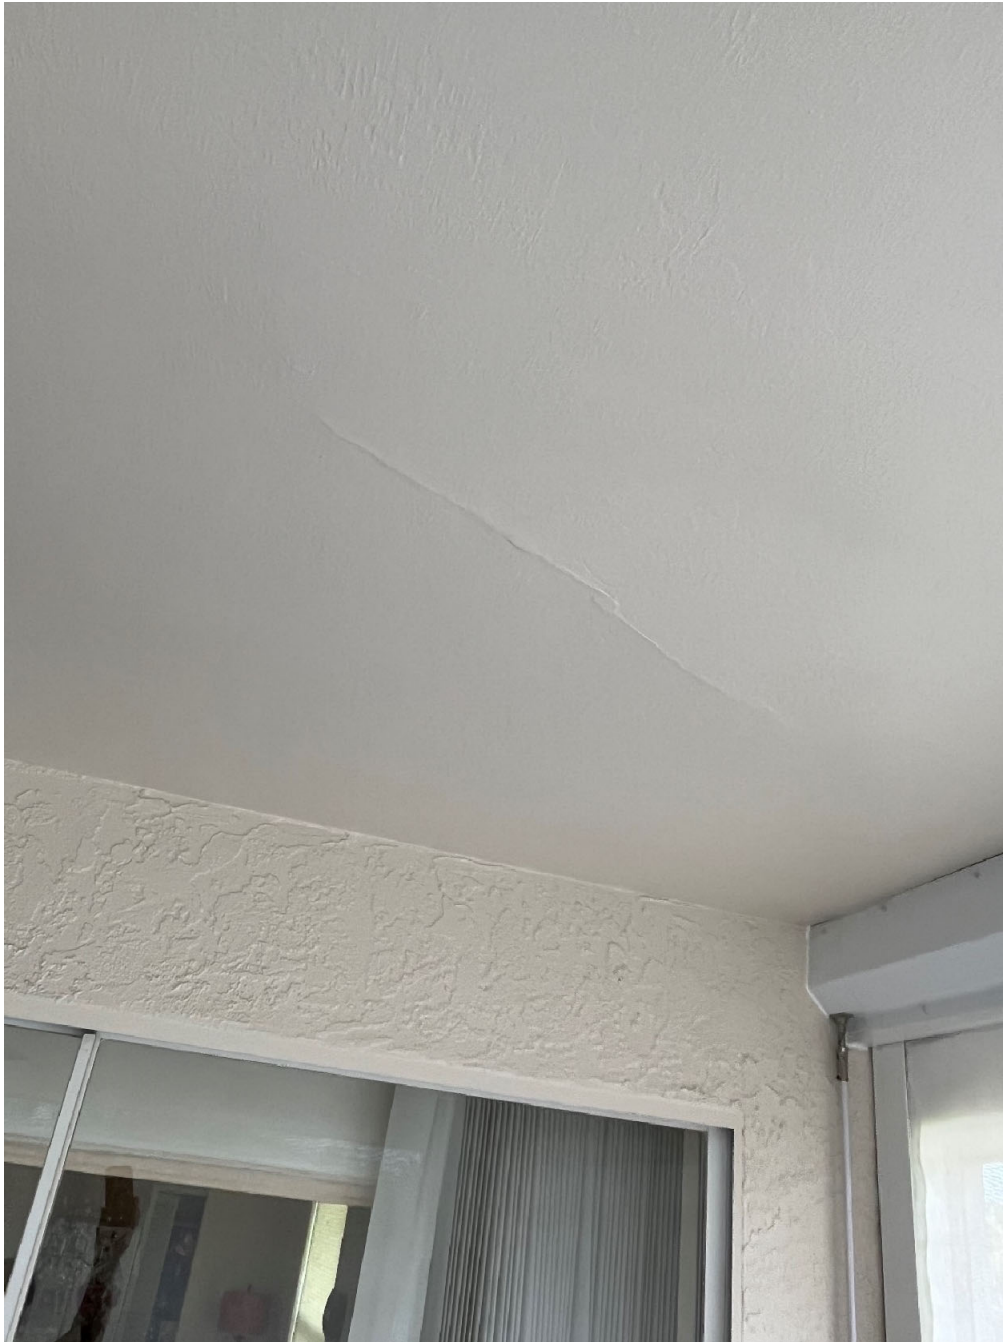
Unit 113 – Building 3554

This Unit 113 had a suspicious wrinkle in the ceiling of the lanai. Issue that caused this condition may have been adequately addressed as no further evidence of leaks or staining was present. Most likely caused by water coming from the lanai above. Suggest having this wrinkle repaired and then monitored over time to see if it attempts a reappearance.

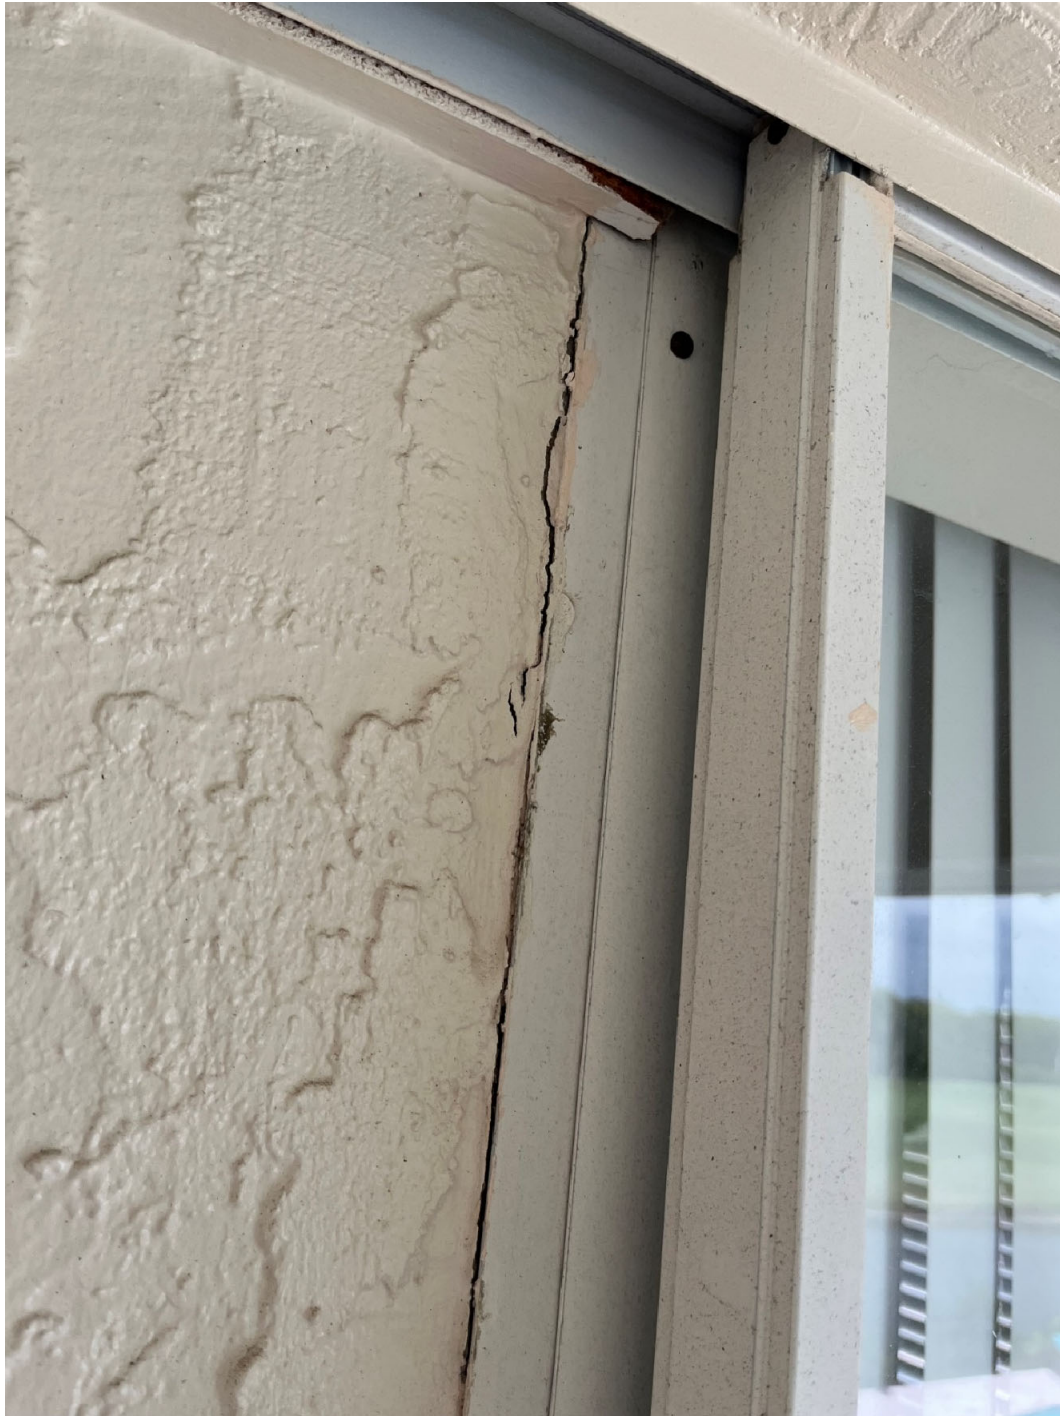
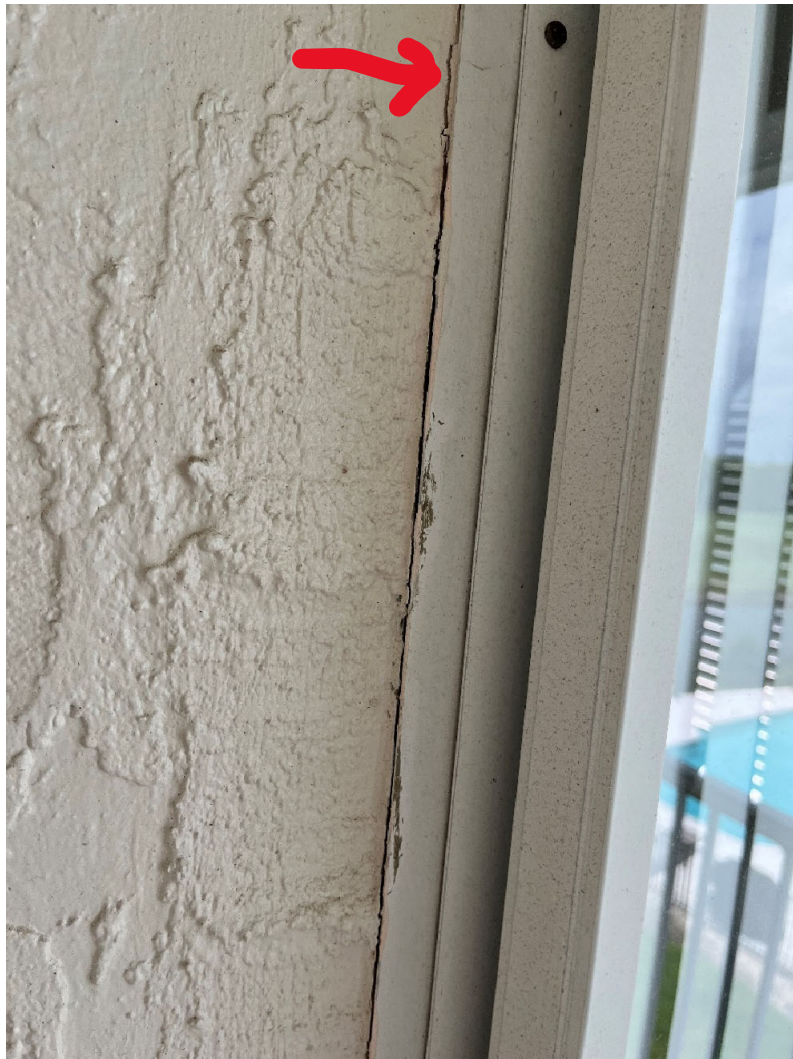
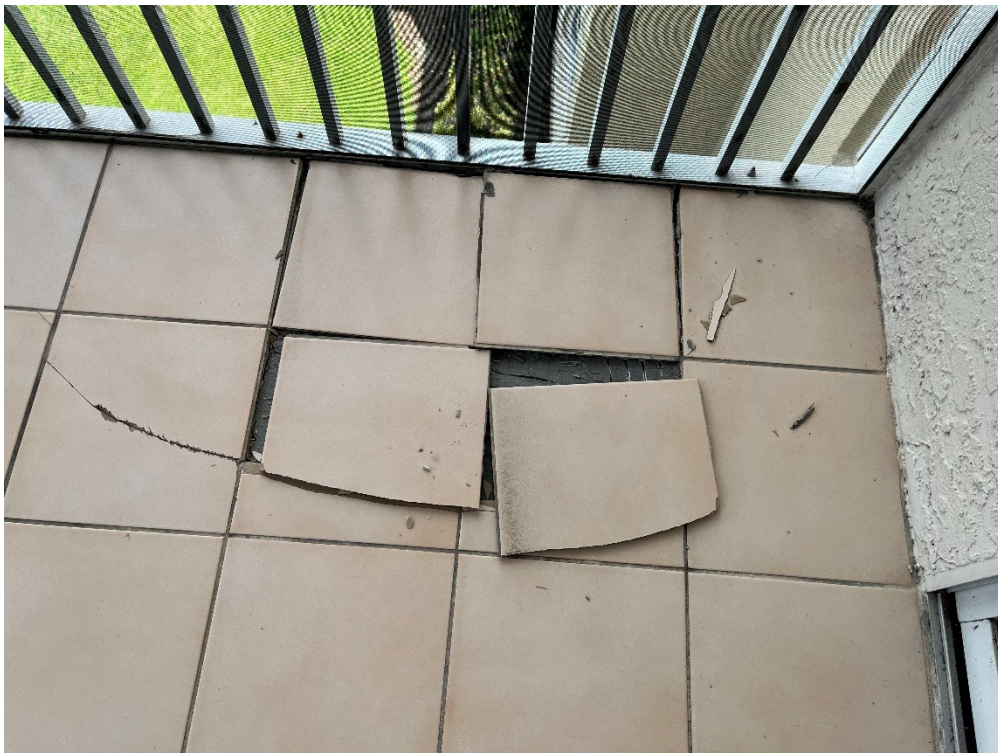
Unit 131 – Building 3554

This Unit 131 had some significant cracks on the lanai adjacent the sliding glass door from the Master Bedroom. This being an outdoor area, it is more critical to maintain a tight seal from the elements. Suggest having these crack calked with a good grade of calk to match the color of adjacent surfaces. Also there were several loose tiles on the right end of the lanai. These tile protect the underlying slab from moisture penetration, which can cause rusting of reinforcing steel in the slab leading to a failure of the slab structure. Suggest having these loose tiles repaired as soon as possible.

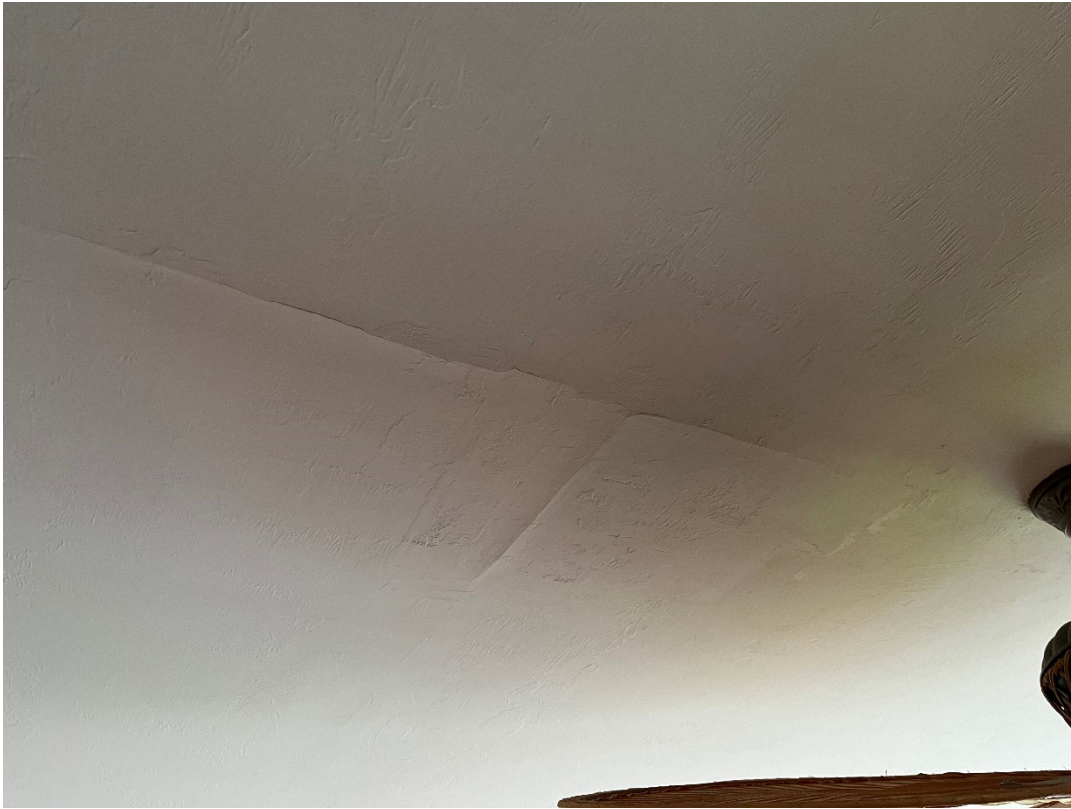
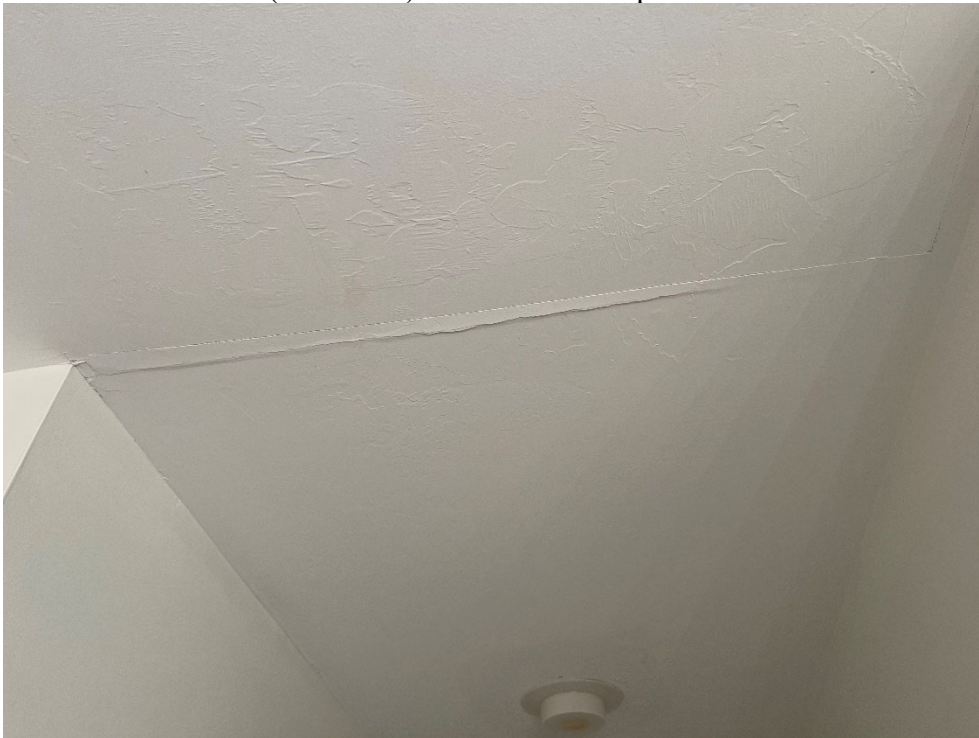
Unit 136 – Building 3554

In this Unit 136, there were some odd-looking cracks in the ceiling near the ceiling fan in the Living Room. Since this unit is on the top floor, this condition was most likely caused by a previous roof leak that was resolved when the new roof was installed. Suggest having these cracks better repaired then monitored to be sure they do not return. Also there was a similar crack over the Master Shower (see below) that should be repaired at the same time.
