SECTION 1 – INTRODUCTION

BONDURANT
ARCHITECTURE

COMPASS POINT SOUTH AT WINDSTAR

Site-Visit Date:
August 09, 2023

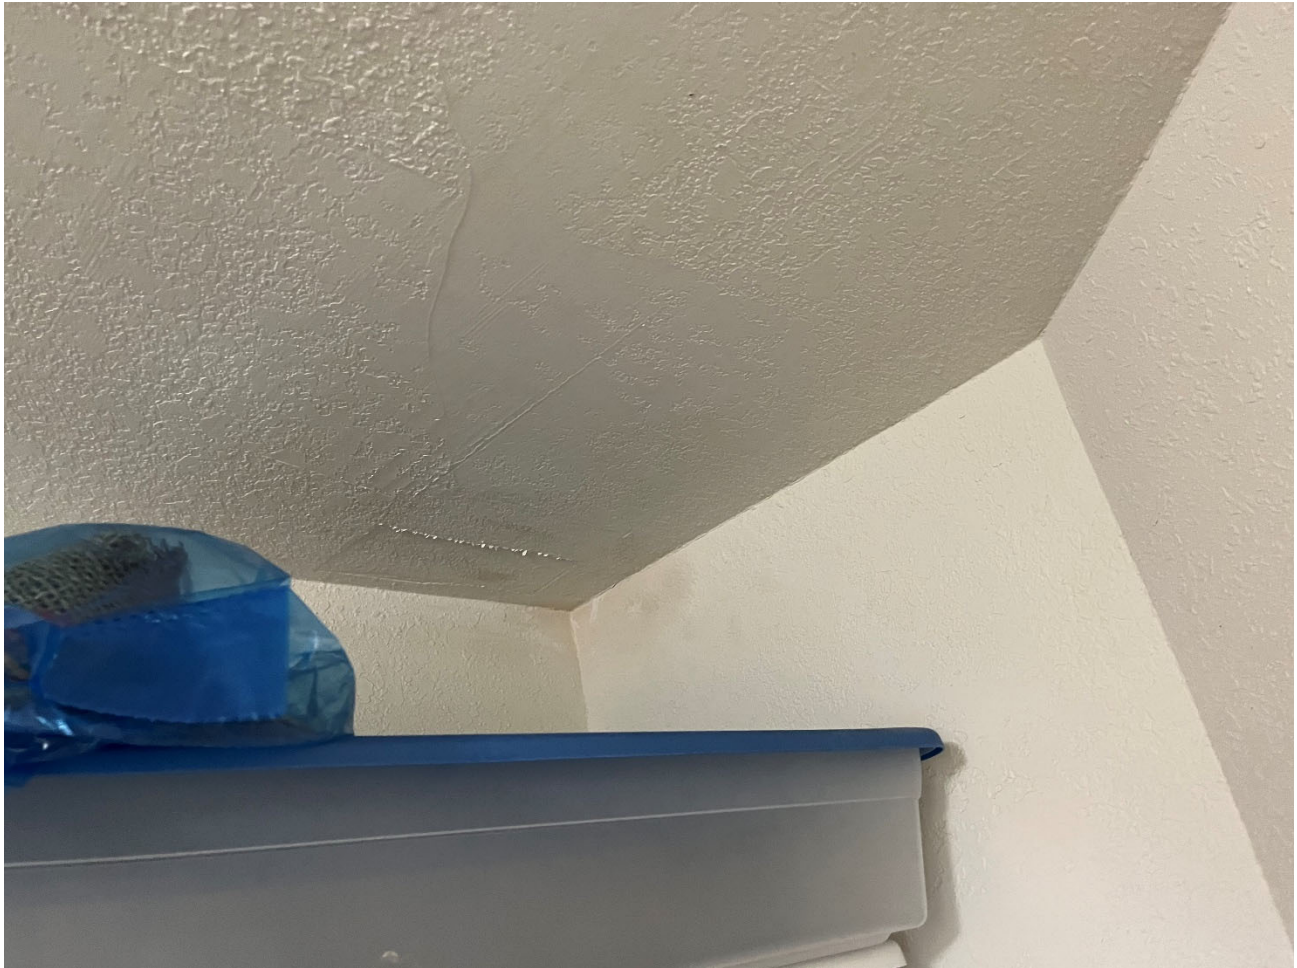
Unit 112 – Building 3570

This Unit 112 had a water stain in the upper right corner of the left Master Closet. Residents were not aware of its existence. Most likely caused by a problem in the shower of the unit above this area and may have been corrected. Suggest having this stain painted over, then watched to see if the stain tries to reappear.

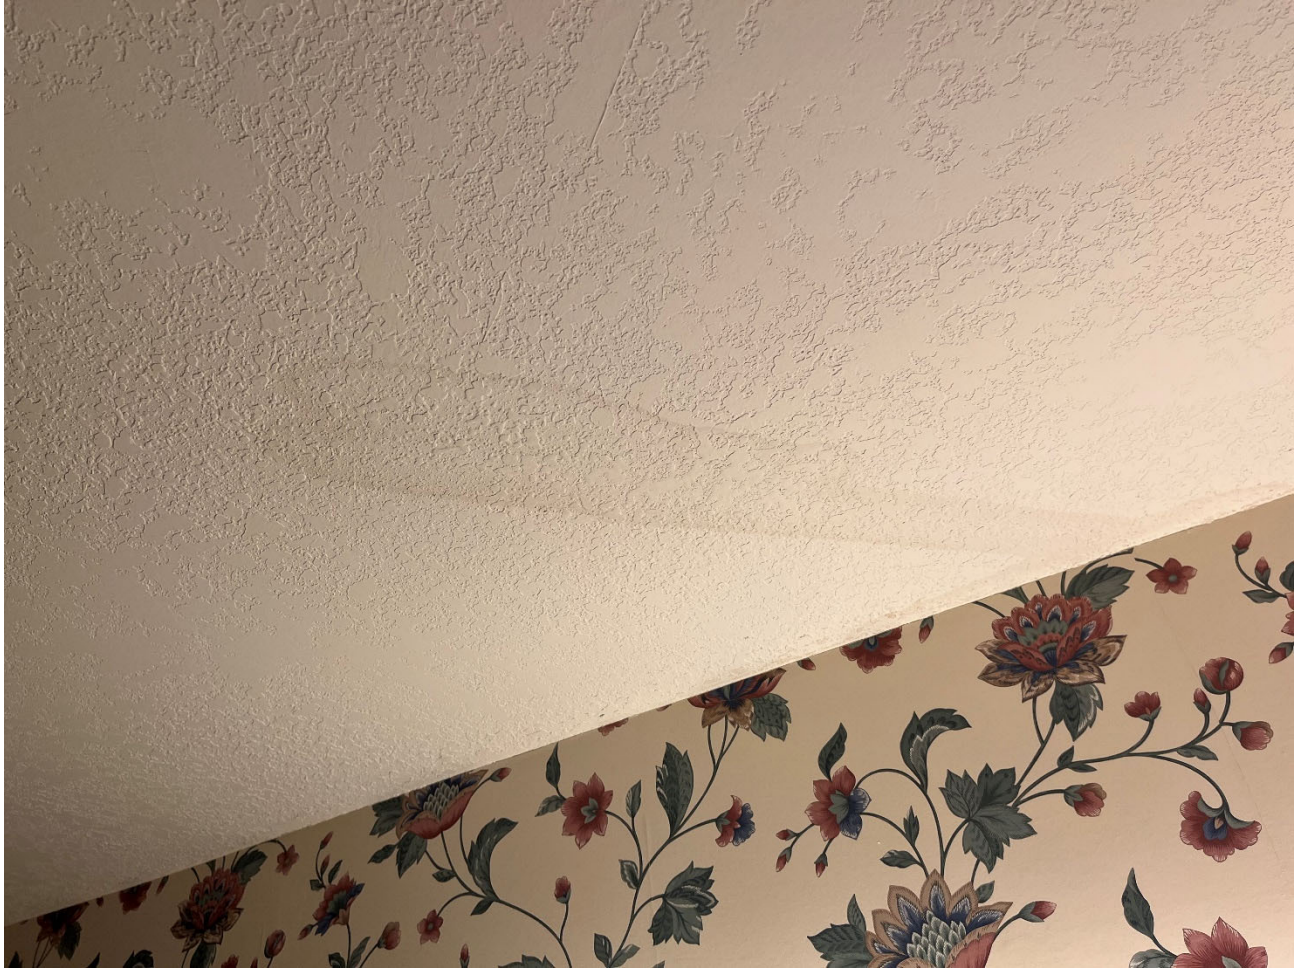
Unit 121 – Building 3570

This Unit 121 has a significant water stain over the Master Bathroom vanities. Suggest having this stain painted over with a high hide primer (i.e. Kilz), then finish painted. Monitor the repairs to see if the staining tries to reappear.

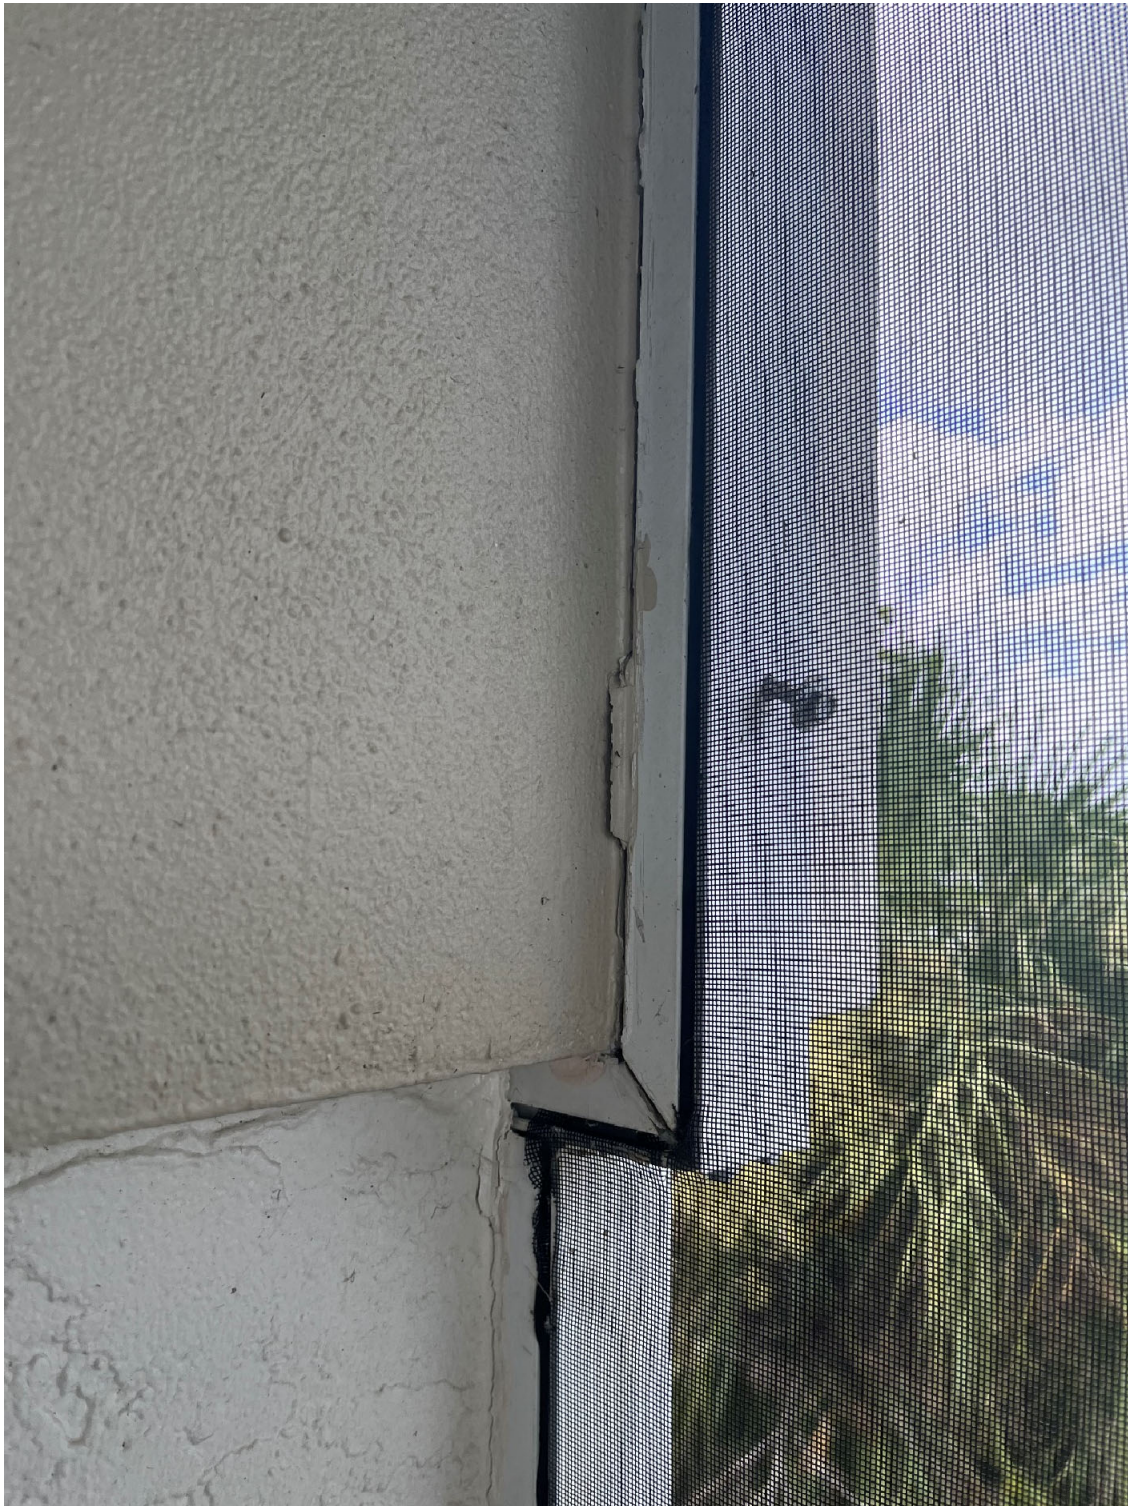
Unit 132 – Building 3570

This Unit 132 had some aging calking around the screen frame. This condition is mostly cosmetic but may prevent some moisture from getting into substrate materials through the hole created by the screw in the photo. Even more important for the outside edge to be calked as well so that needs to be evaluated at the same time.

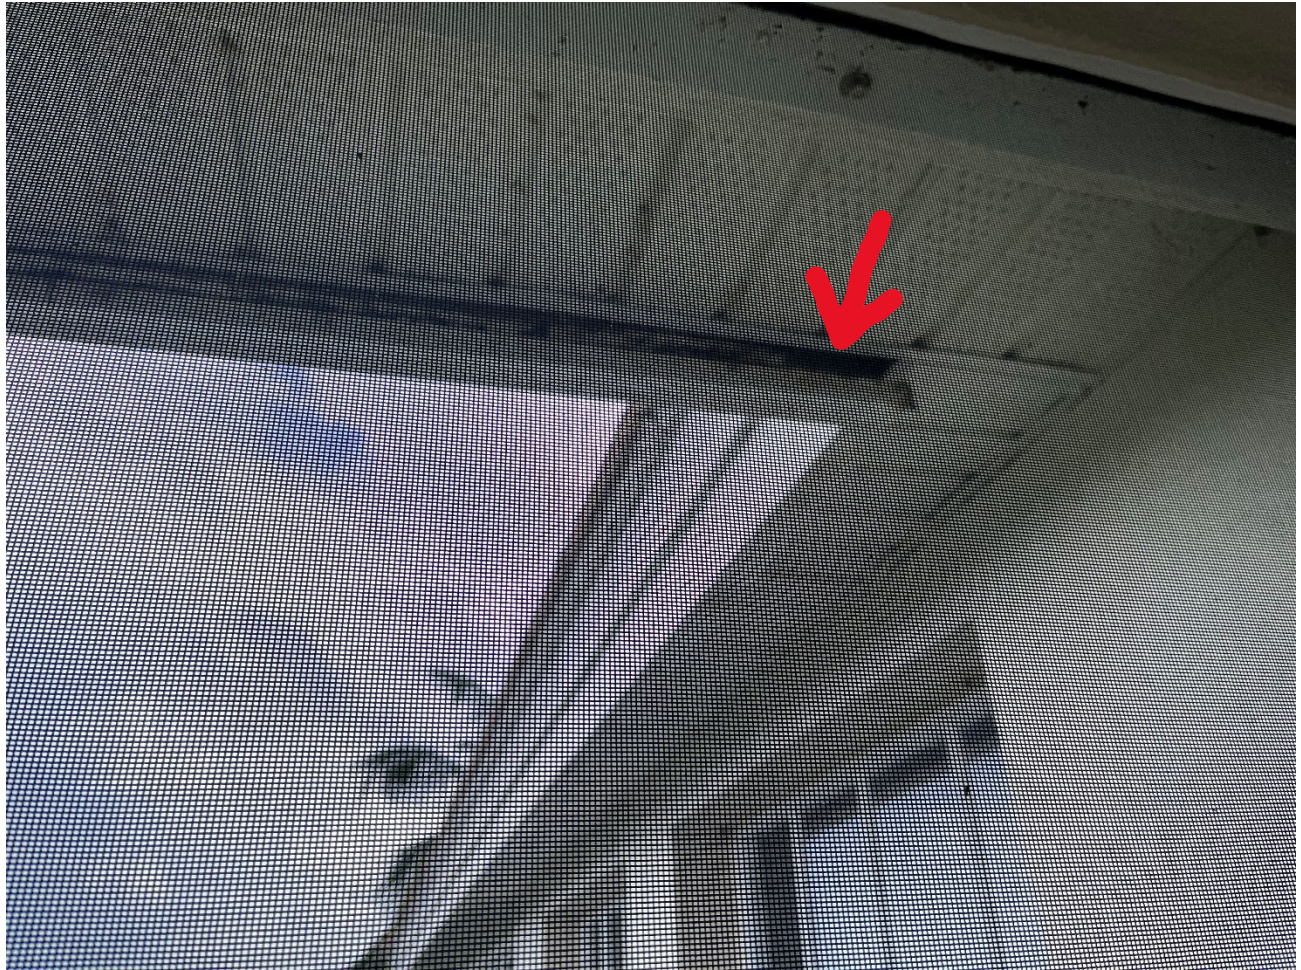
Unit 134 – Building 3570

With apologies for screen obscuring photo, this overhang condition was observed on the right end of the lanai in this Unit 134. There appears to be a gap behind the fascia. This is troubling as it may be the result of deteriorated wood substrate that supports the fascia. Suggest having a framing contractor remove the fascia in this area to observe the condition of the wood components behind it. Replace any deteriorated parts, then reassemble the components to maintain an effective seal against the elements.

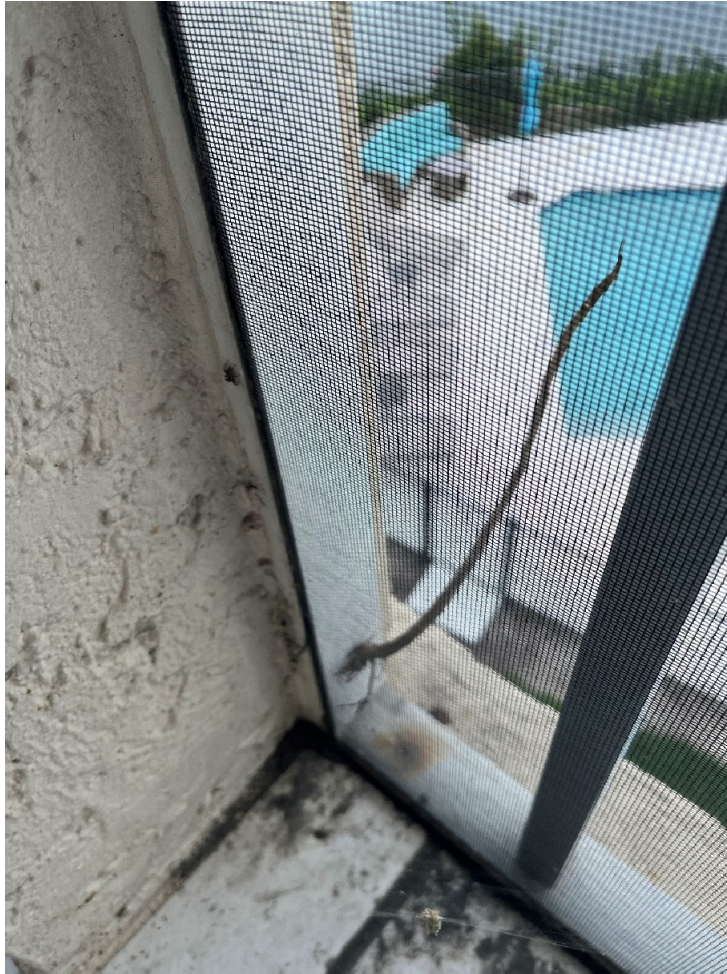
Unit 136 – Building 3570

This Unit 136 was undergoing major renovations. All substrate materials looked normal in the exposed areas; however, there was a vine that was growing out of the screen frame that was disconcerting. Organics like these can do serious damage to building components. Suggest having this vine removed and any organics in the vicinity removed as well. Photo below of renovations for information purposes only.
