Compass Point South at Windstar C.A.
Non-SIRS Components
Naples, FL

Report #: 49202-0
Beginning: January 1, 2025
Expires: December 31, 2025

RESERVE STUDY
"Full"

May 29, 2024

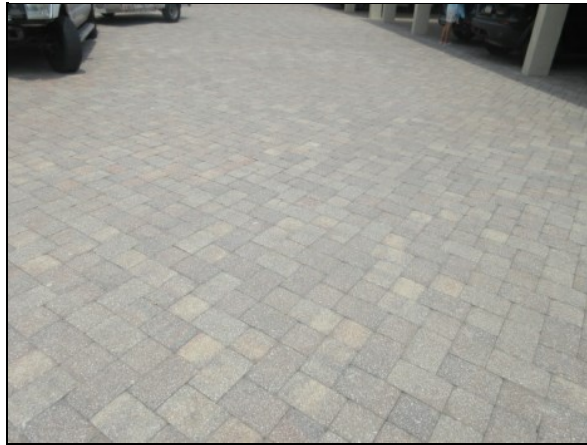
Useful Life:
40 years

Remaining Life:
24 years

Best Case: \$ 438,000

Worst Case: \$ 436,000

Lower estimate to replace

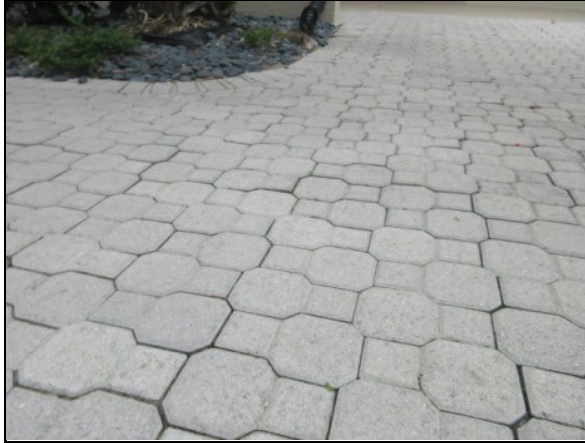
Useful Life:
40 years

Remaining Life:
1 years

Best Case: \$ 30,500

Worst Case: \$ 37,200

Lower estimate to replace

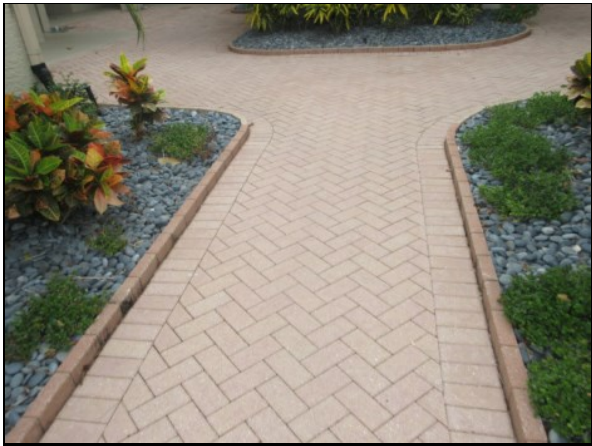
Useful Life:
40 years

Remaining Life:
24 years

Best Case: \$ 9,300

Worst Case: \$ 11,300

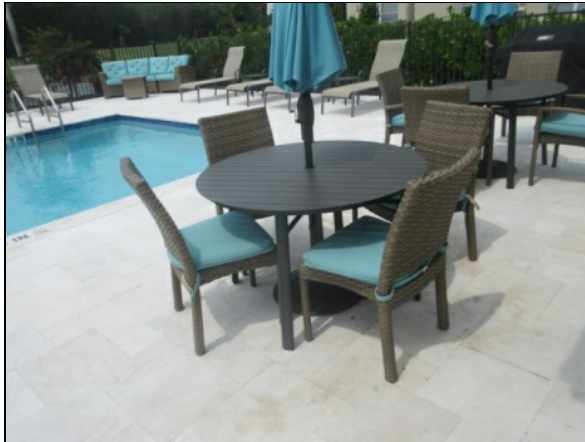
Useful Life:
8 years

Remaining Life:
7 years

Best Case: \$ 25,000

Worst Case: \$ 35,000

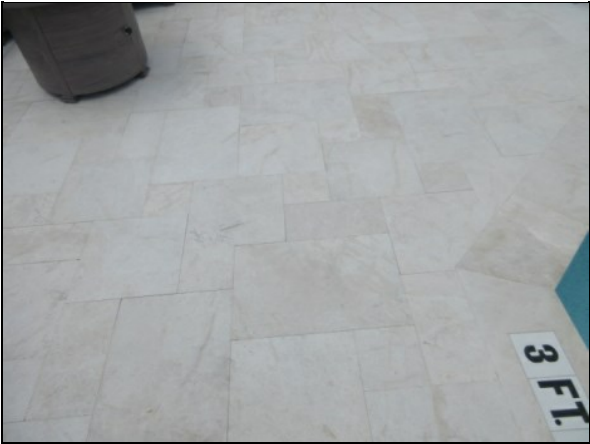
Useful Life:
30 years

Remaining Life:
27 years

Best Case: \$ 86,800

Worst Case: \$ 106,000

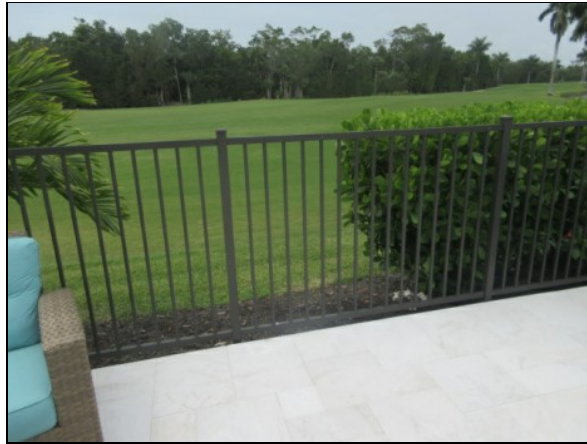
Useful Life:
25 years

Remaining Life:
22 years

Best Case: \$ 23,800

Worst Case: \$ 29,000

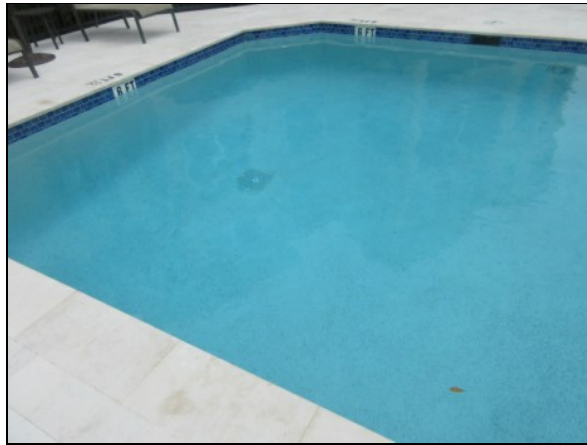
Remaining Life:

9 years

Best Case: \$ 60,000

Worst Case: \$ 80,000

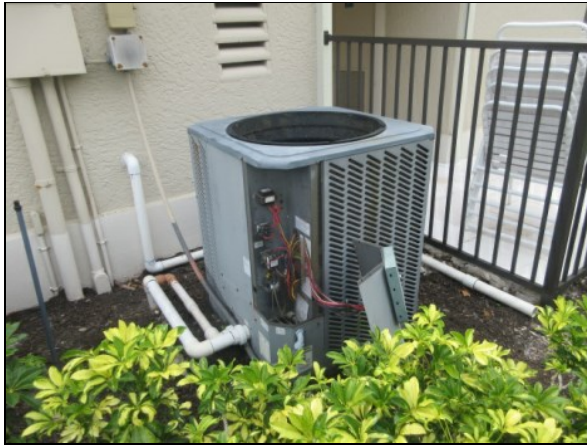
Useful Life:
8 years

Remaining Life:
2 years

Best Case: \$ 10,800

Worst Case: \$ 13,200

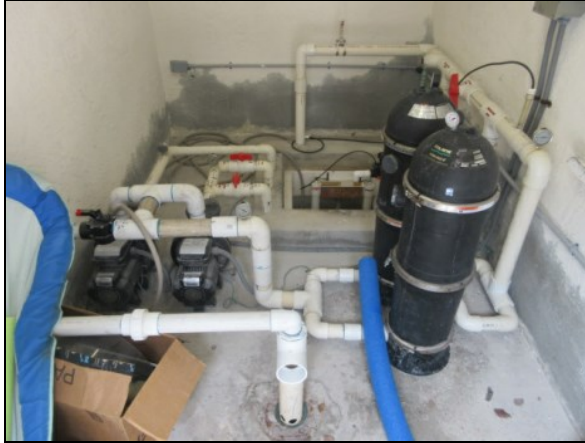
Useful Life:
10 years

Remaining Life:
5 years

Best Case: \$ 7,500

Worst Case: \$ 12,500

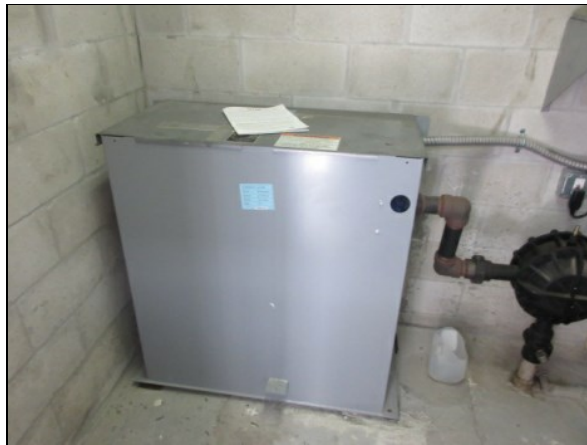
Useful Life:
25 years

Remaining Life:
20 years

Best Case: \$ 200,000

Worst Case: \$ 260,000

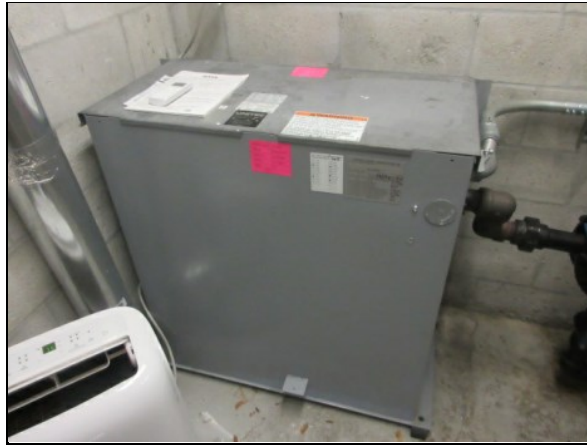
Remaining Life:

22 years

Best Case: \$ 100,000

Worst Case: \$ 130,000

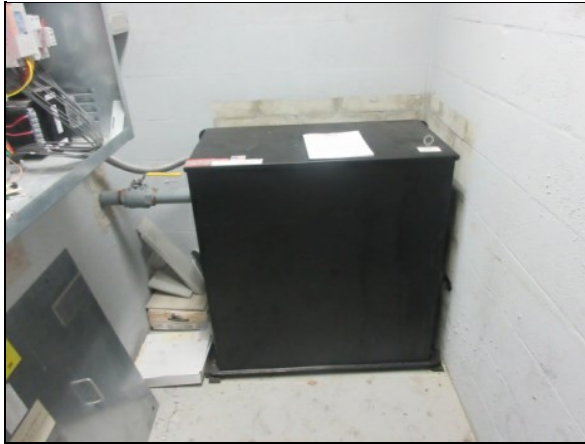
Useful Life:
25 years

Remaining Life:
15 years

Best Case: \$ 100,000

Worst Case: \$ 130,000

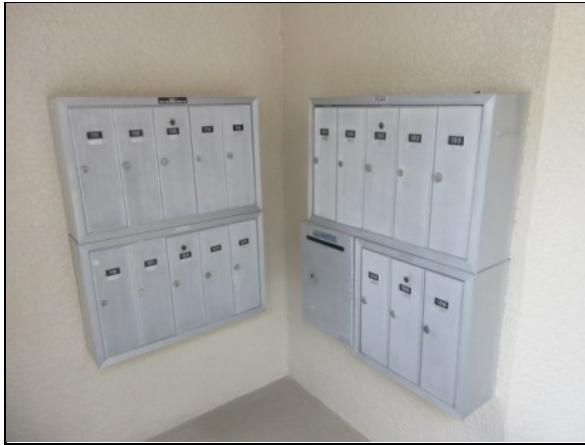
Useful Life:
20 years

Remaining Life:
5 years

Best Case: \$ 8,000

Worst Case: \$ 12,000

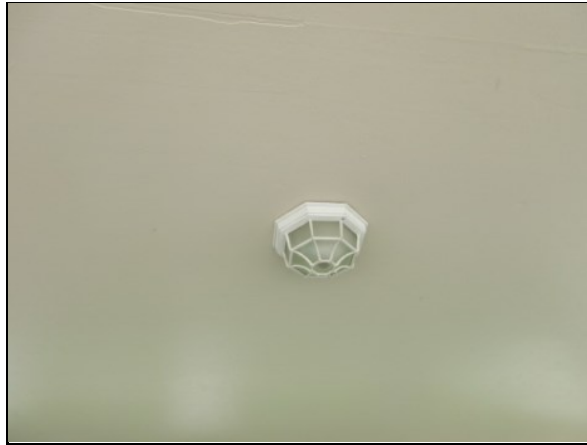
Useful Life:
20 years

Remaining Life:
19 years

Best Case: \$ 4,300

Worst Case: \$ 5,300

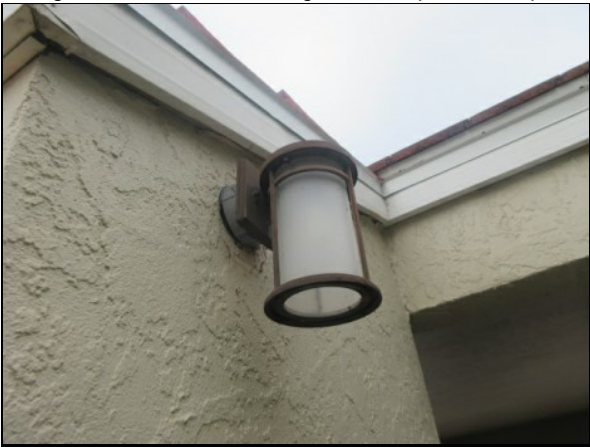
Useful Life:
20 years

Remaining Life:
14 years

Best Case: \$ 21,200

Worst Case: \$ 25,900
