Compass Point South at Windstar C.A
SIRS Components
Naples, FL

Report #: 49202-0
Beginning: January 1, 2025
Expires: December 31, 2025

RESERVE STUDY
"Full"

May 29, 2024

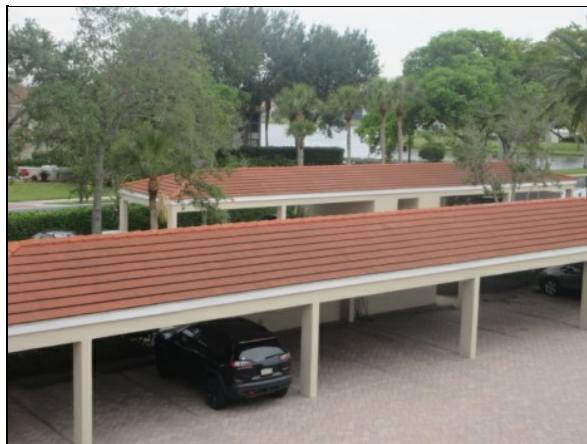
Comp #: 2383 Tile Roofing (2018-2019) - Replace

Useful Life:
25 years

Remaining Life:
18 years

Best Case: \$ 784,000

Worst Case: \$ 959,000

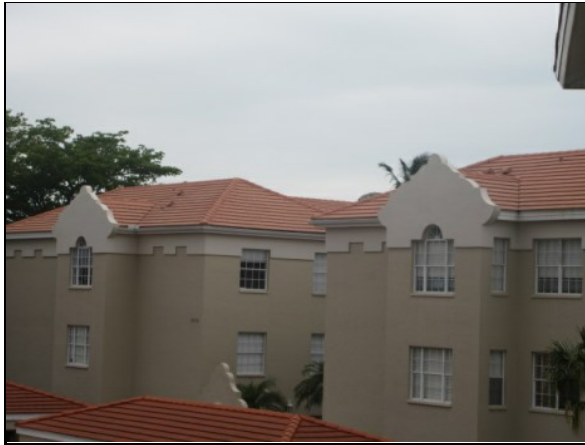
Useful Life:
25 years

Remaining Life:
8 years

Best Case: \$ 180,000

Worst Case: \$ 220,000

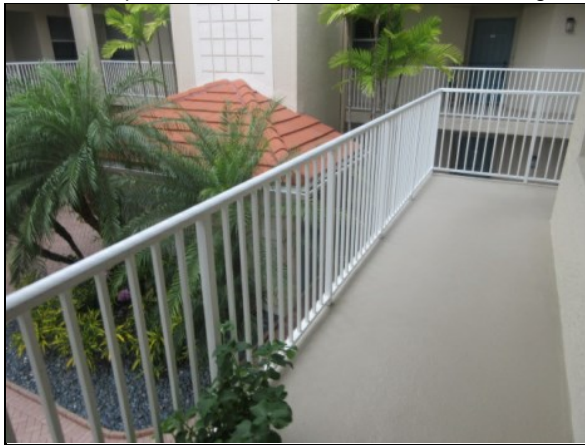
Useful Life:
20 years

Remaining Life:
10 years

Best Case: \$ 169,000

Worst Case: \$ 206,000

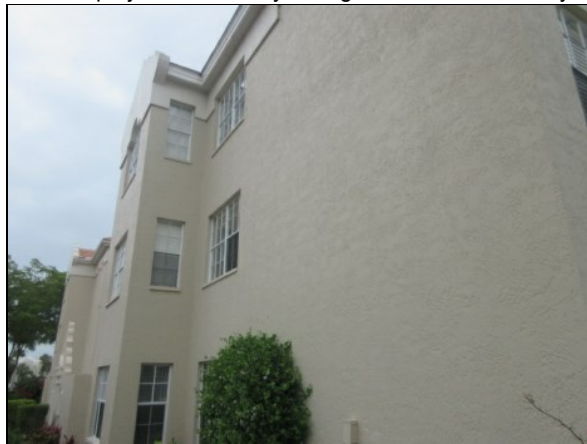
Useful Life:
8 years

Remaining Life:
2 years

Best Case: \$ 186,000

Worst Case: \$ 228,000

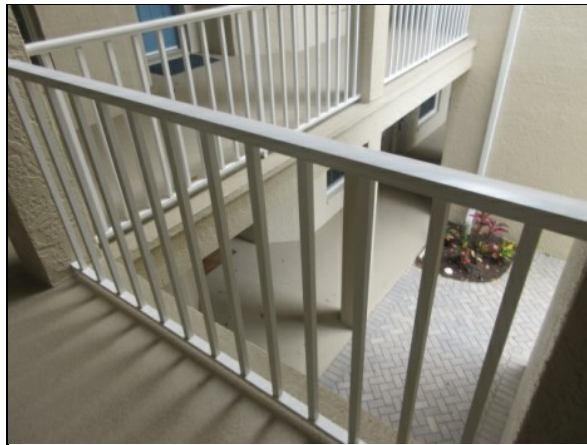
Useful Life:
30 years

Remaining Life:
10 years

Best Case: \$ 149,000

Worst Case: \$ 182,000

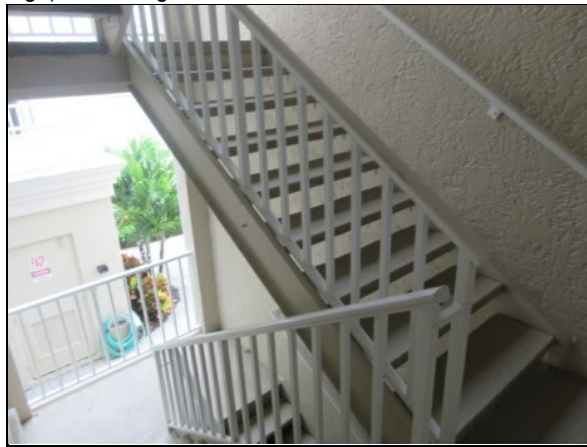
Useful Life:
40 years

Remaining Life:
10 years

Best Case: \$ 64,000

Worst Case: \$ 80,000
