### COMPASS POINT SOUTH AT WINDSTAR

**Site-Visit Date:**  
August 09, 2023

**Report Date:**  
August 11, 2023

### 1.0 INTRODUCTION

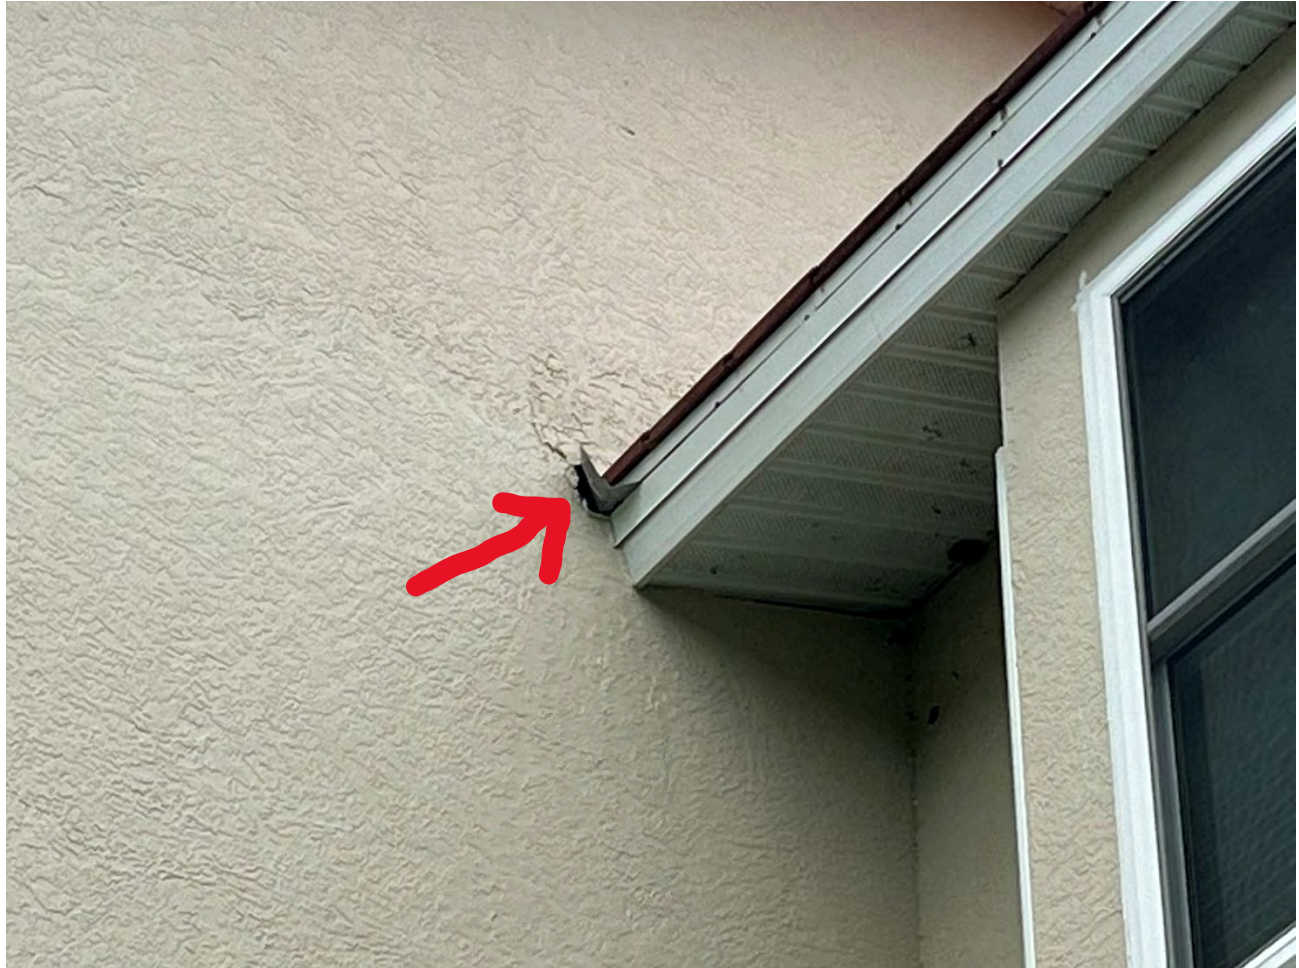
### **Stucco Repair Needed on Left side of Building 3522**

There was an area at the intersection of the left wall and the overhang of the setback that looked to have a significant opening in the stucco finish just behind the metal flashing diverter. Suggest having a stucco technician review this intersection to assure no moisture is being allowed to penetrate behind the surface of the stucco.

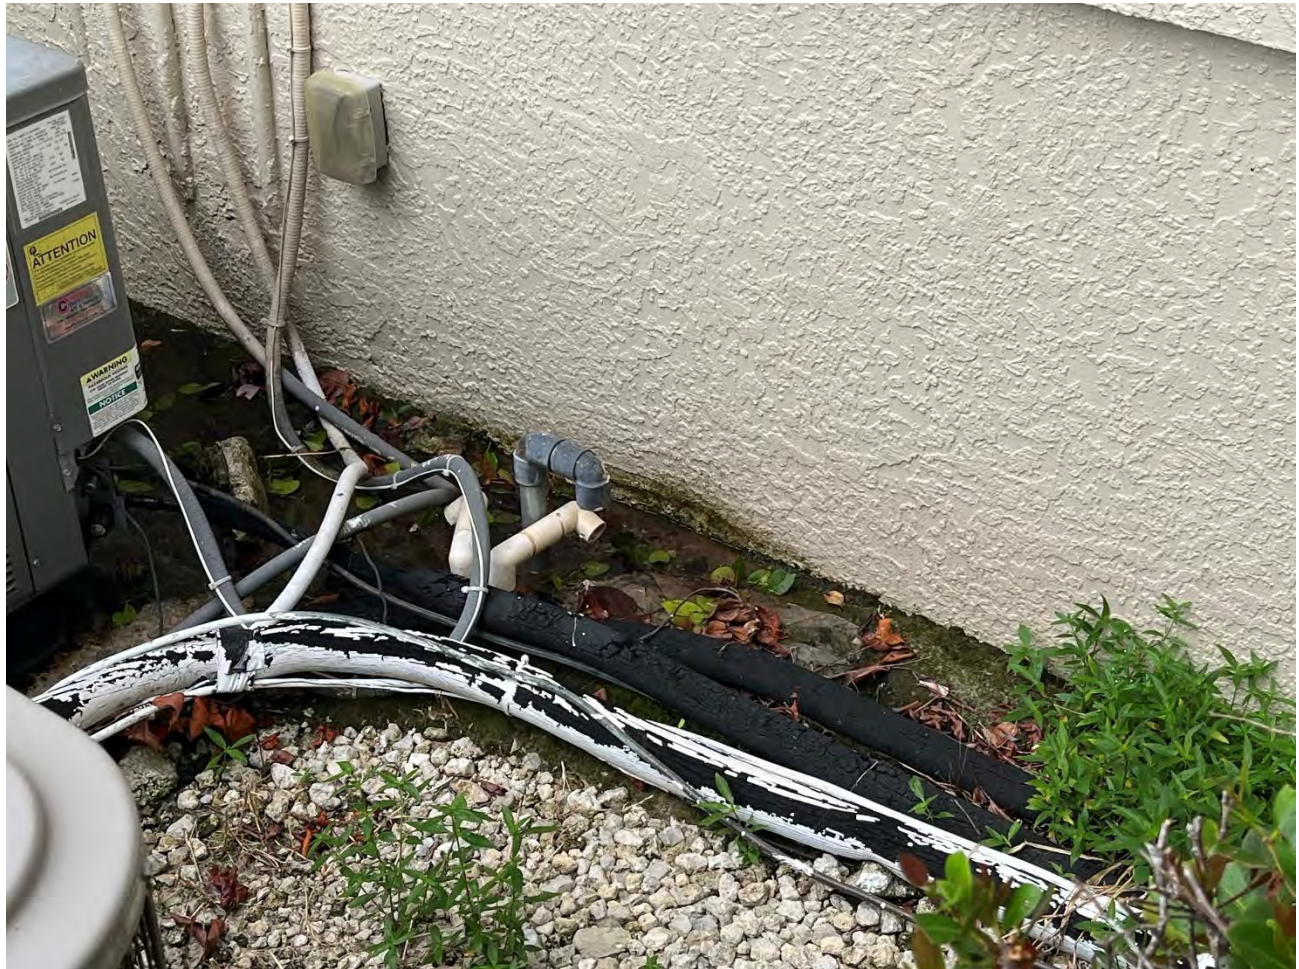
### **Ponding of Condensate Against Building 3522**

Also on the left side of this building was an area where some condensate drains from the air conditioners was emptying. The water was ponding against the building which can lead to a deterioration of the supporting soils and/or the structural components of the foundation. Suggest either having this area graded so it slopes away from the building, or install a drain to route water away from the building.

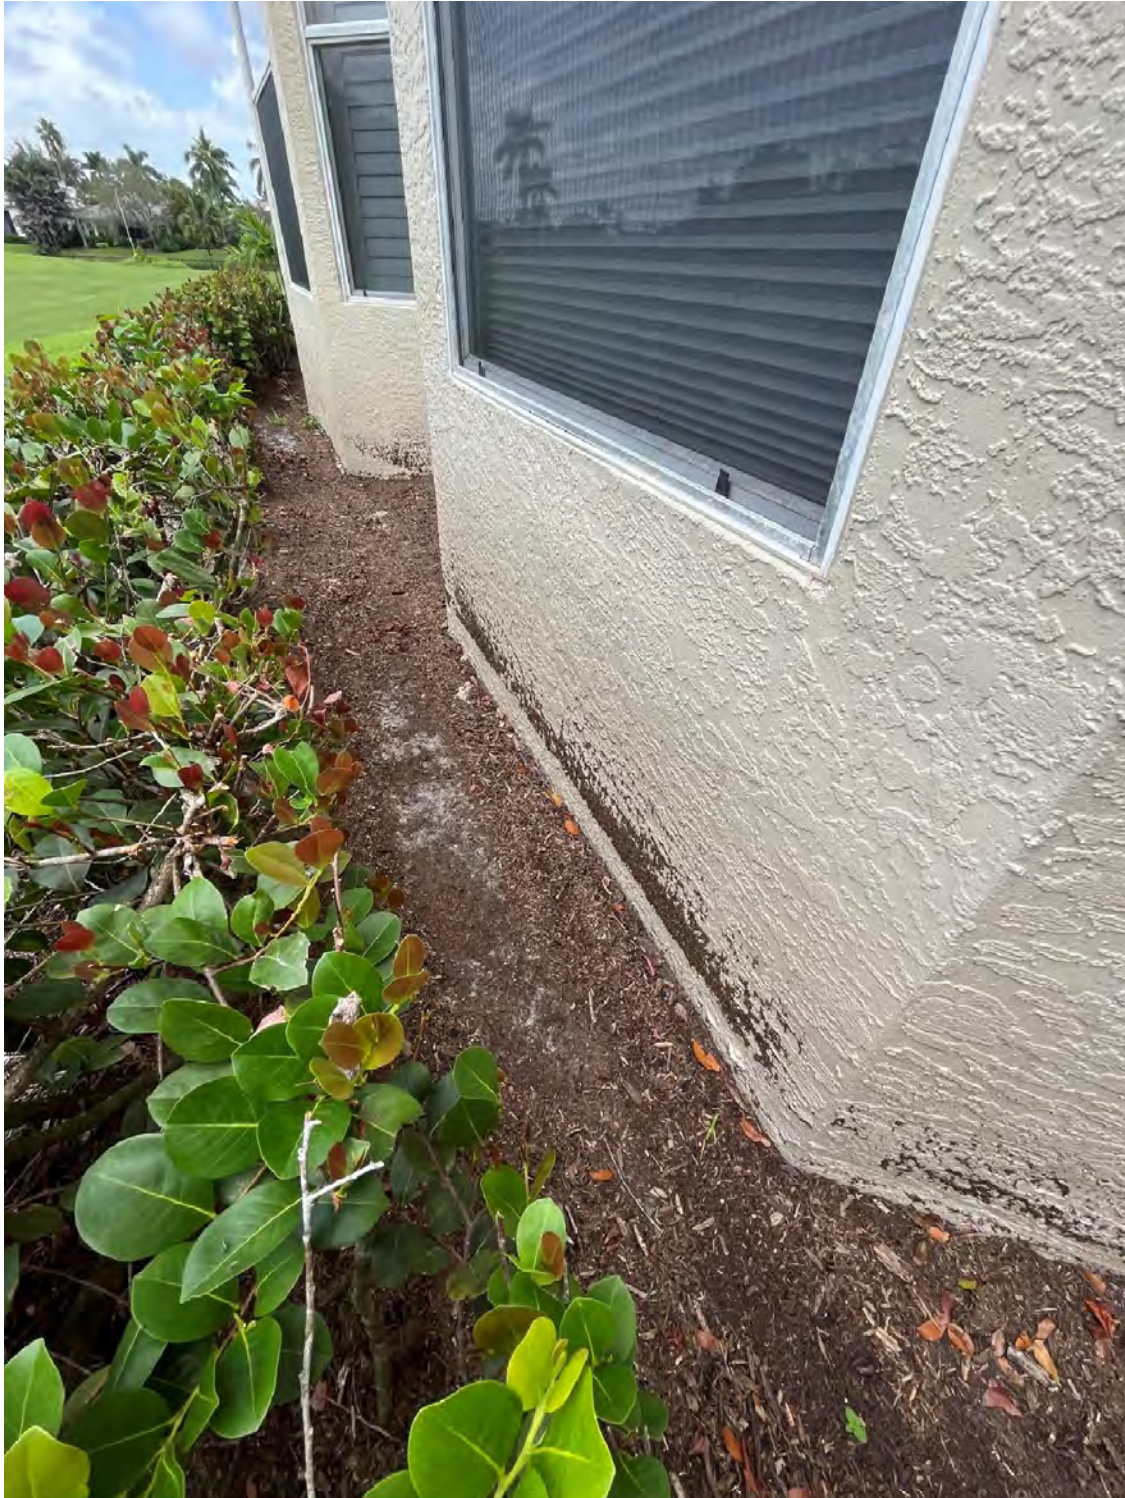
### **Dirt Splashed onto Building**

This condition was observed in a few locations on several of the buildings. The dirt is being splashed onto the building by the rain running off the roof and dropping a long distance to grade. Gutters on the rear of the building would solve this issue but if gutters are not desired, then more impact resistant materials on grade could prevent this splash up. See following photo of solution behind Building 3570 that well addresses this condition.

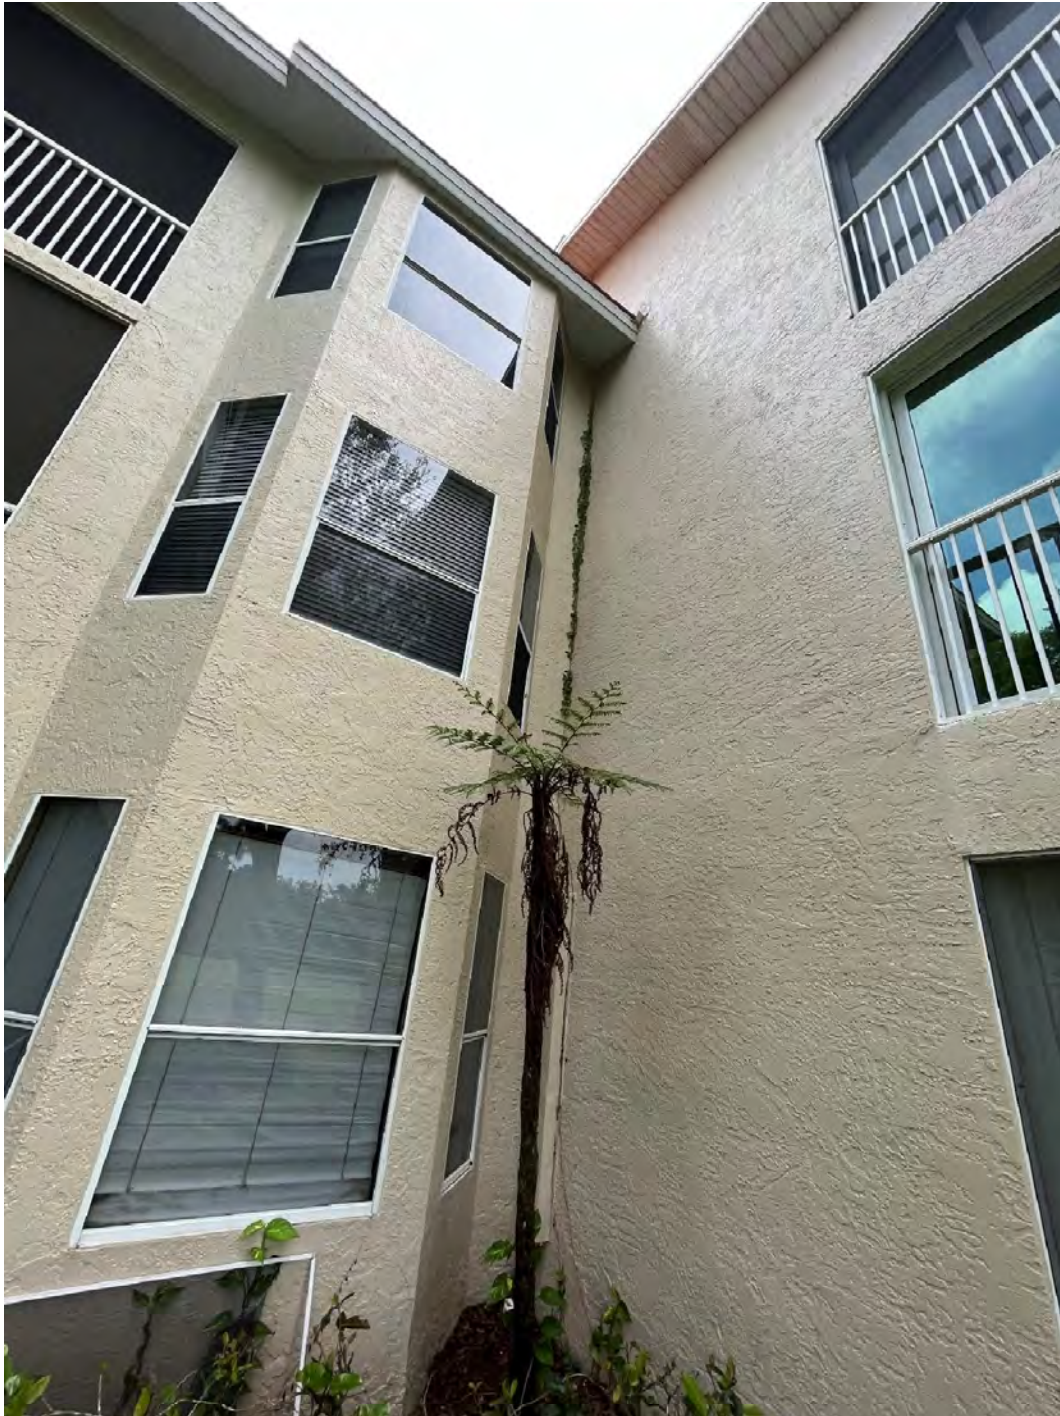
### **Landscaping Growing Up Face of Building**

In one of the inside corners on the rear of the building, a vine was being allowed to grow. These organic materials can damage the stucco and components on the face of the building. Suggest having this vine removed, and keep all landscaping trimmed off the face of the building.

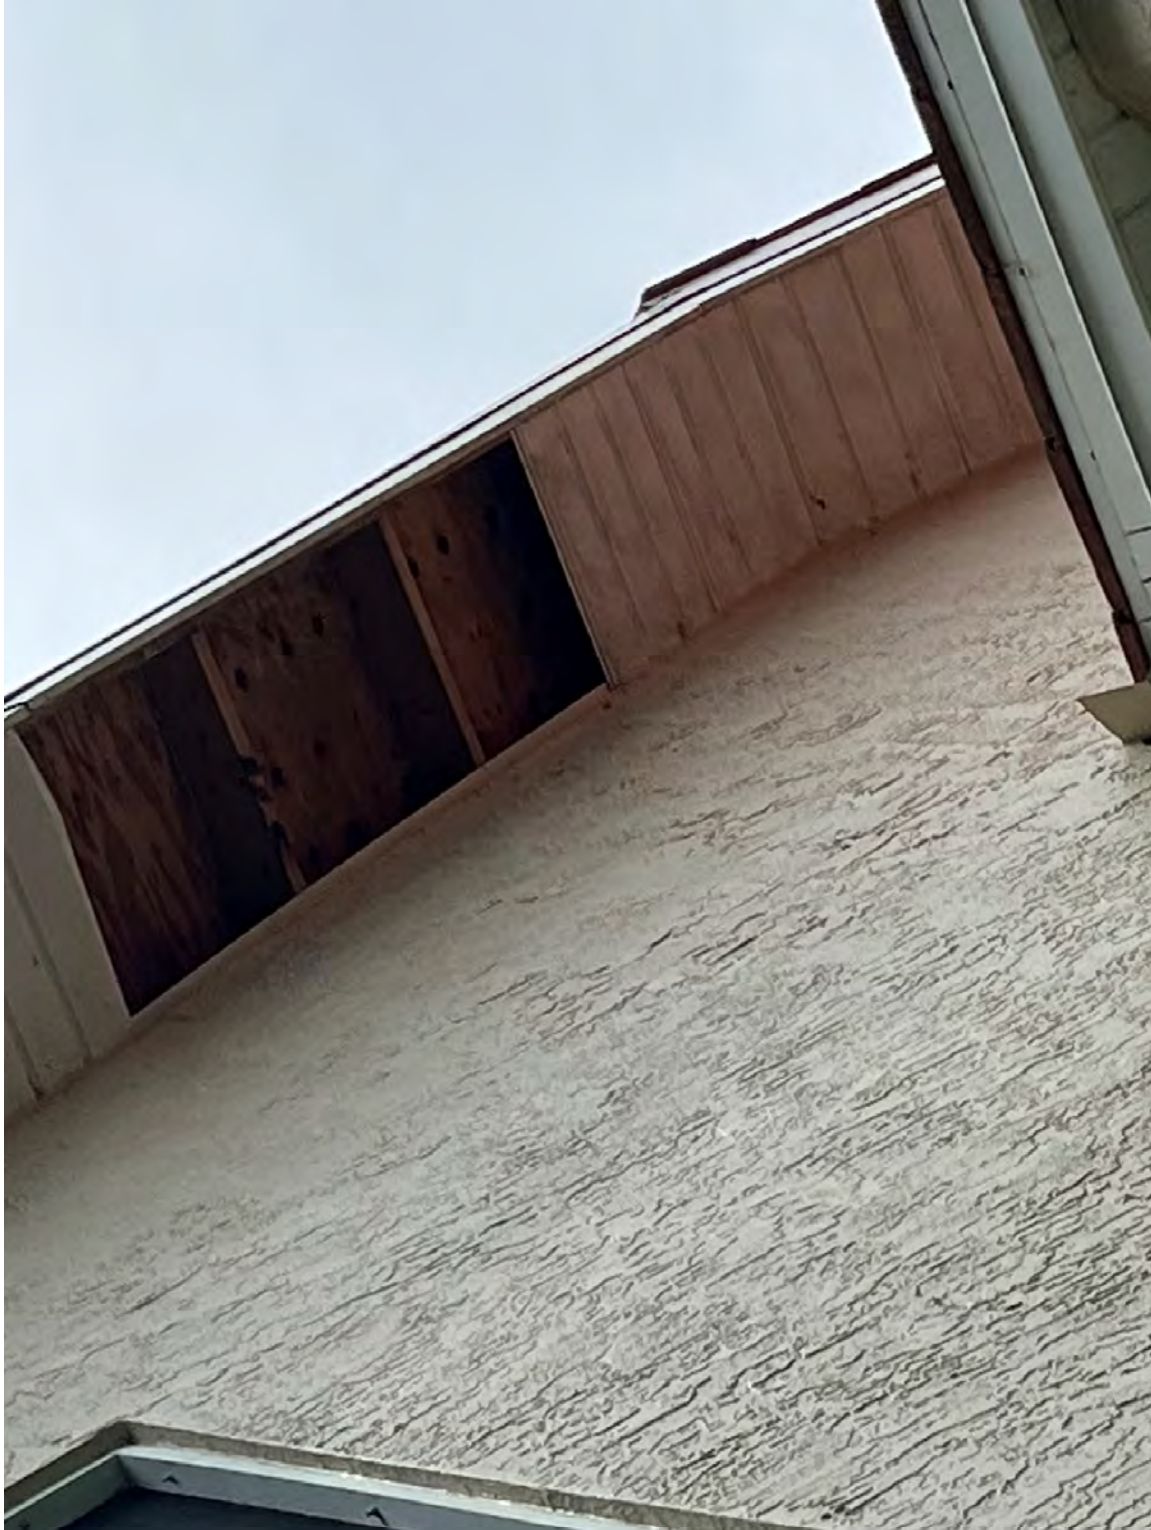
### **Missing Soffit Material from Eave on Left Side of Building**

On the left side of the building there was a significant amount of the soffit missing. This covering protects important structural components from moisture. Suggest having this condition repaired as soon as possible, and the adjacent soffit materials evaluated to see if more water damaged parts need replacing as well.

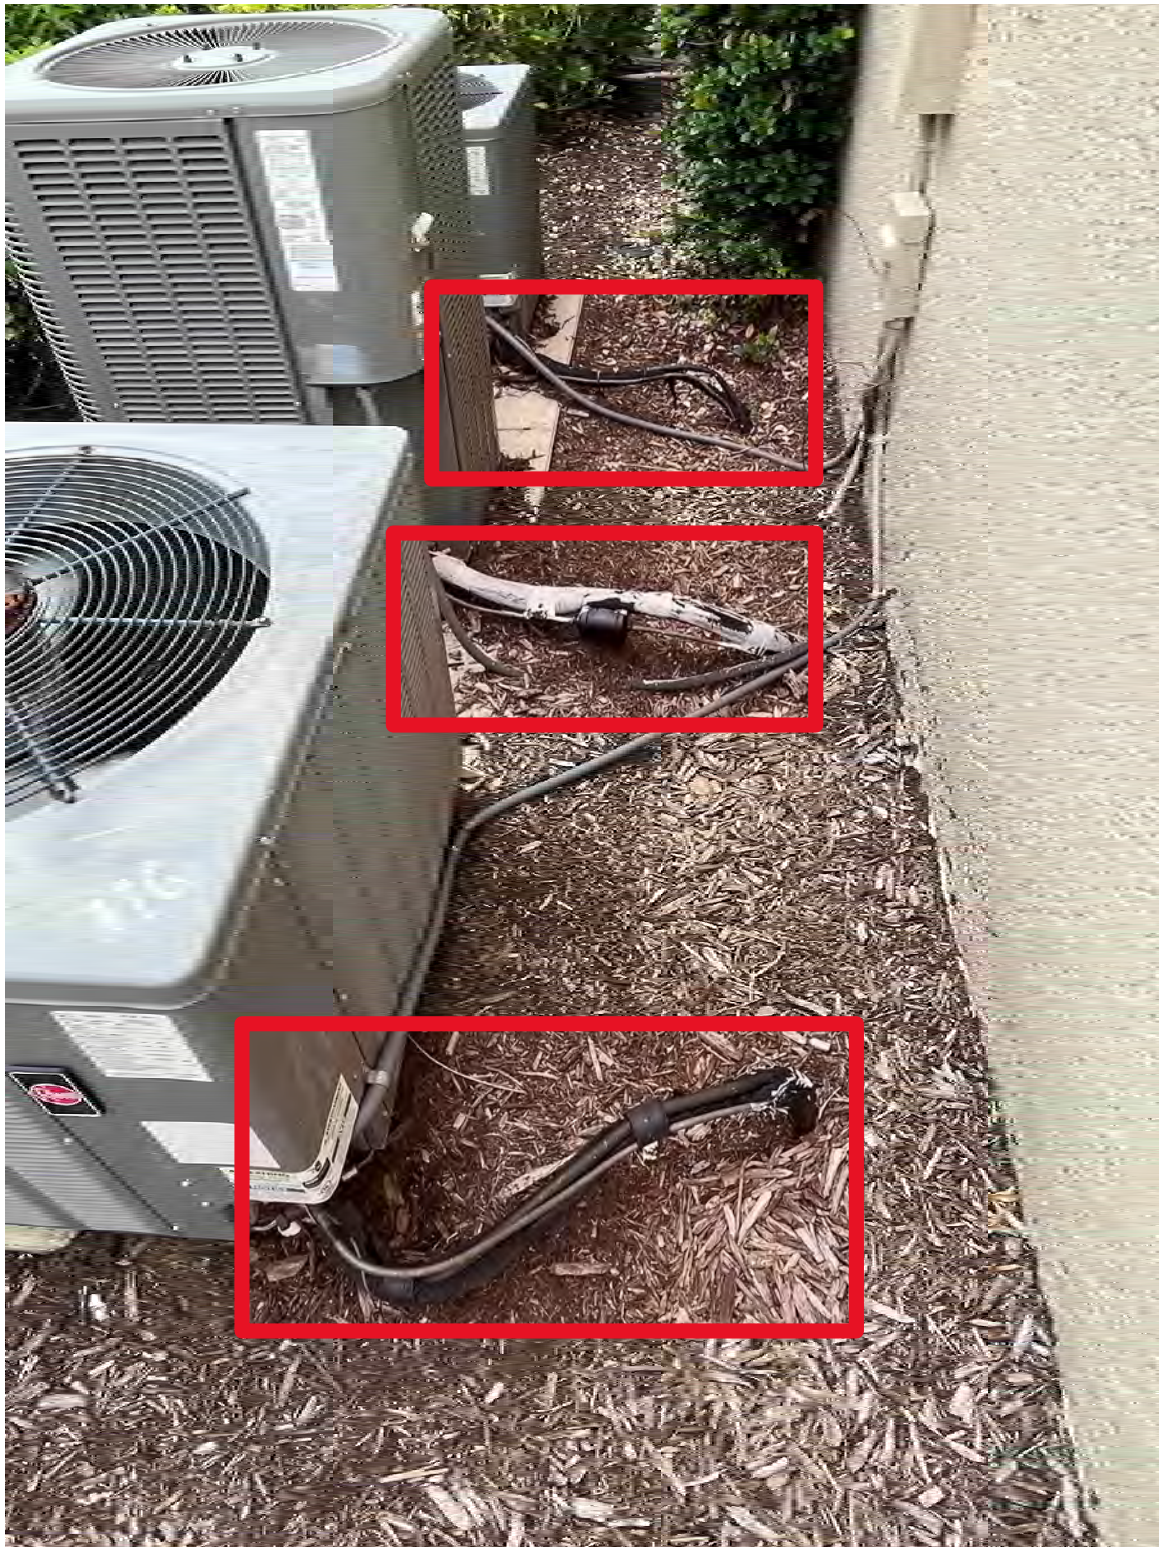
### Missing or Damaged Coolant Lines on AC Units

On the front right of Building 3570, the inspector observed the insulation on the condenser coolant lines was either damaged or missing. This decreases the efficiency of the unit and can shorten the life of the unit and/or these coolant lines. The problem may be worse because of the lack of gutters on the eave above these units. If gutters are not desired, suggest provided some impact resistant covers over them, once the insulation is repaired or replaced.

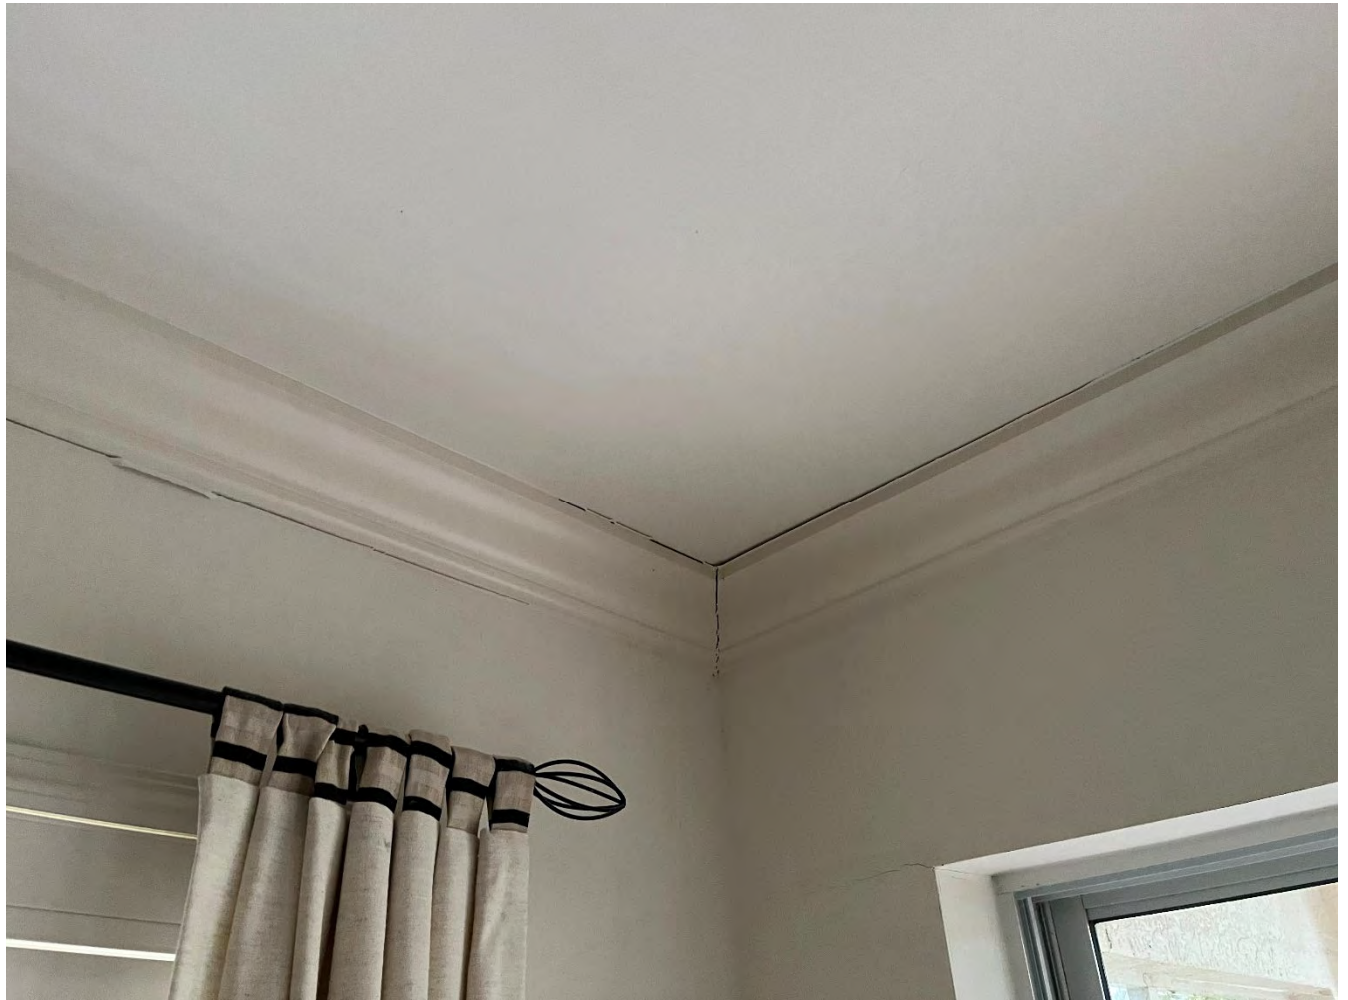
#### **Unit 112 – Building 3538**

This Unit 112 had several hairline cracks in and around the crown mould at the ceiling. This is just a cosmetic condition most likely caused by the expansion and contraction of dissimilar materials; however, inspector suggests having these repaired and monitored over time to see if they try to return. If they reappear, it may be a result from excessive moisture and need further evaluation.

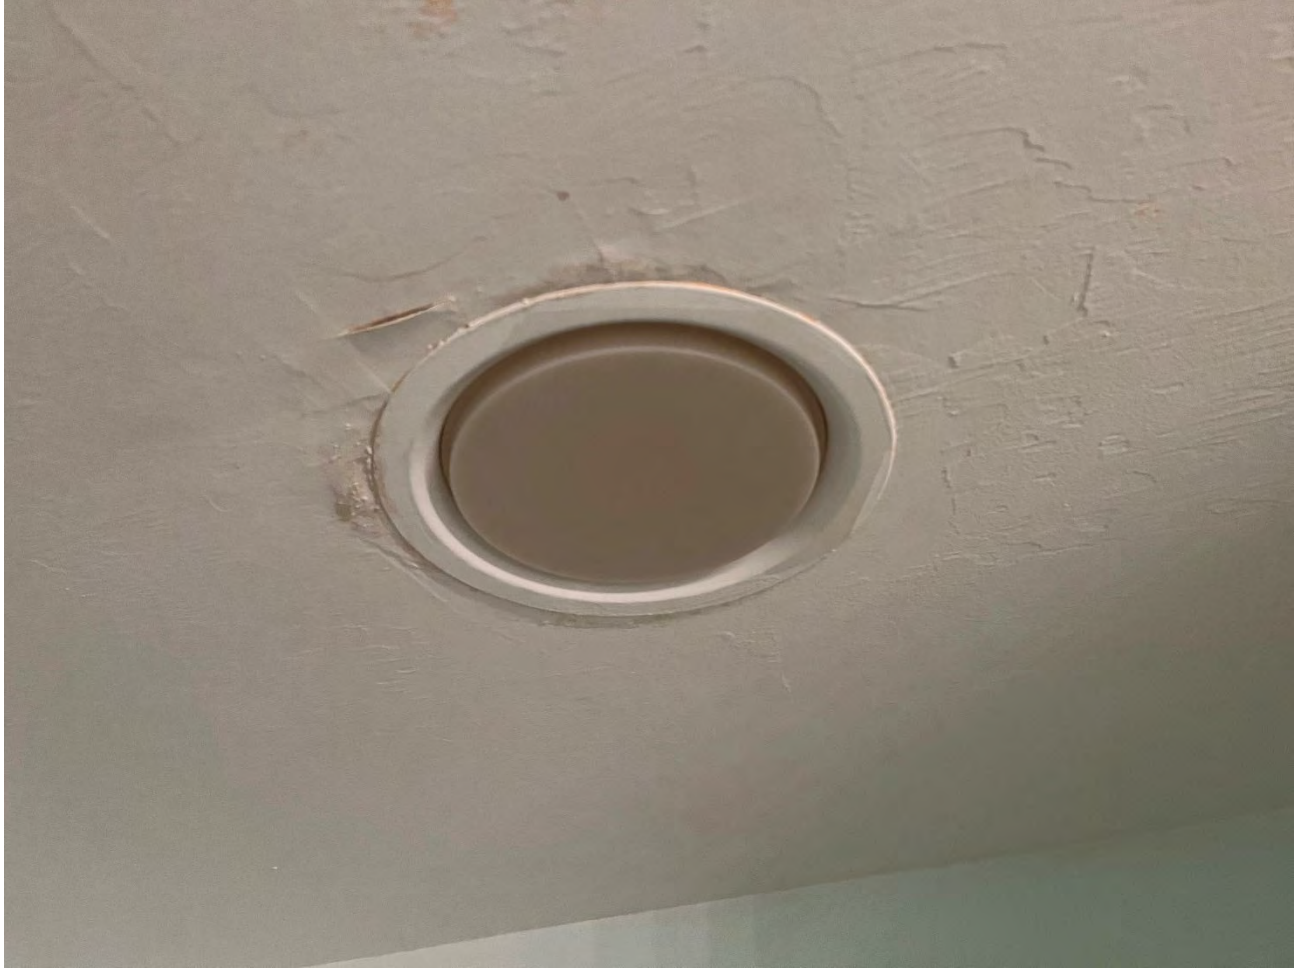
## Unit 115 – Building 3538

The shower in the Master Bath of Unit 115 had some water damage around the light fixture above it. Water in electrical components is a safety hazard so inspector suggests having this condition evaluated to be sure that water leak above this area has been corrected. Repair water damaged areas and monitor for any reoccurrence.

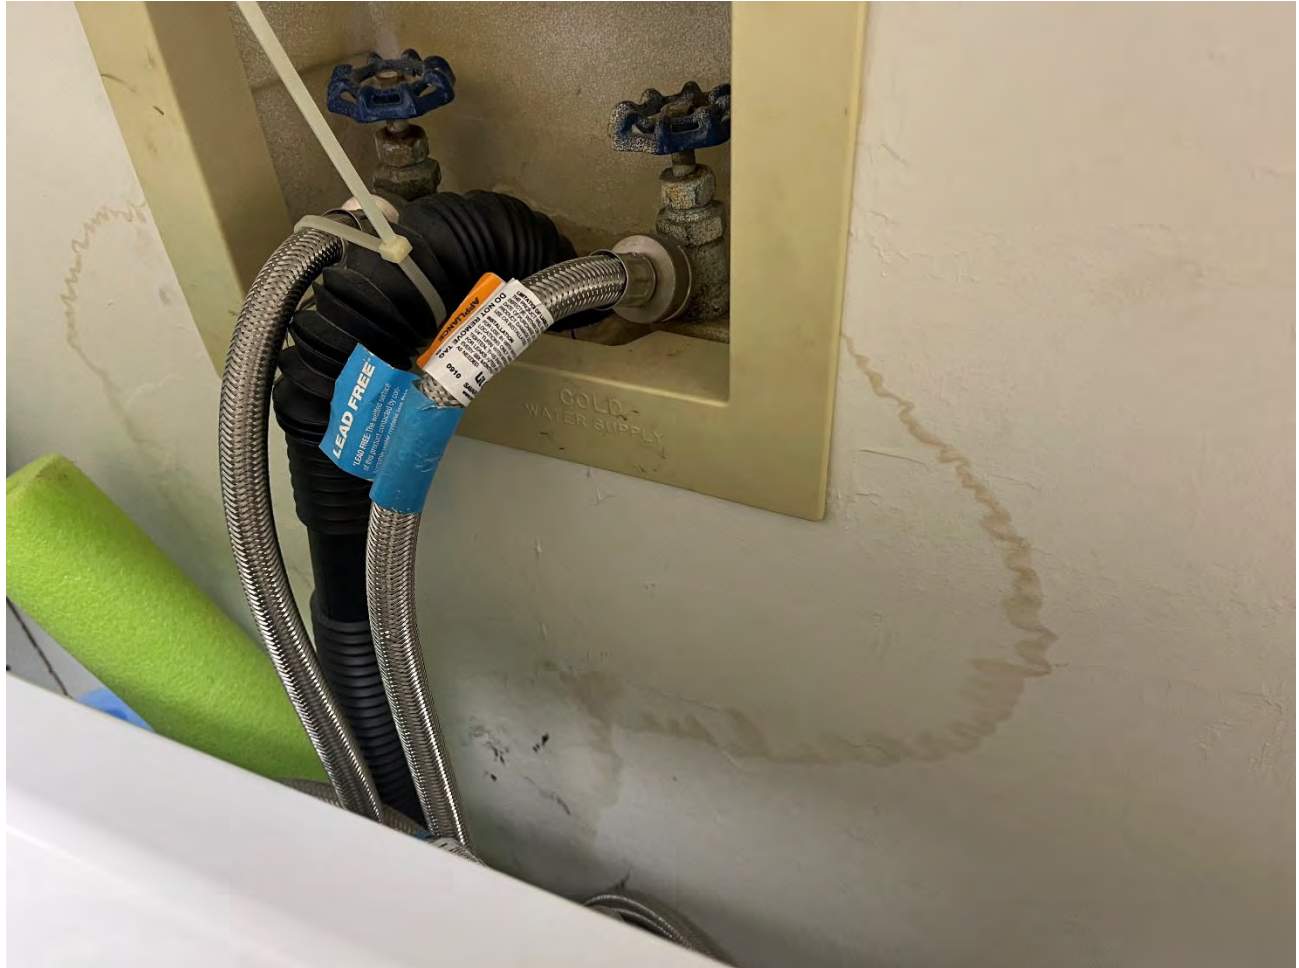
## Unit 116 - Building 3538

This unit had a water stain around the washer connection box. A chronic leak in this area can erode or damage structural components over time. Suggest having plumber evaluate this area to be sure that water leak has been fixed. Paint over this water stain with a high coverage primer (i.e. Kilz), then apply final coat of paint. Area should be monitored after repair to see if evidence of a water issue tries to return.

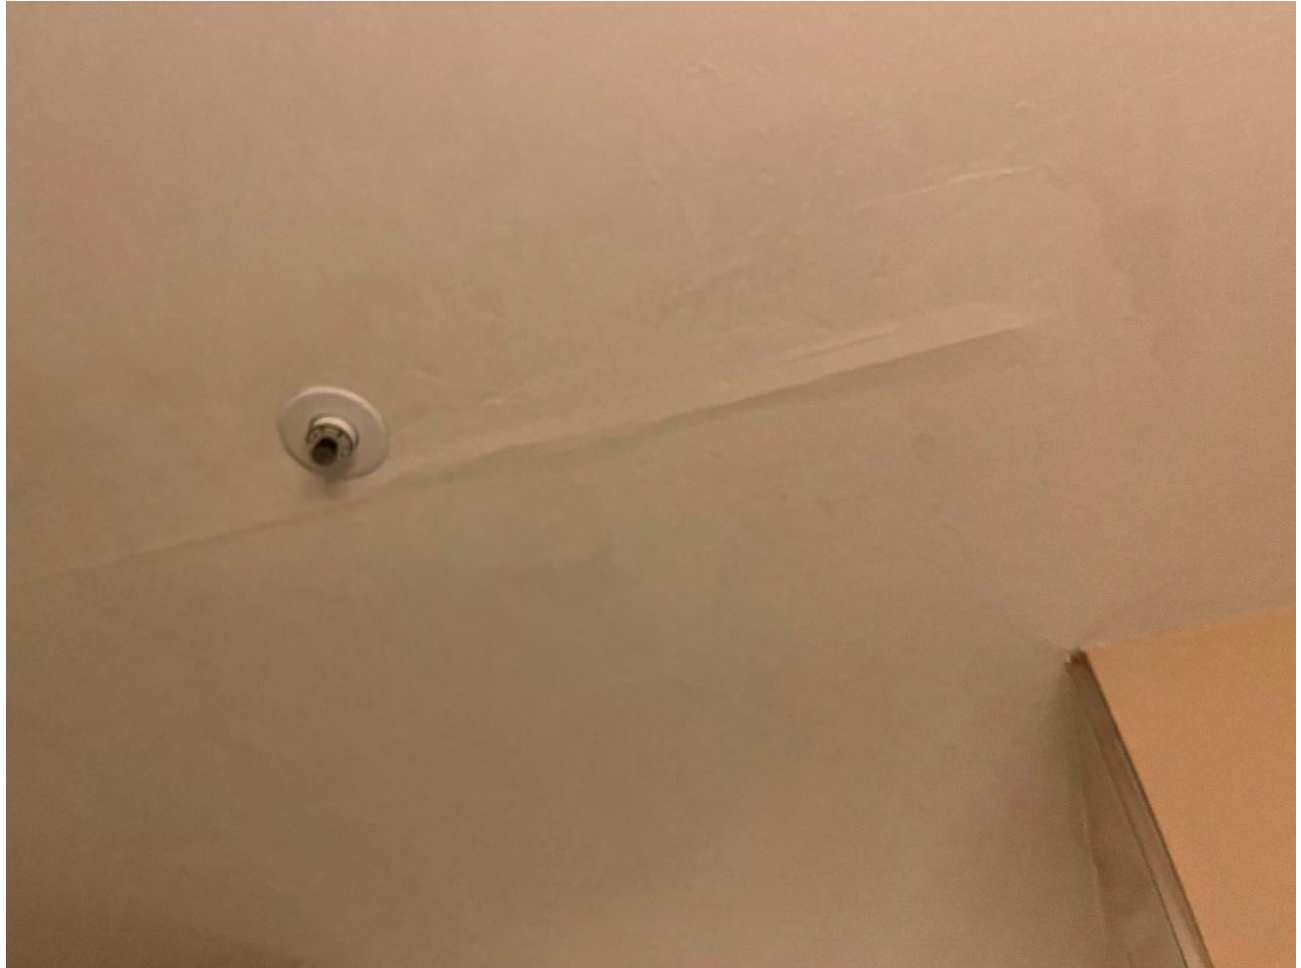
## Unit 131 – Building 3538

This photo is of the ceiling of the Master Bath in Unit 131. This is evidence that a water issue was realized in this area but has been repaired. Inspector suggests having this wrinkle in the ceiling repaired and then monitored over time to see if it tries to reappear.

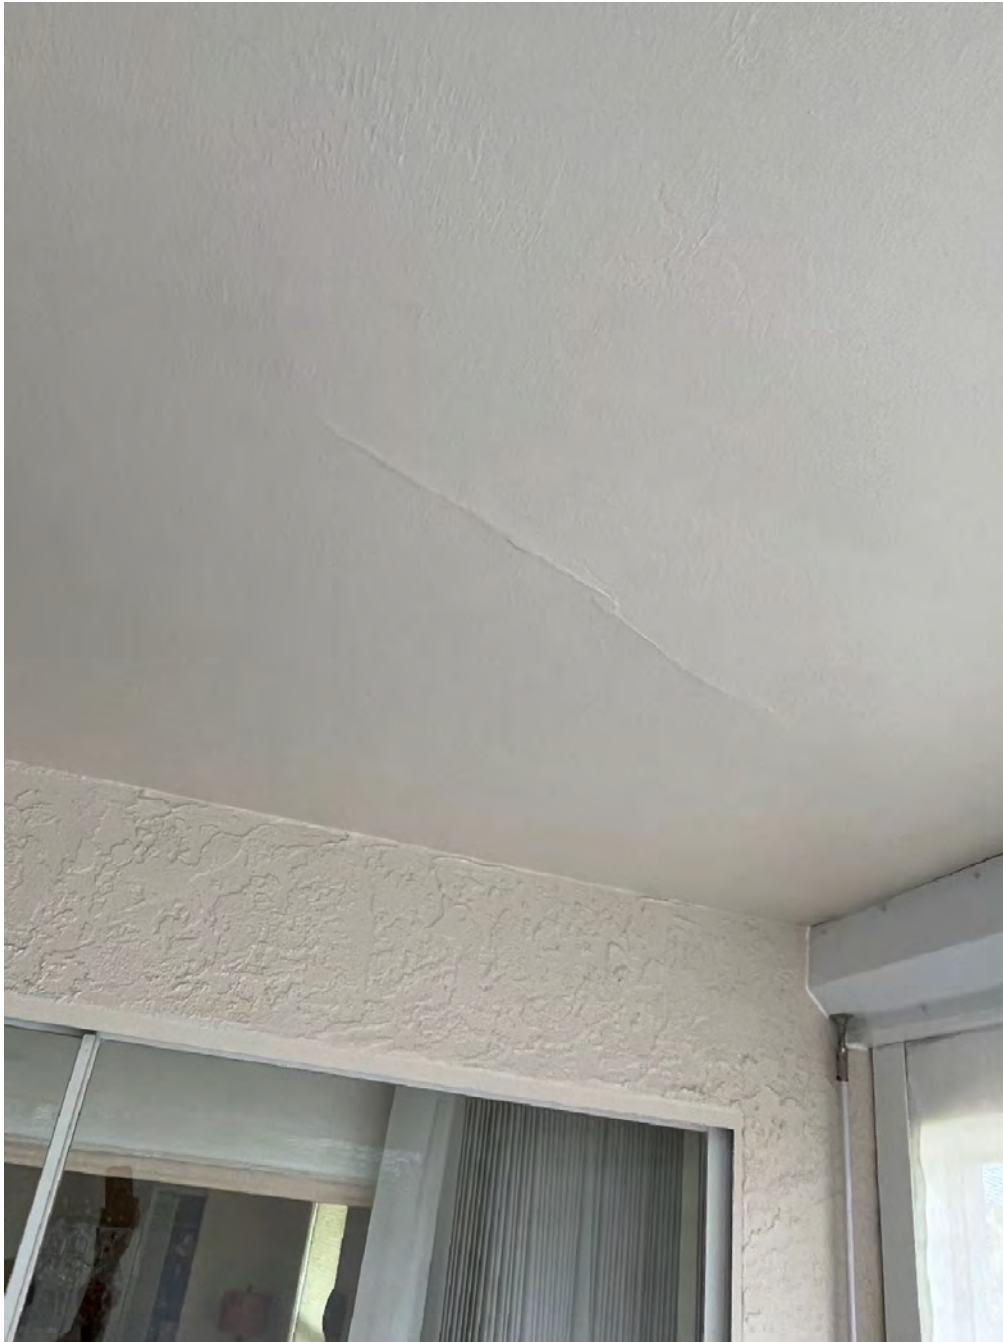
## Unit 113 – Building 3554

This Unit 113 had a suspicious wrinkle in the ceiling of the lanai. Issue that caused this condition may have been adequately addressed as no further evidence of leaks or staining was present. Most likely caused by water coming from the lanai above. Suggest having this wrinkle repaired and then monitored over time to see if it attempts a reappearance.

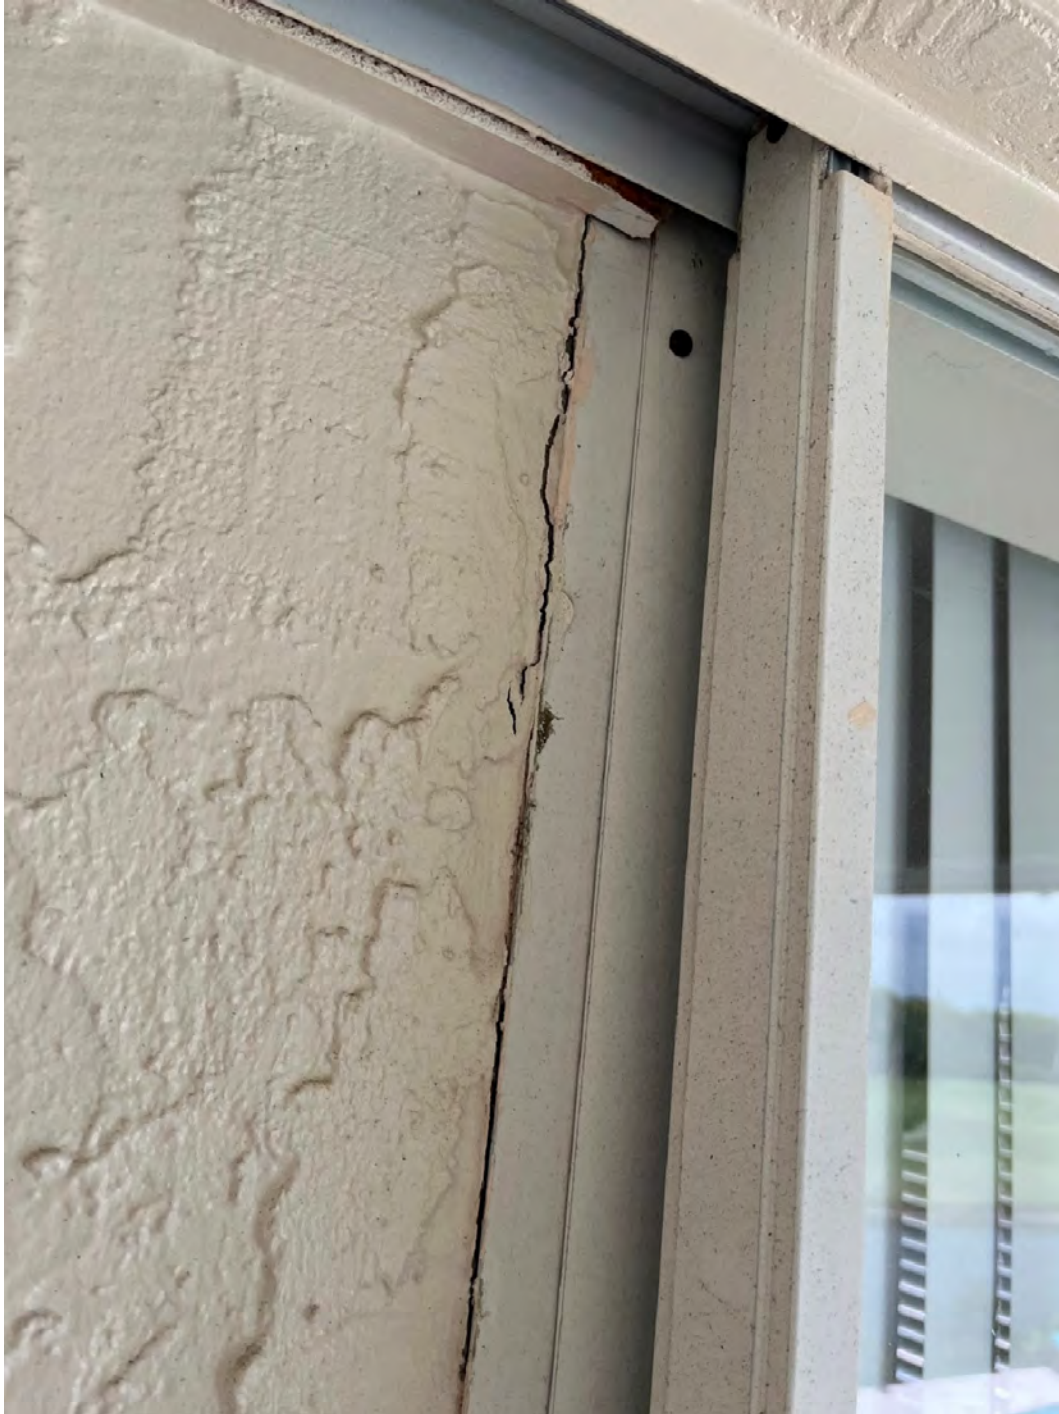
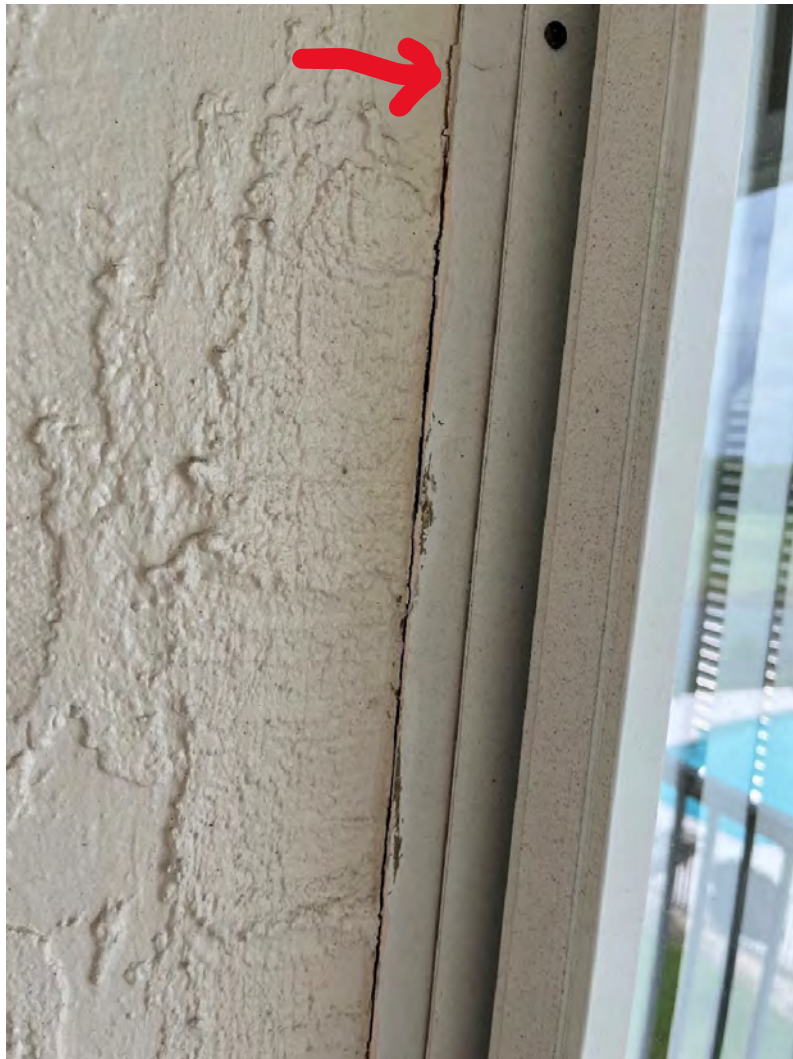
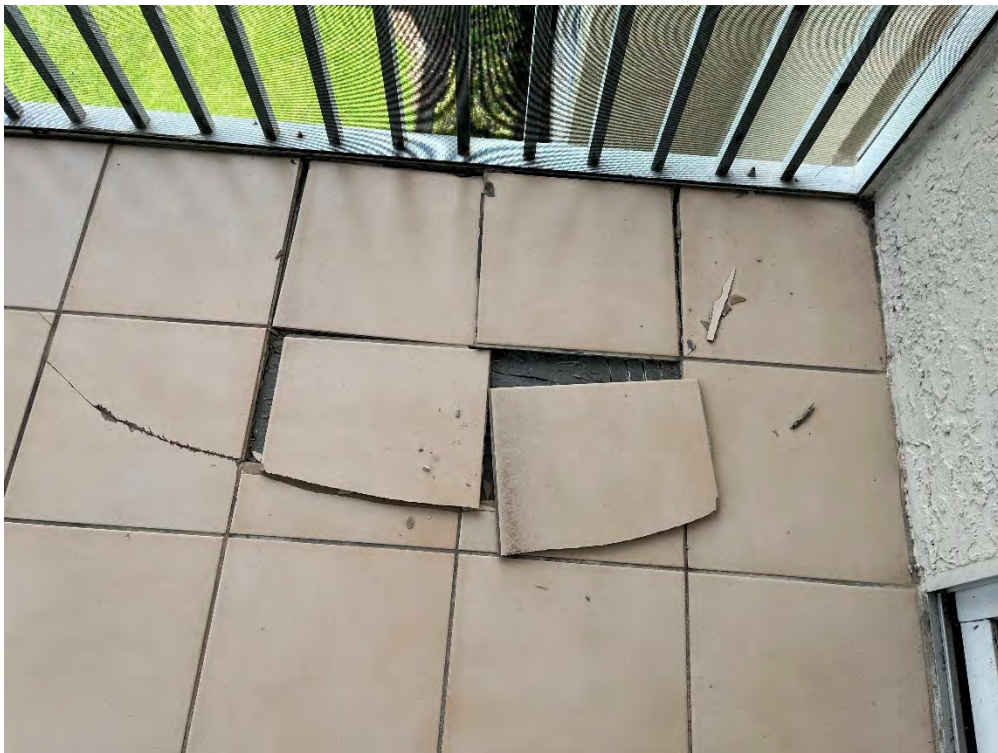
## Unit 131 – Building 3554

This Unit 131 had some significant cracks on the lanai adjacent the sliding glass door from the Master Bedroom. This being an outdoor area, it is more critical to maintain a tight seal from the elements. Suggest having these crack calked with a good grade of calk to match the color of adjacent surfaces. Also there were several loose tiles on the right end of the lanai. These tile protect the underlying slab from moisture penetration, which can cause rusting of reinforcing steel in the slab leading to a failure of the slab structure. Suggest having these loose tiles repaired as soon as possible.

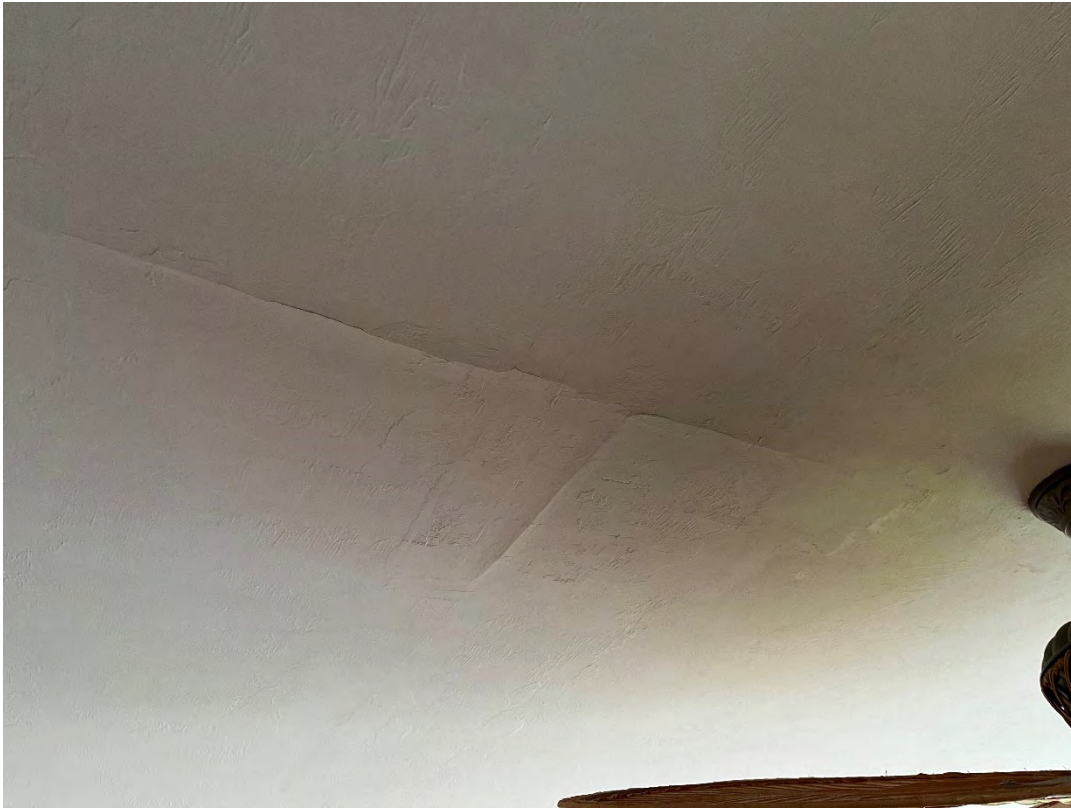
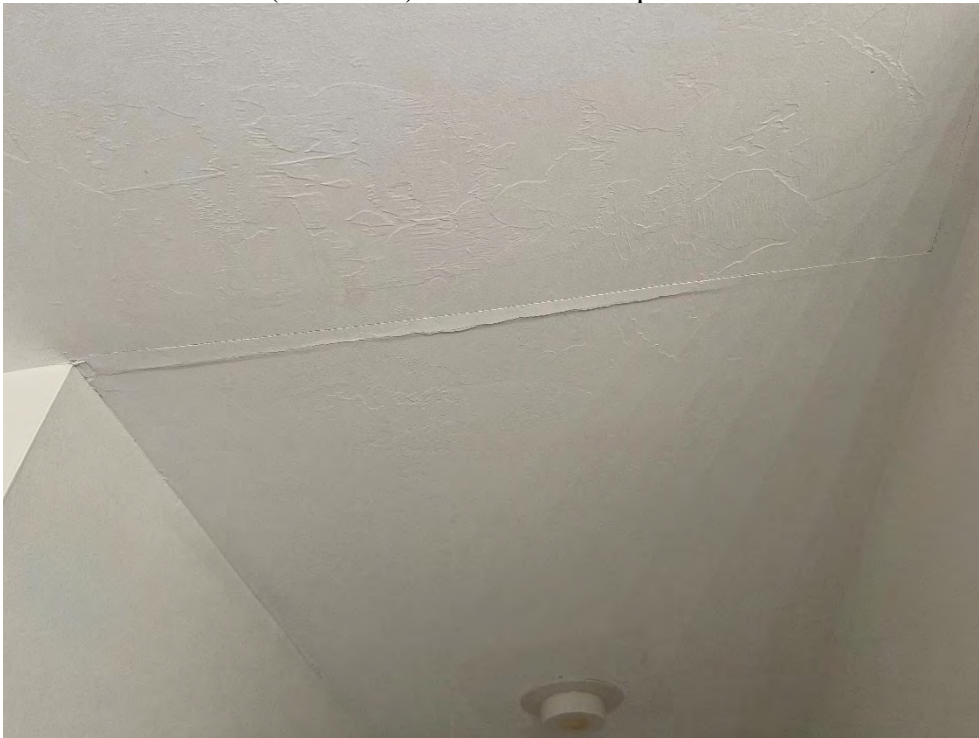
## Unit 136 – Building 3554

In this Unit 136, there were some odd-looking cracks in the ceiling near the ceiling fan in the Living Room. Since this unit is on the top floor, this condition was most likely caused by a previous roof leak that was resolved when the new roof was installed. Suggest having these cracks better repaired then monitored to be sure they do not return. Also there was a similar crack over the Master Shower (see below) that should be repaired at the same time.
