### COMPASS POINT SOUTH AT WINDSTAR

**Site-Visit Date:**  
August 09, 2023

**Report Date:**  
August 11, 2023

### 1.0 INTRODUCTION

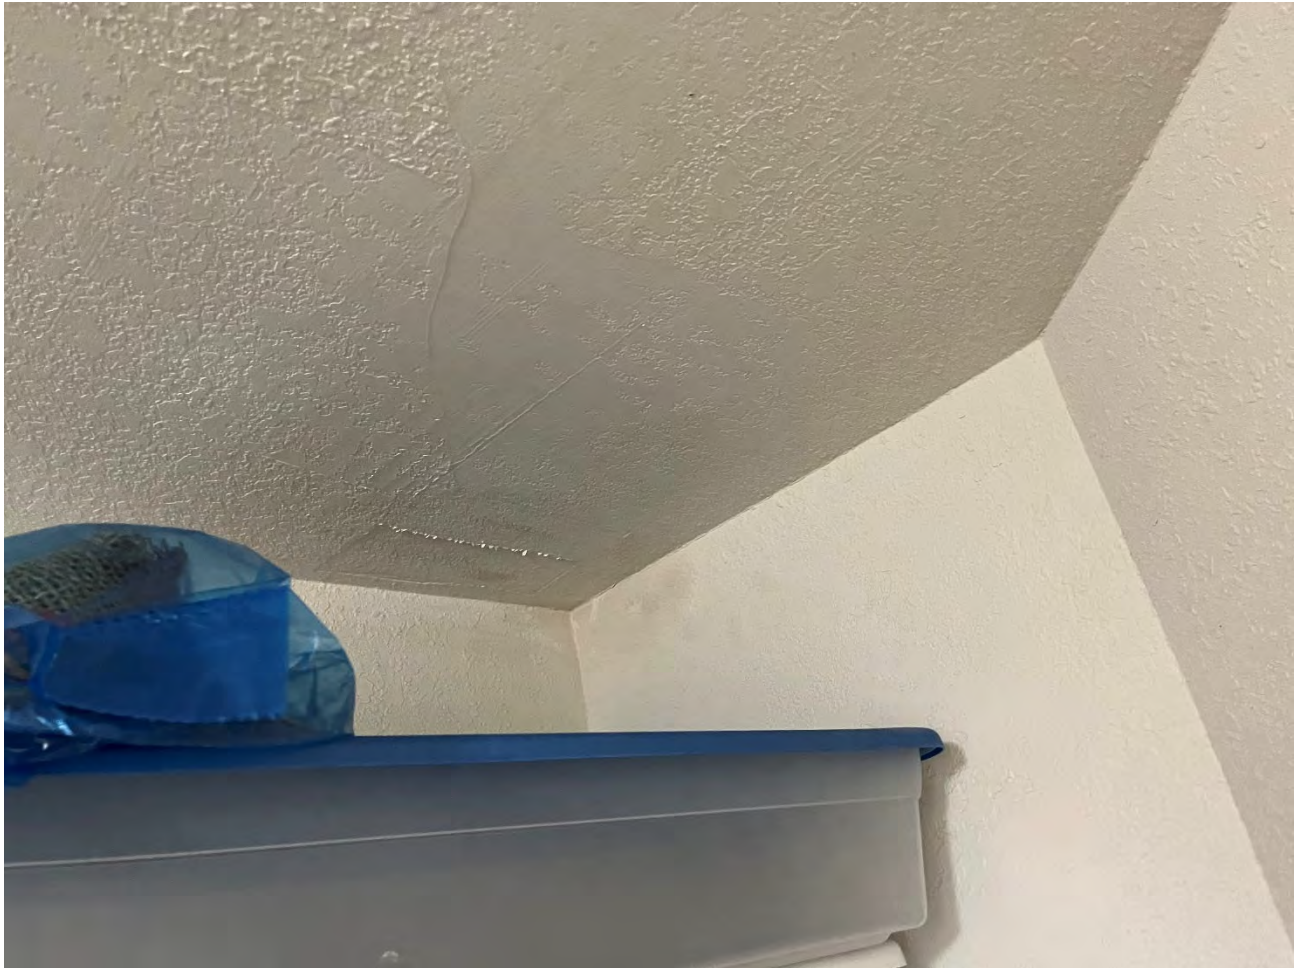
## Unit 112 – Building 3570

This Unit 112 had a water stain in the upper right corner of the left Master Closet. Residents were not aware of its existence. Most likely caused by a problem in the shower of the unit above this area and may have been corrected. Suggest having this stain painted over, then watched to see if the stain tries to reappear.

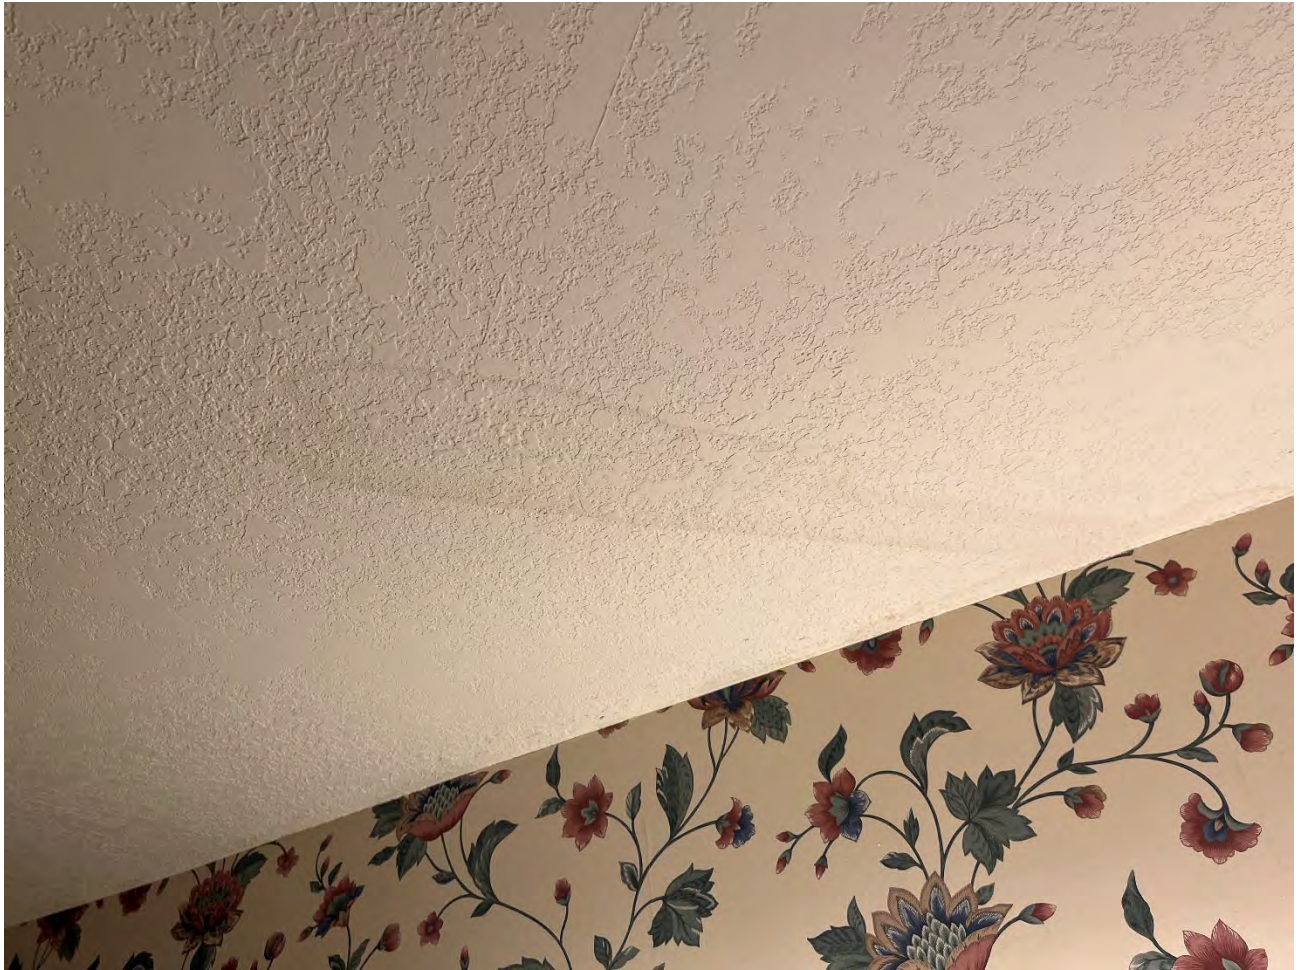
## Unit 121 – Building 3570

This Unit 121 has a significant water stain over the Master Bathroom vanities. Suggest having this stain painted over with a high hide primer (i.e. Kilz), then finish painted. Monitor the repairs to see if the staining tries to reappear.

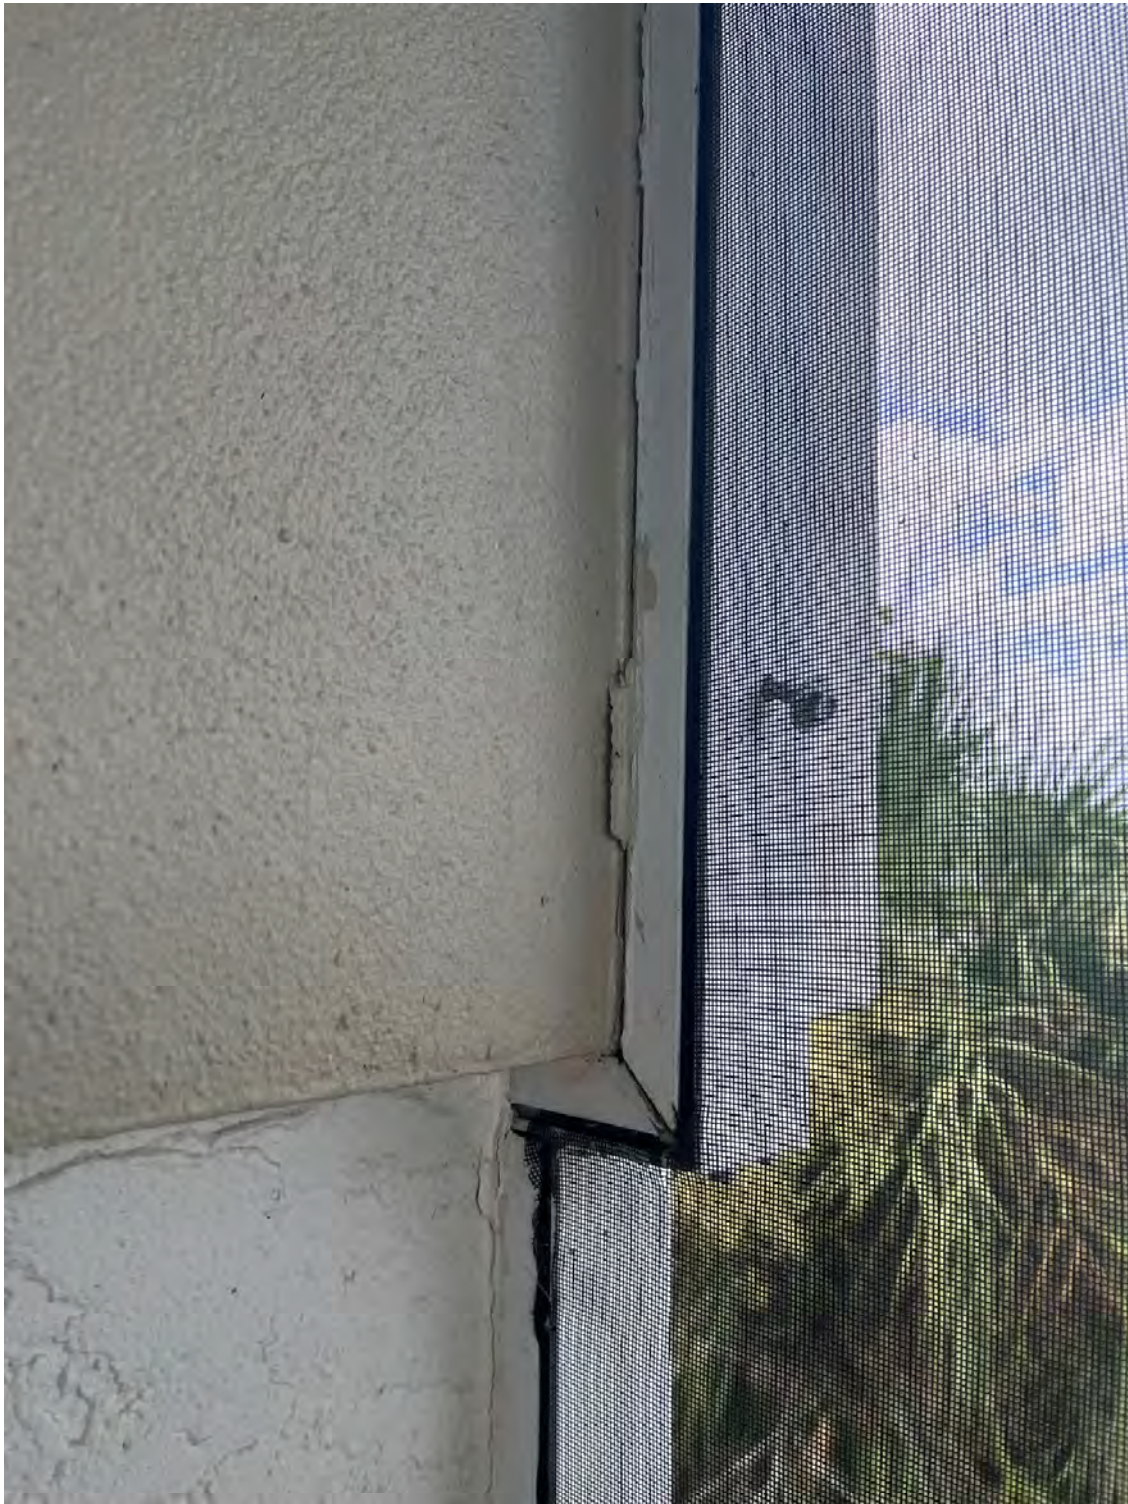
## Unit 132 – Building 3570

This Unit 132 had some aging calking around the screen frame. This condition is mostly cosmetic but may prevent some moisture from getting into substrate materials through the hole created by the screw in the photo. Even more important for the outside edge to be calked as well so that needs to be evaluated at the same time.

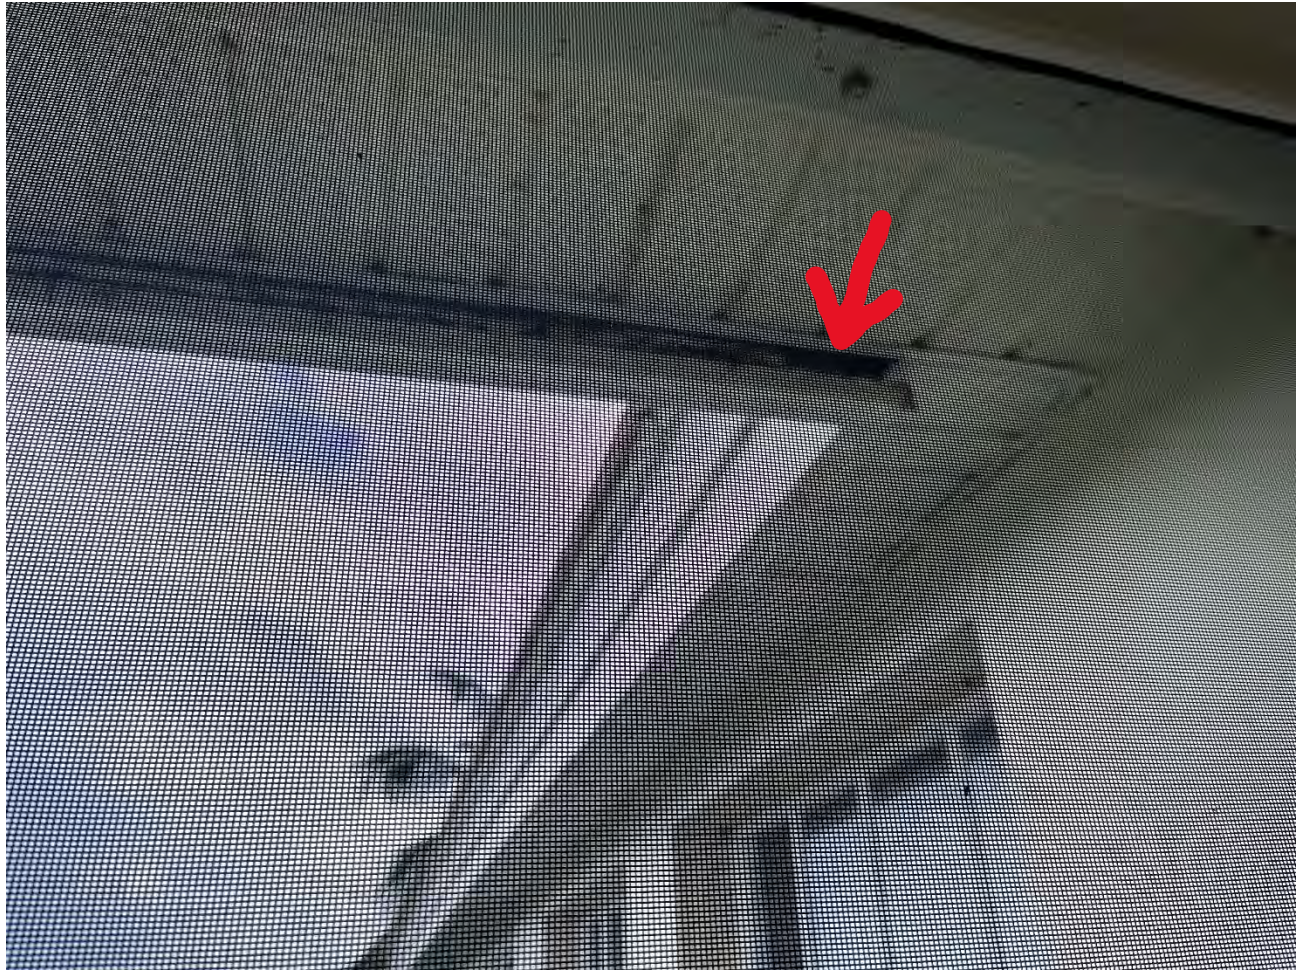
## Unit 134 – Building 3570

With apologies for screen obscuring photo, this overhang condition was observed on the right end of the lanai in this Unit 134. There appears to be a gap behind the fascia. This is troubling as it may be the result of deteriorated wood substrate that supports the fascia. Suggest having a framing contractor remove the fascia in this area to observe the condition of the wood components behind it. Replace any deteriorated parts, then reassemble the components to maintain an effective seal against the elements.

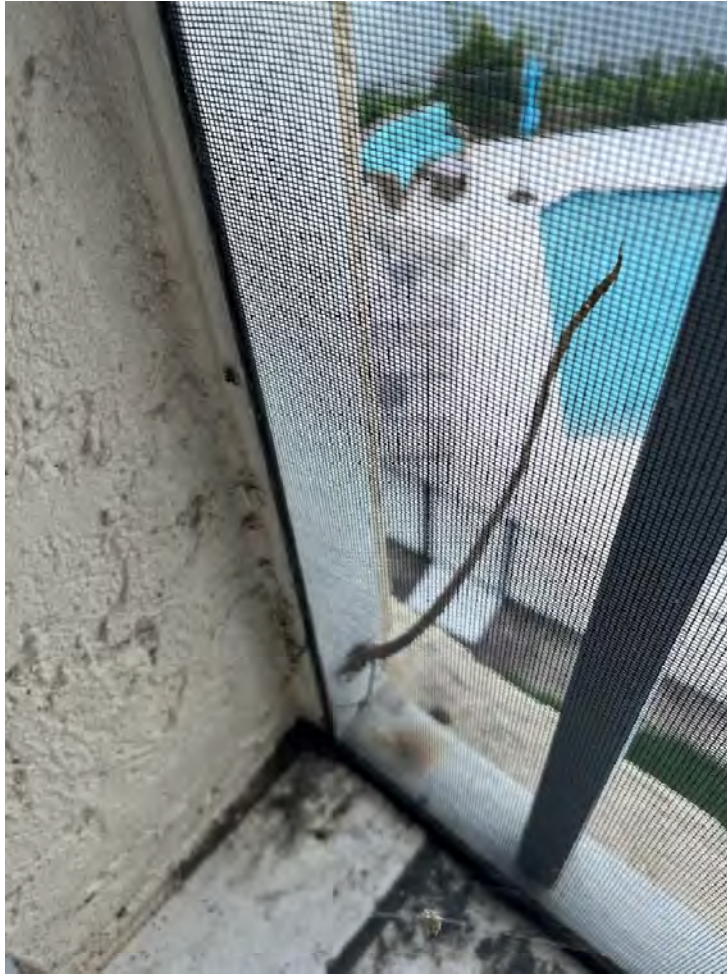
## Unit 136 – Building 3570

This Unit 136 was undergoing major renovations. All substrate materials looked normal in the exposed areas; however, there was a vine that was growing out of the screen frame that was disconcerting. Organics like these can do serious damage to building components. Suggest having this vine removed and any organics in the vicinity removed as well. Photo below of renovations for information purposes only.
