SECTION 1 – INTRODUCTION

BONDURANT
ARCHITECTURE

COMPASS POINT SOUTH AT WINDSTAR

Site-Visit Date:
August 09, 2023

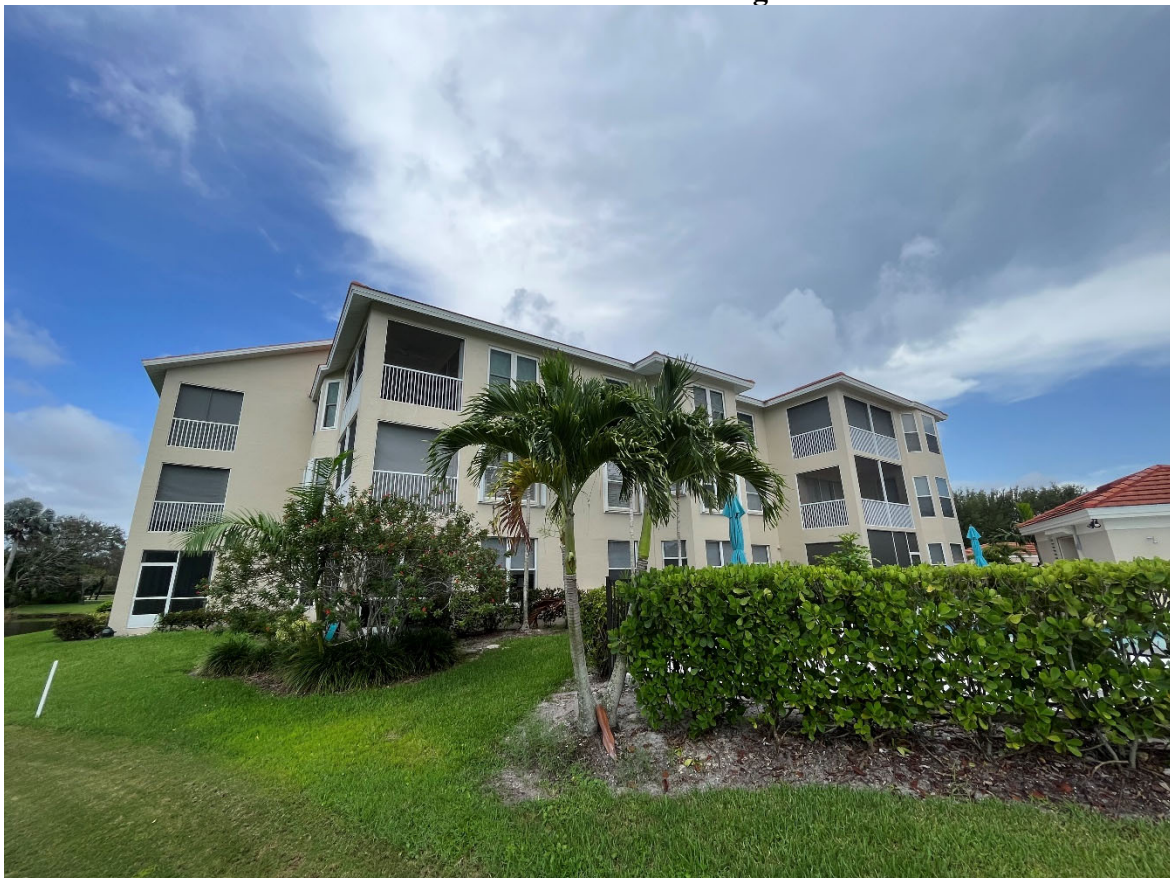
Left Side of 3522 Building

Stucco Repair Needed on Left side of Building 3522

There was an area at the intersection of the left wall and the overhang of the setback that looked to have a significant opening in the stucco finish just behind the metal flashing diverter. Suggest having a stucco technician review this intersection to assure no moisture is being allowed to penetrate behind the surface of the stucco.

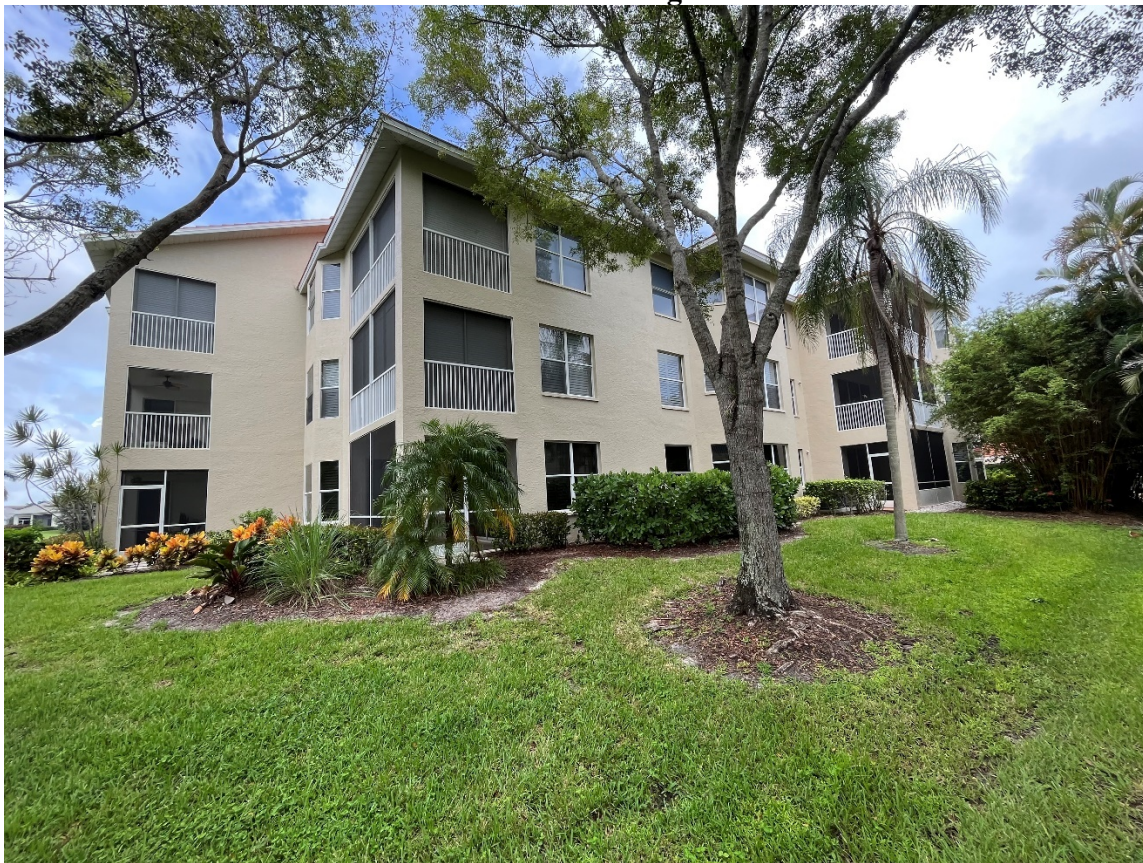
Left Side of Building 3538

Dirt Splashed onto Building

This condition was observed in a few locations on several of the buildings. The dirt is being splashed onto the building by the rain running off the roof and dropping a long distance to grade. Gutters on the rear of the building would solve this issue but if gutters are not desired, then more impact resistant materials on grade could prevent this splash up. See following photo of solution behind Building 3570 that well addresses this condition.

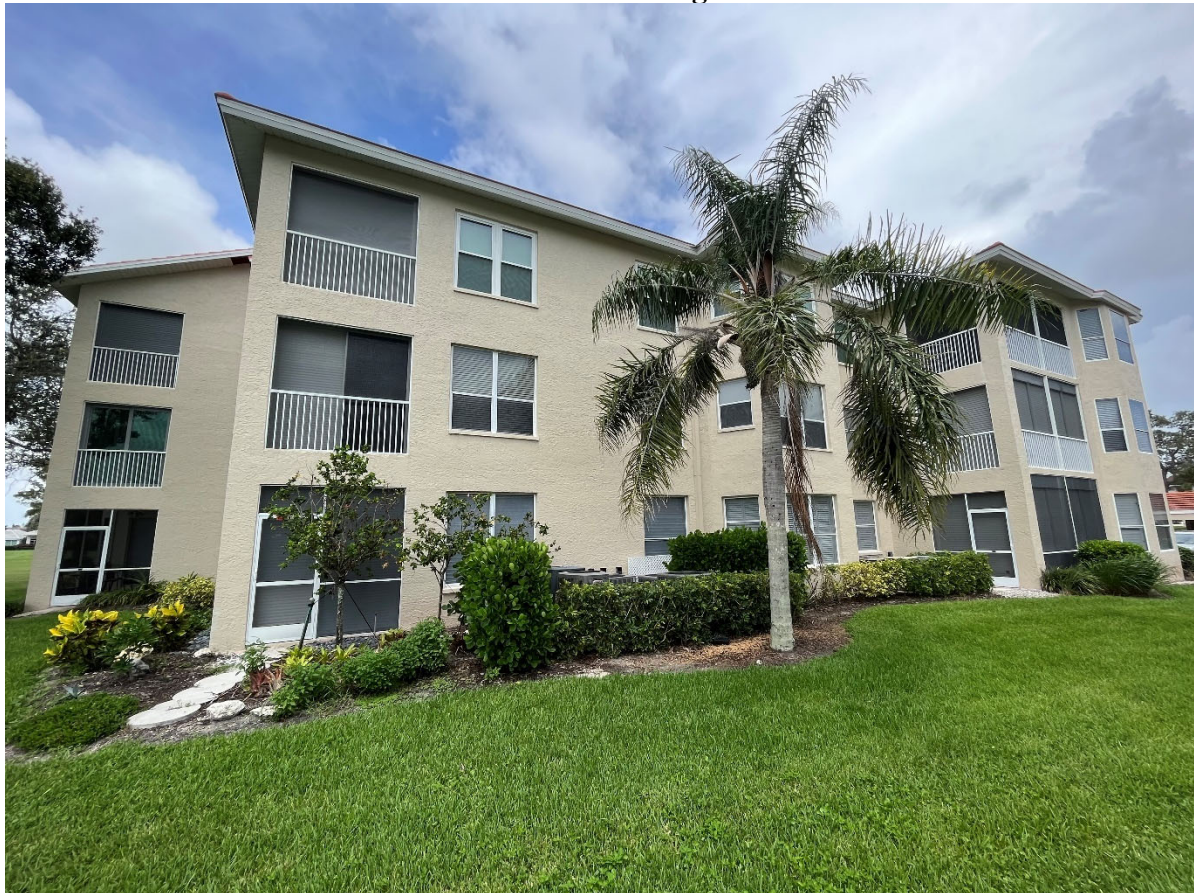
Left Side of Building 3554

Landscaping Growing Up Face of Building

In one of the inside corners on the rear of the building, a vine was being allowed to grow. These organic materials can damage the stucco and components on the face of the building. Suggest having this vine removed, and keep all landscaping trimmed off the face of the building.

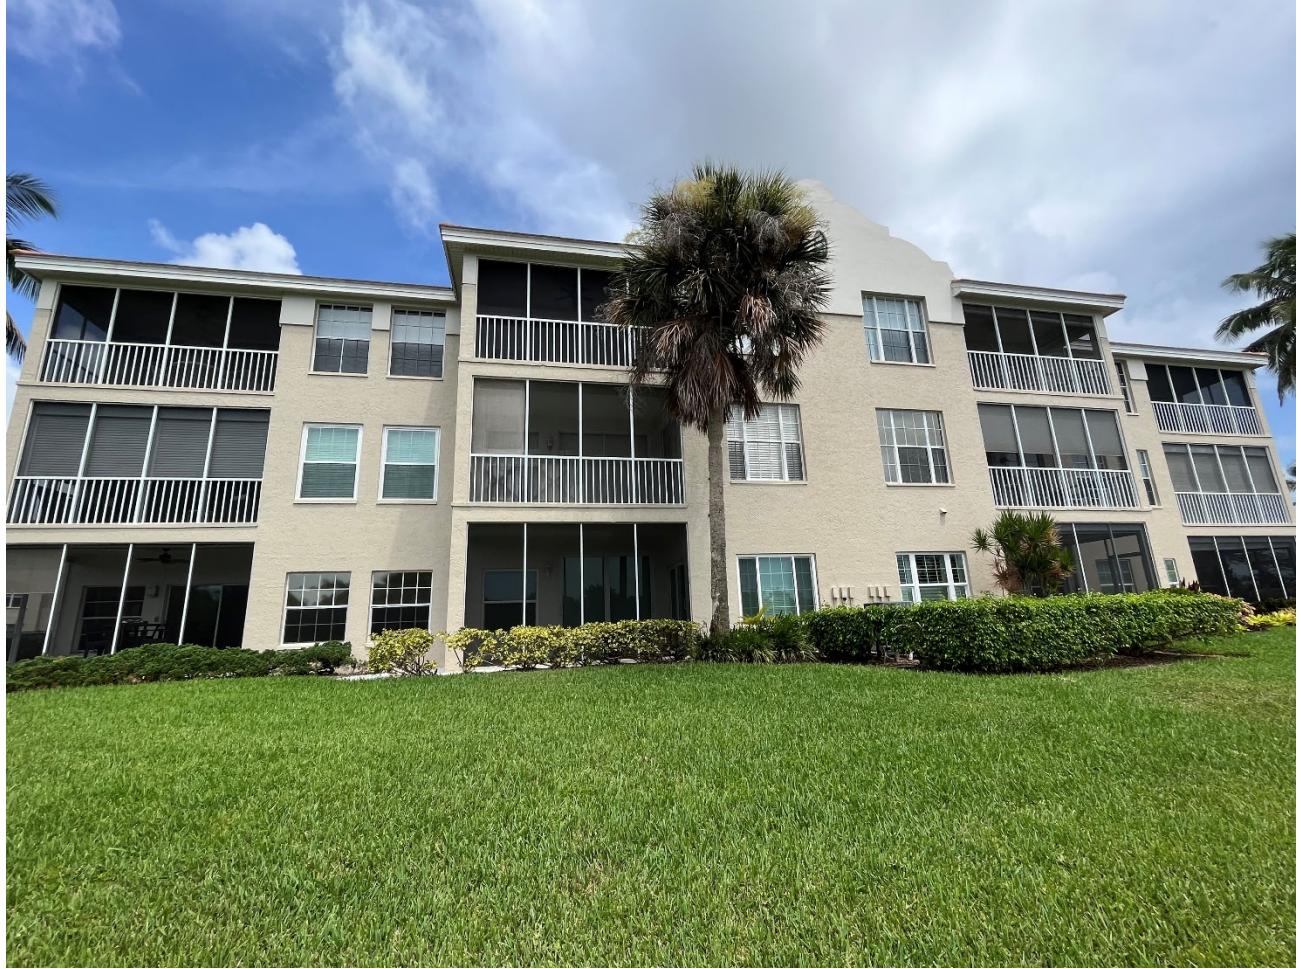
Rear View of 3570 Building

Exterior Conclusions

The exteriors of these four buildings did not exhibit any visual signs of structural deficiencies or impending failure. Each face was examined closely for any abnormalities or visual indications that more than this Phase One visual inspection is necessary. It is the opinion of this inspector that no visual signs or indicators are present currently, so no further investigations are warranted at this time.

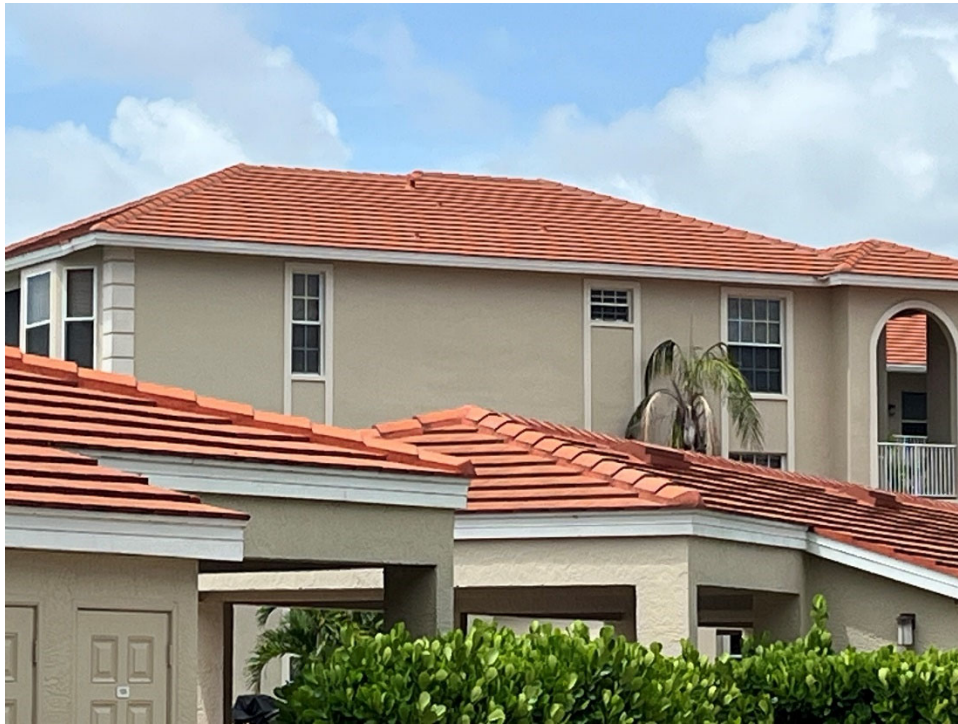
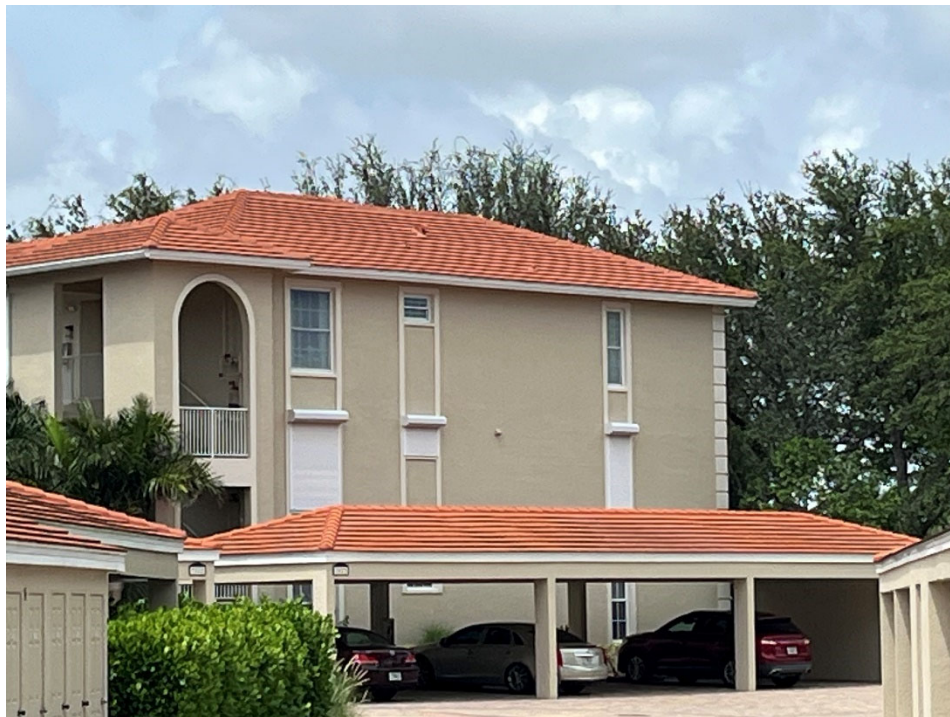
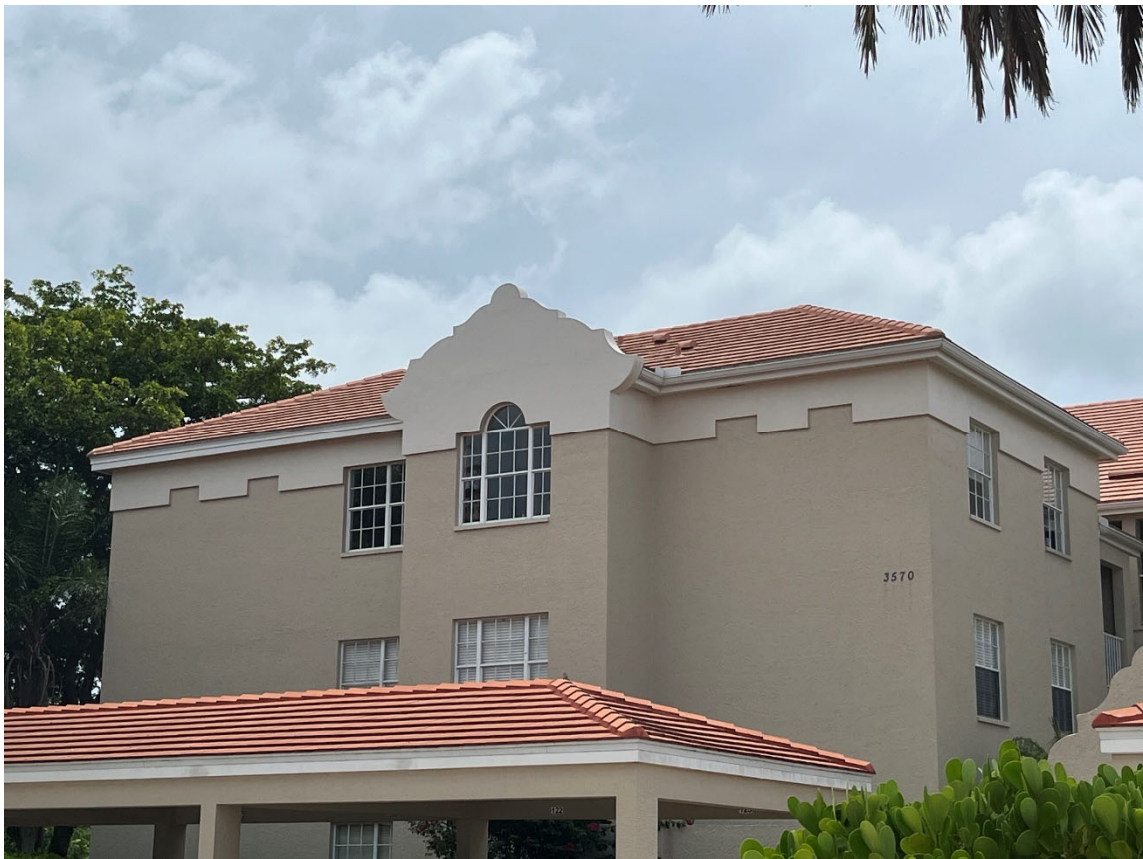
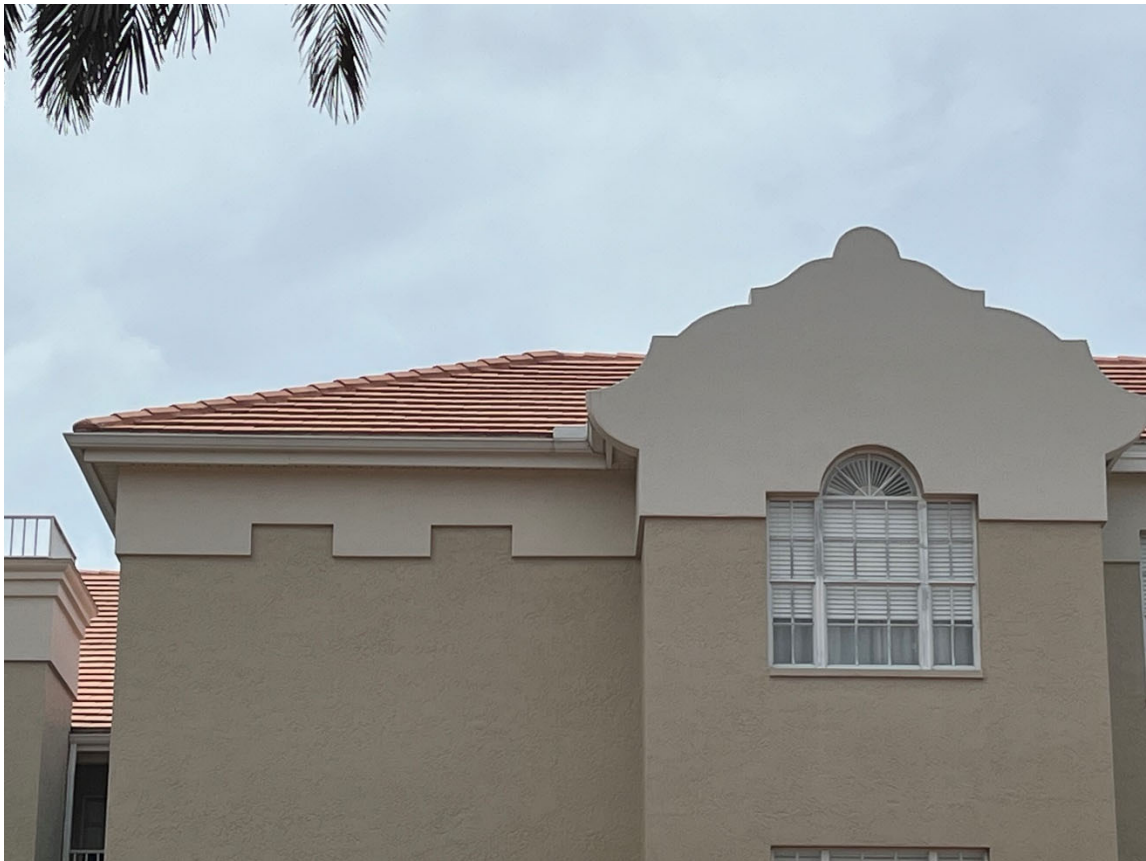
Roof Photos (Continued)

The roofing on these buildings were all of clay colored cement tiles. The roof was evaluated from the ground but there were no anomalies present in any face viewable from the ground. Residents said the roof had been replaced in recent years and its condition confirms this assertion. Following are some representative photos of the roof system. Inspector believes the remaining service life of the roofs to be in excess of twenty years.

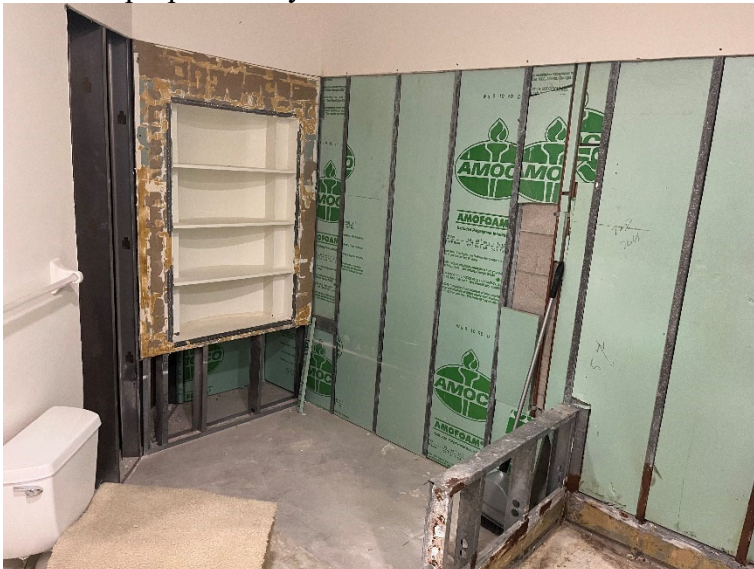
This Unit 136 was undergoing major renovations. All substrate materials looked normal in the exposed areas; however, there was a vine that was growing out of the screen frame that was disconcerting. Organics like these can do serious damage to building components. Suggest having this vine removed and any organics in the vicinity removed as well. Photo below of renovations for information purposes only.

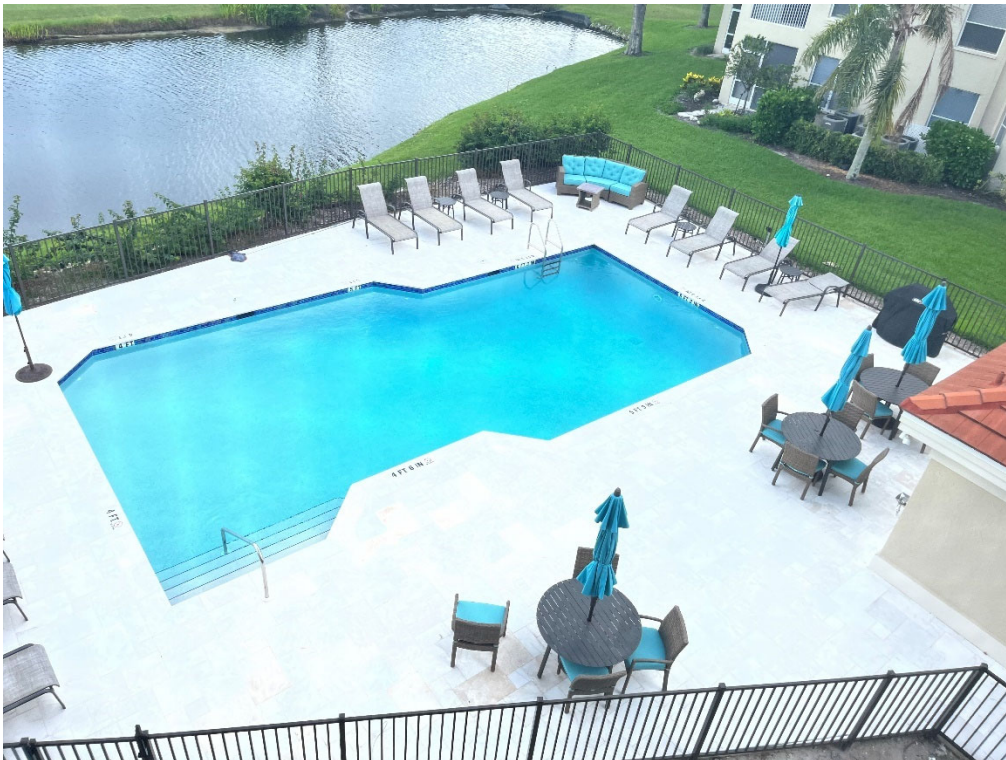
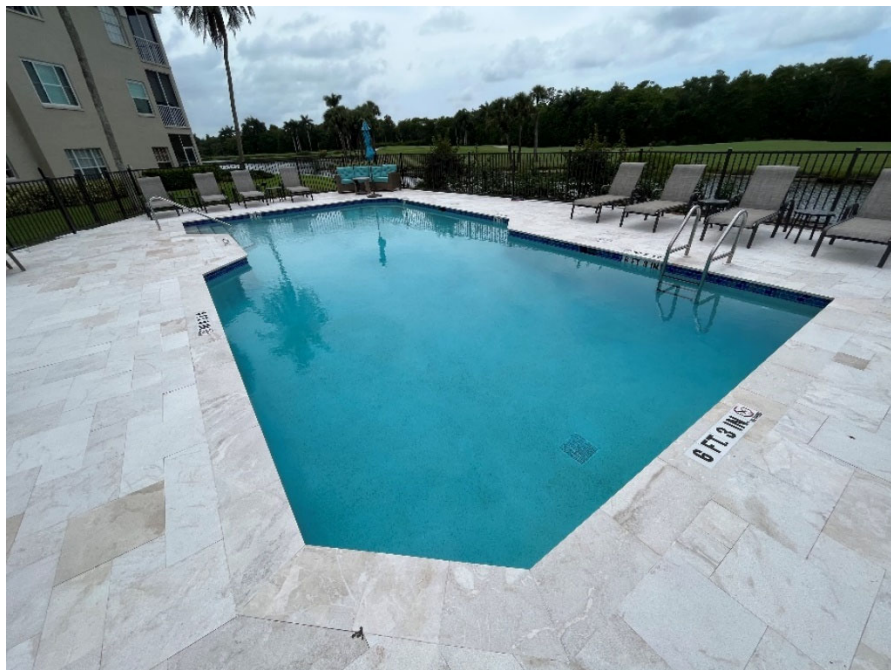
Pool between Buildings 3570 and 3554

Both of the swimming pools in this complex were inspected and evaluated. All components were functioning normally and no anomalies in the pool interior or deck were observed. Access was gained to the pool equipment rooms where equipment was functioning normally with no leaks in the associated piping. All electrical components in the pool rooms were well secured and professionally attached. Photos below are merely for information only.
