### COMPASS POINT SOUTH AT WINDSTAR

**Site-Visit Date:**  
August 09, 2023

**Report Date:**  
August 11, 2023

### 1.0 INTRODUCTION

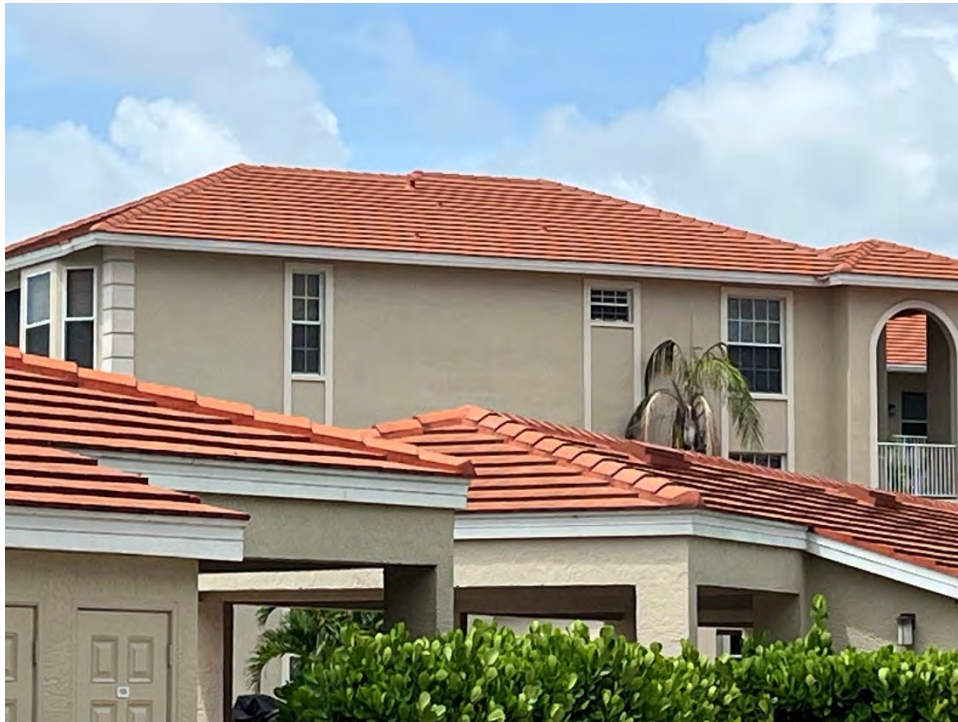
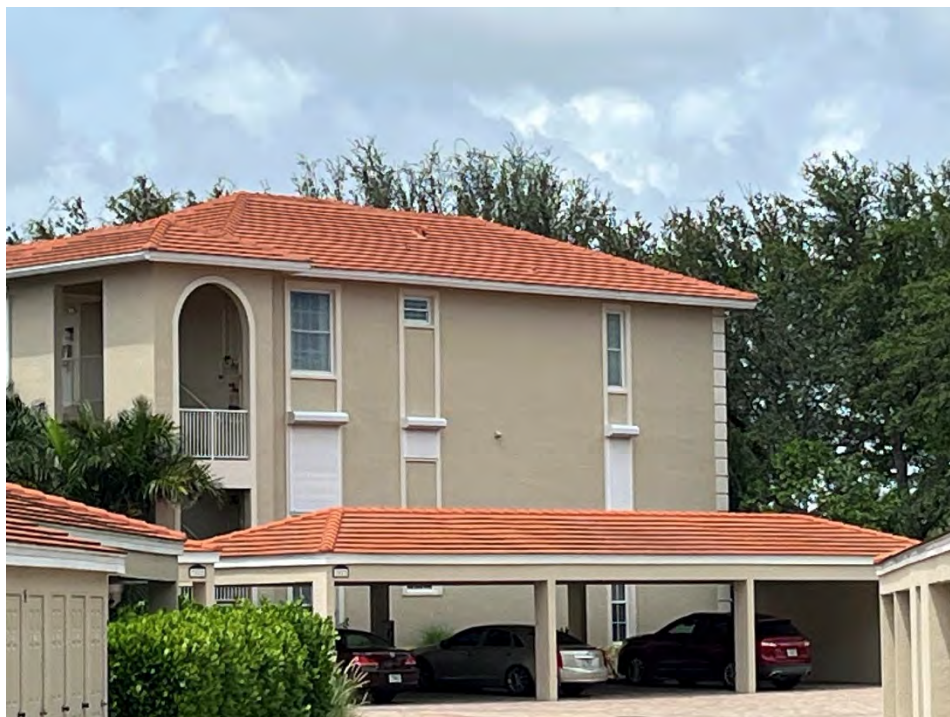
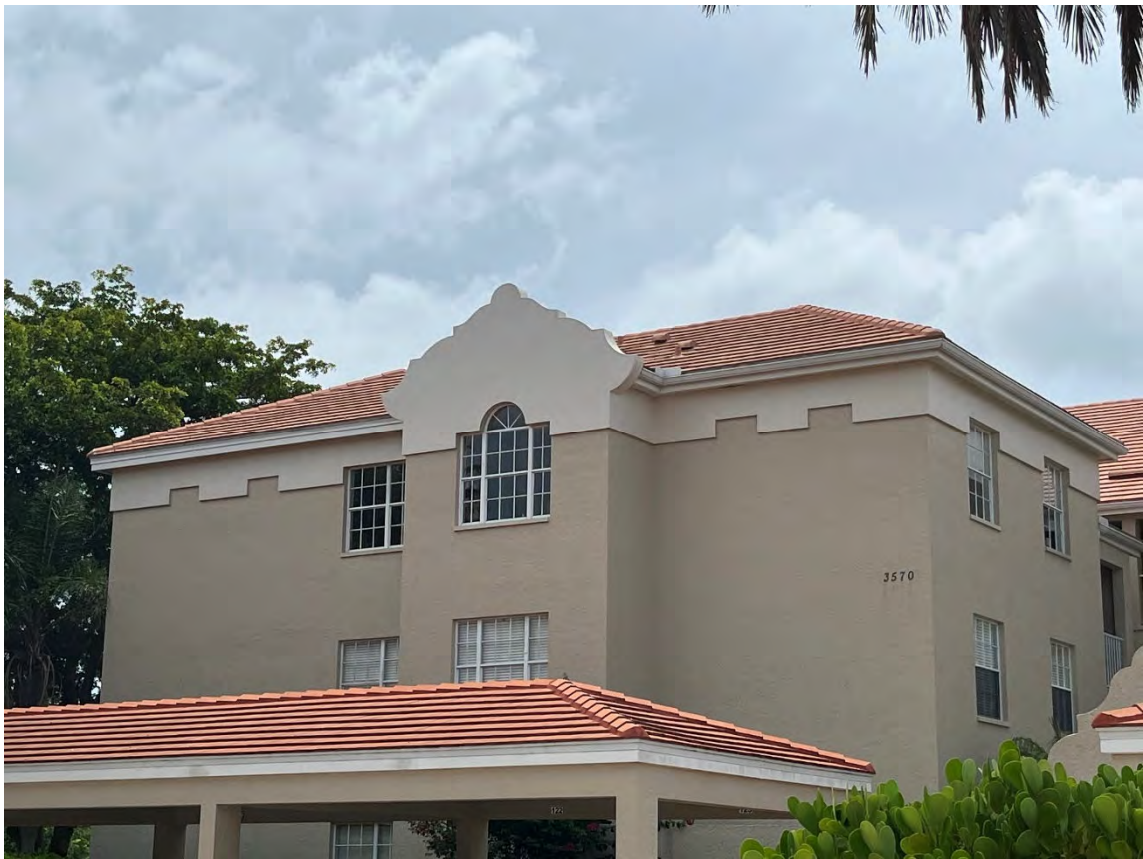
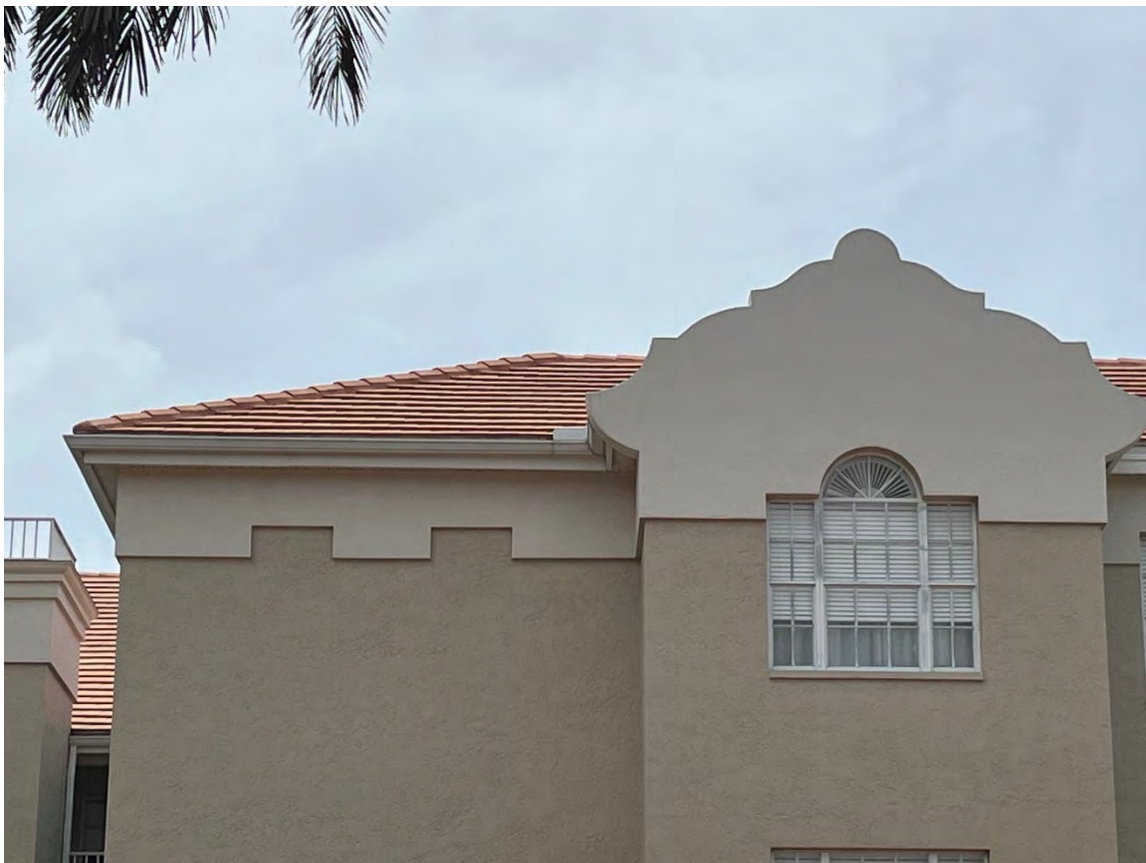
The roofing on these buildings were all of clay colored cement tiles. The roof was evaluated from the ground but there were no anomalies present in any face viewable from the ground. Residents said the roof had been replaced in recent years and its condition confirms this assertion. Following are some representative photos of the roof system. Inspector believes the remaining service life of the roofs to be in excess of twenty years.

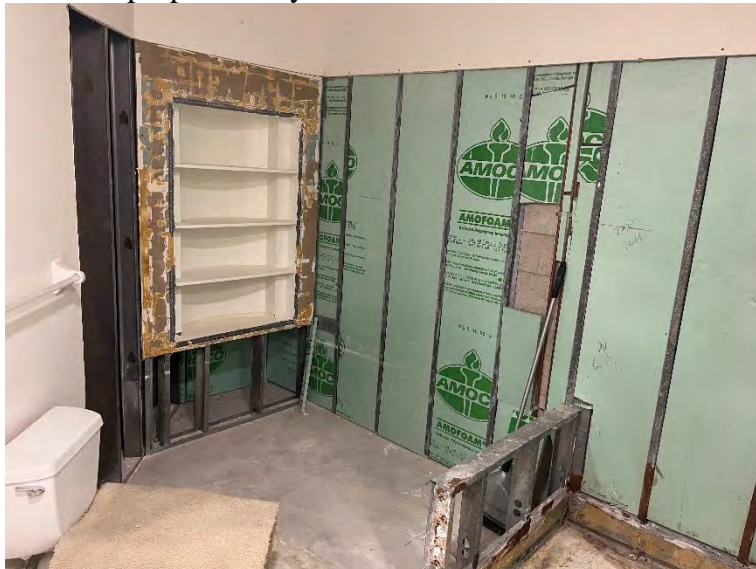
This Unit 136 was undergoing major renovations. All substrate materials looked normal in the exposed areas; however, there was a vine that was growing out of the screen frame that was disconcerting. Organics like these can do serious damage to building components. Suggest having this vine removed and any organics in the vicinity removed as well. Photo below of renovations for information purposes only.

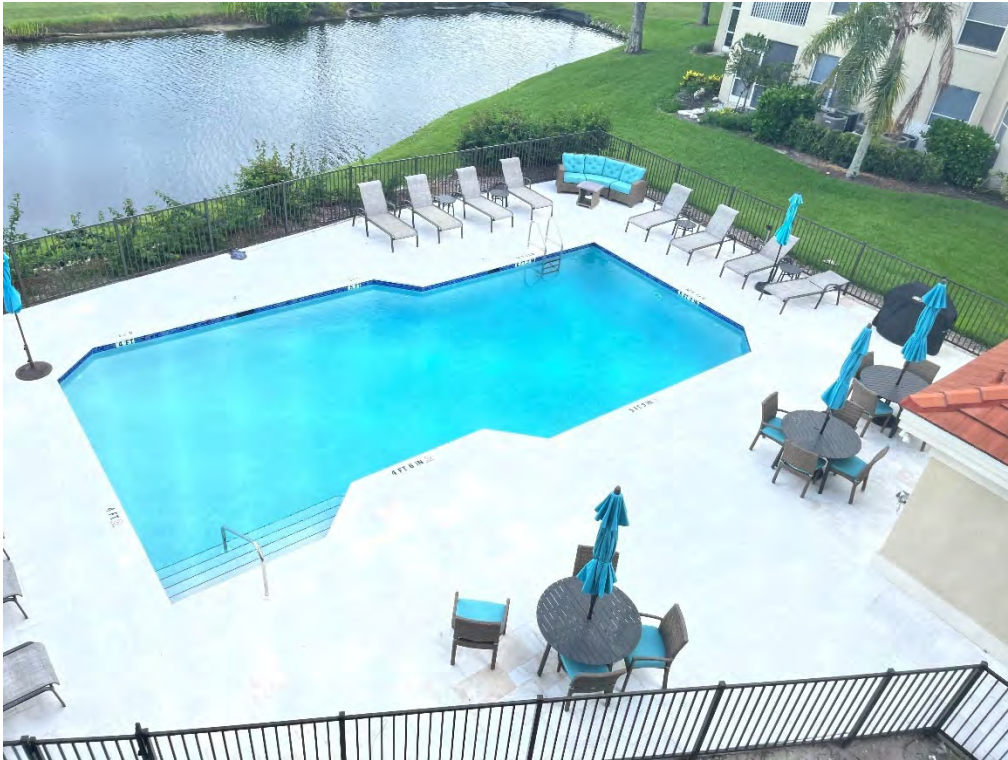
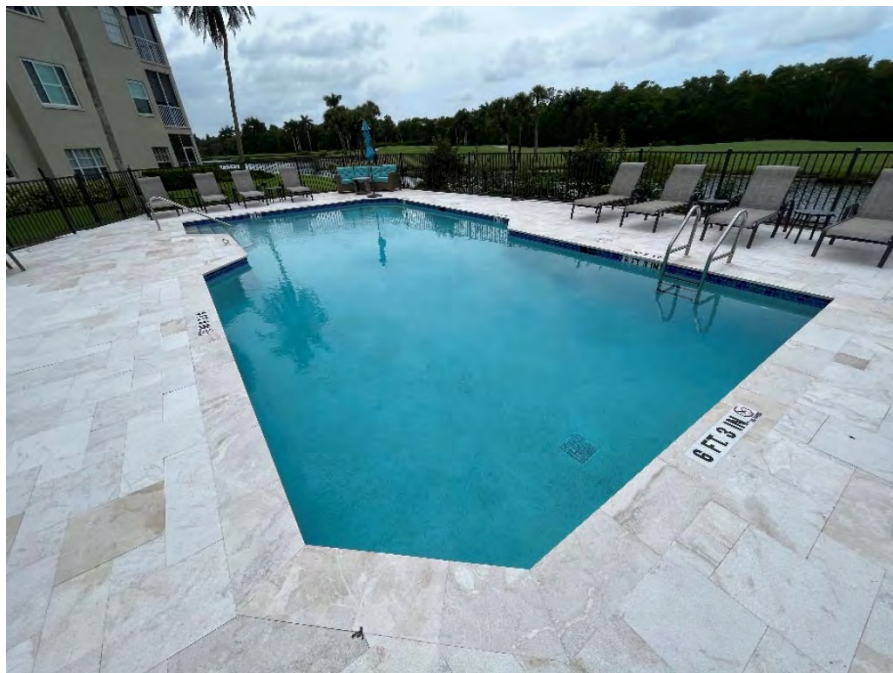
**Pool between Buildings 3570 and 3554**

Both of the swimming pools in this complex were inspected and evaluated. All components were functioning normally and no anomalies in the pool interior or deck were observed. Access was gained to the pool equipment rooms where equipment was functioning normally with no leaks in the associated piping. All electrical components in the pool rooms were well secured and professionally attached. Photos below are merely for information only.
